FEASIBILITY STUDY FOR
THE EXTERIOR RESTORATION OF
SOMERSET OLD TOWN HALL

1480 COUNTY STREET, SOMERSET, MASSACHUSETTS

PREPARED FOR
THE SOMERSET HISTORICAL COMMISSION
MAY 9, 2016

CHRISTOPHER T. WISE - ARCHITECT, 103 SUMMIT AVENUE, PROVIDENCE, RI

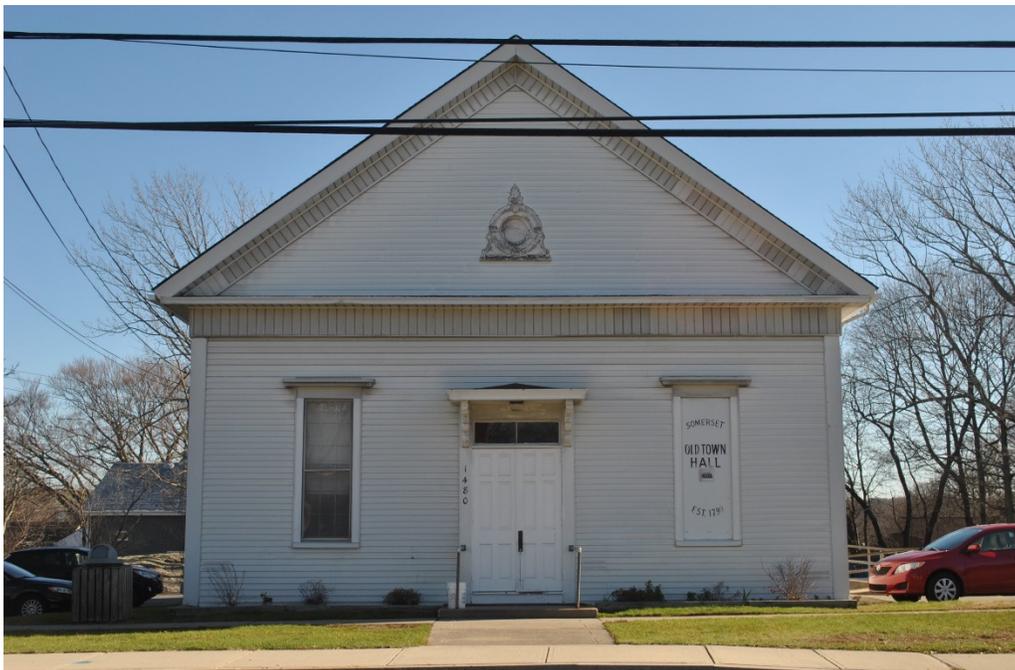
Old Town Hall today, West Elevation showing aluminum siding

The most significant remediation to the building will be the removal of the aluminum siding and trim. Explorations under the aluminum have shown that much of the original siding, which is wood clapboards, and other original wood trim, including corner boards, fascias, soffits, friezes, cornices, casings and the like, remain in place under the aluminum. Not until the siding is completely removed will it be possible to fully assess the condition of these elements. In the case of the siding, the old wood clapboards may be salvageable, requiring only patching, scraping and painting. But it is more likely that complete replacement of the siding will prove to be in the best interests of the building. New cement fiber clapboards, which have the identical appearance of wood clapboards, would provide a long lasting, highly durable, paintable and low maintenance exterior. Estimates provided in this report reflect the range of costs that might be associated with repair or replacement of the clapboard siding.

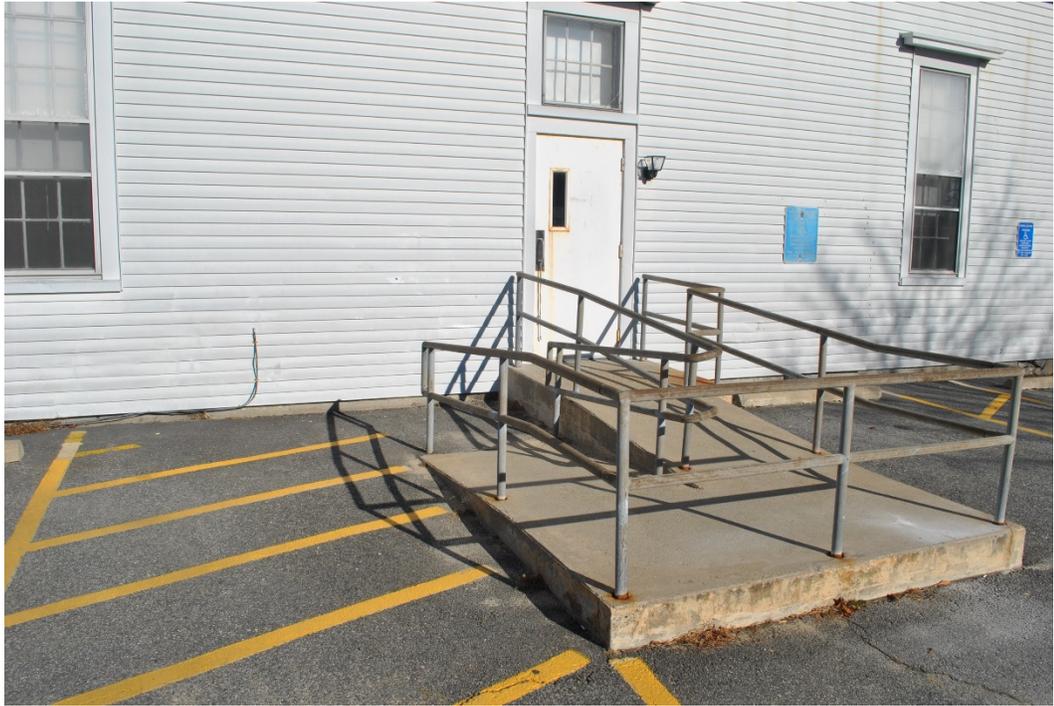
Accessible entry and wheelchair ramp

Relocation of the accessible entry from the south side of the building to the main entry on the west will accomplish two important goals:

2. Removal of the concrete wheelchair ramp will allow modification of the parking area on the south side of the building. There will be space for three handicap parking spaces, including one van space. There is adequate space in the driveway between the Old Town Hall and the adjacent Library to allow these parking spaces to be shifted away from the south wall of the Old Town Hall, which has been damaged by cars parked too close.

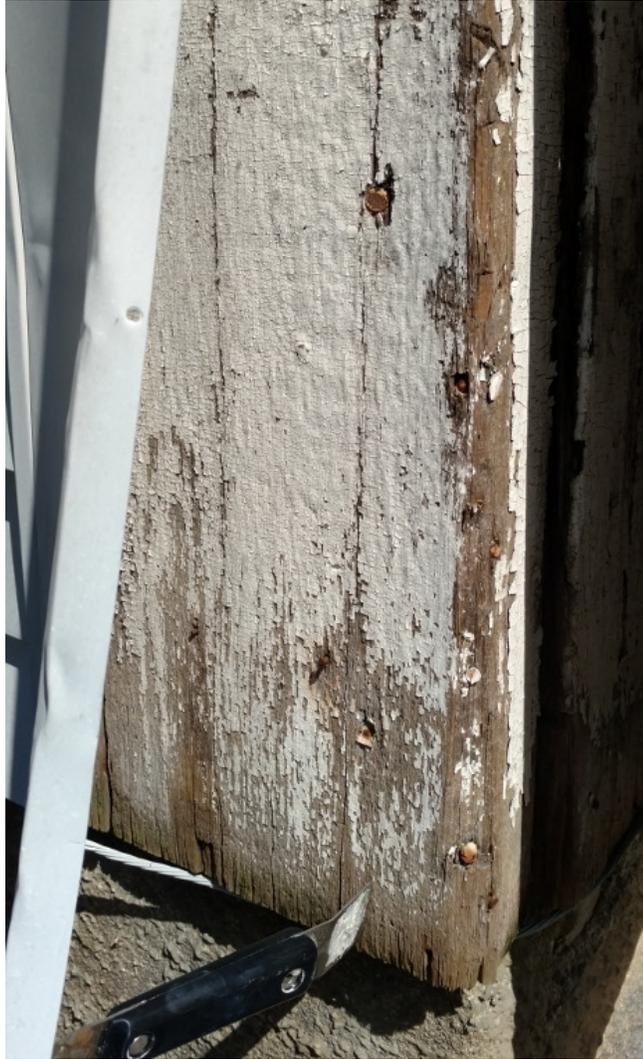
Corner Board under aluminum trim

As is the case with the siding, the condition of the surviving wood trim under the aluminum will not be fully known until the aluminum is completely removed. Spot investigations under the aluminum show that much of the trim is still in place, although damage and missing elements are apparent. For instance, at least two of the ten inch wide corner boards are cracked, and the bed molding between the soffit and frieze of the main roof cornice was removed to facilitate installation of the aluminum. The trim may only require miscellaneous repairs, scraping and painting, or extensive replacement. Under any circumstance moldings and other elements that are entirely missing should be replaced. Again, estimates in this report will cover a range of costs for repair or replacement of the trim.

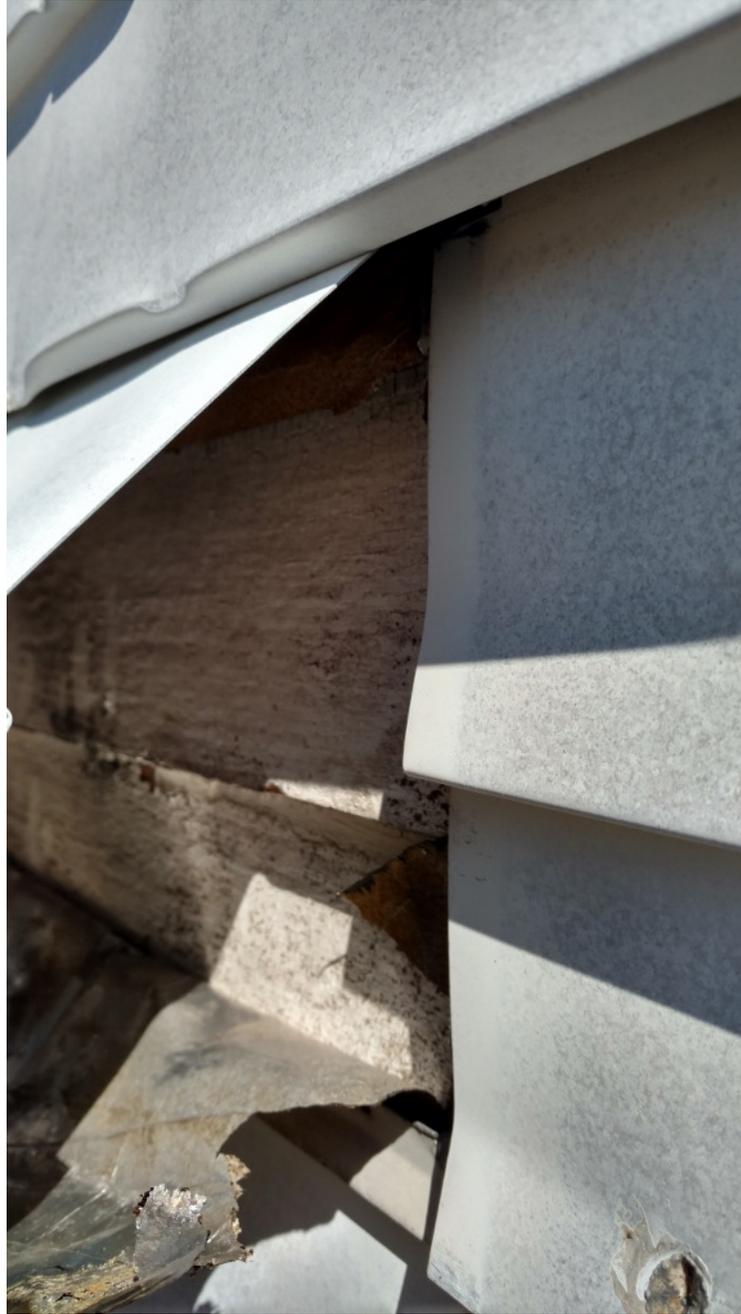
Clapboards under aluminum siding

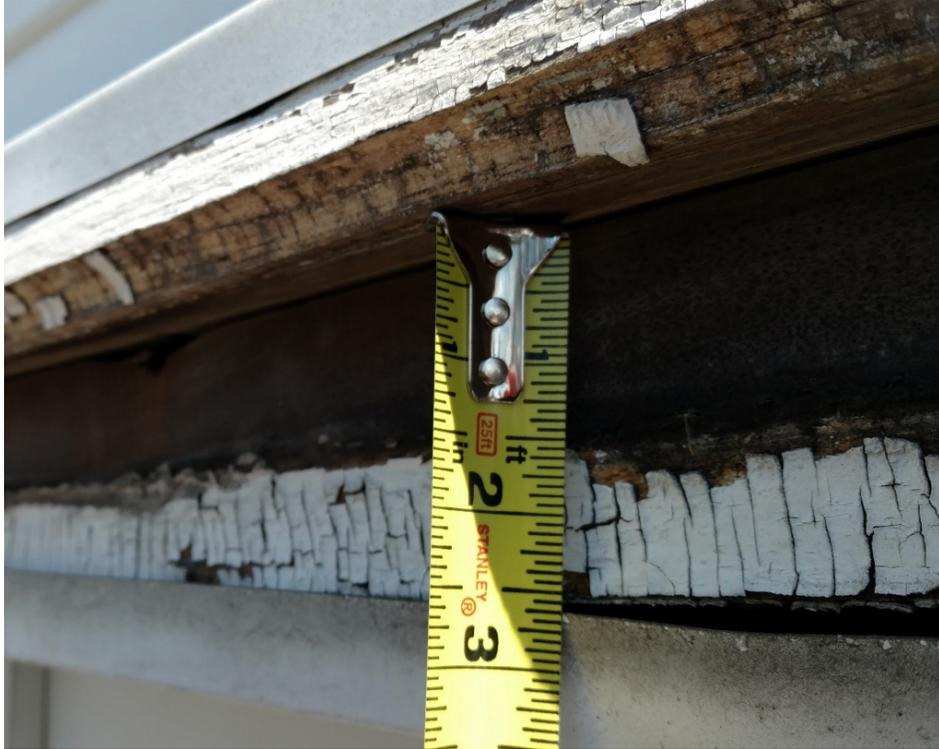
Window cornice – paint line indicates missing bed molding

The precise condition of the exterior window trim will not be known until the aluminum is removed. It is encouraging to note, though, that when the aluminum was installed, the window cornices were not hacked off and the wide sills were not cut back, as often happens with the installation of aluminum or vinyl siding. It is clear, however that a small bed molding under the cornice was removed. This can easily be replaced.
