# Water & Sewer Commissioners

August 8, 2023

## Water Turbidity and Discoloration

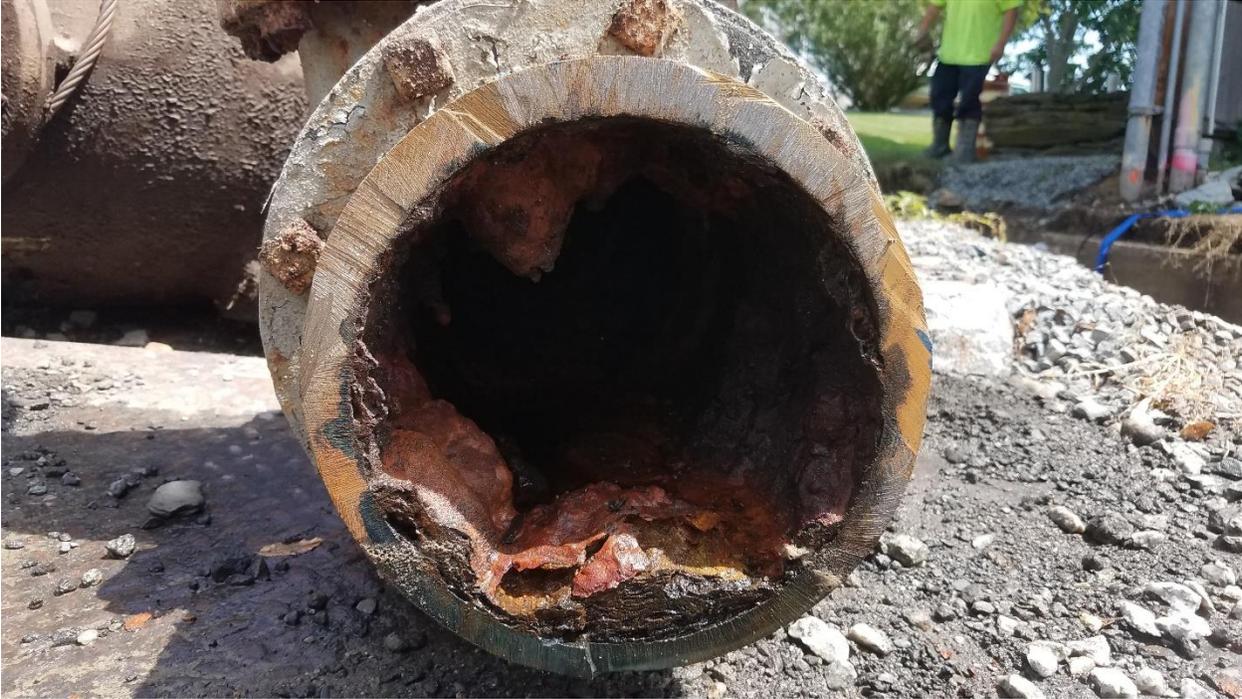
Turbidity/discoloration can occur when the clear, pristine water from the treatment facility enters our distribution system, of which, large sections are over 100 years old. Over time, the inside surface of these cast iron pipelines deteriorates (called tuberculation) and the water passing through picks up flaked off cast iron and other naturally occurring minerals in the water. As the pipe ages, the tuberculation worsens to the point that it will reduce the interior diameter of the pipelines. **Based on observations of our pipe interiors, the age of the pipelines in question, and the reports of turbidity/discoloration received, it is time for these 100-year-old pipelines to be rehabilitated or replaced.** The rehabilitation process involves in-place cleaning and lining with cement-mortar. Rehabilitation restores the pipelines to like-new flow capacity and eliminates the turbidity/discoloration problem where applied. Additionally, rehabilitation is a cost-effective alternative to pipe replacement, in some cases. There are several miles of pipeline in Somerset that consist of 2" galvanized steel. These aged pipelines must be replaced because they are rotted through and/or too small to meet proper water delivery standards. Additionally, there are miles of asbestos cement pipe that should be replaced due to constant breakage and inadequate size. Recently, the Board of Selectmen designated \$1,000,000 of ARPA funding to the Water Department to be used for replacement of water mains. This funding is a good start but much more will be needed to finish the job.

It should be noted that recent street repaving over some sections of our older pipelines, involving vibratory rolling, may have exacerbated the turbidity/discoloration problem. The vibration can cause the tuberculation to flake off and be carried away by the water flowing in the pipe.

100-Year-Old 12" Unlined Cast Iron Water Main with Tuberculation

Somerset Water Department has implemented its annual water main flushing program. However, excessive flushing to reduce turbidity/discoloration presents its own set of problems, such as the need for increased chlorination. Somerset Water Department has embarked on a pipe rehabilitation program to address the water turbidity/discoloration problem related to our large bore water mains. If our customers have any questions, they should feel free to contact our office.

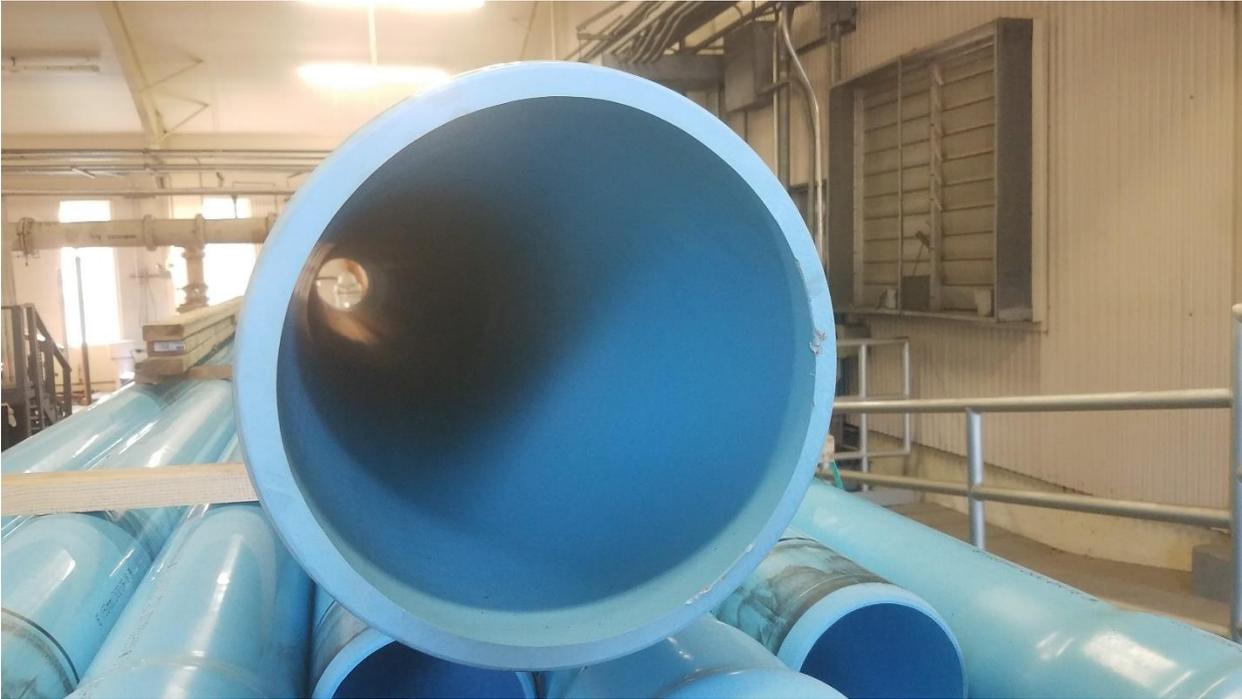
New 12" PVC Water Main

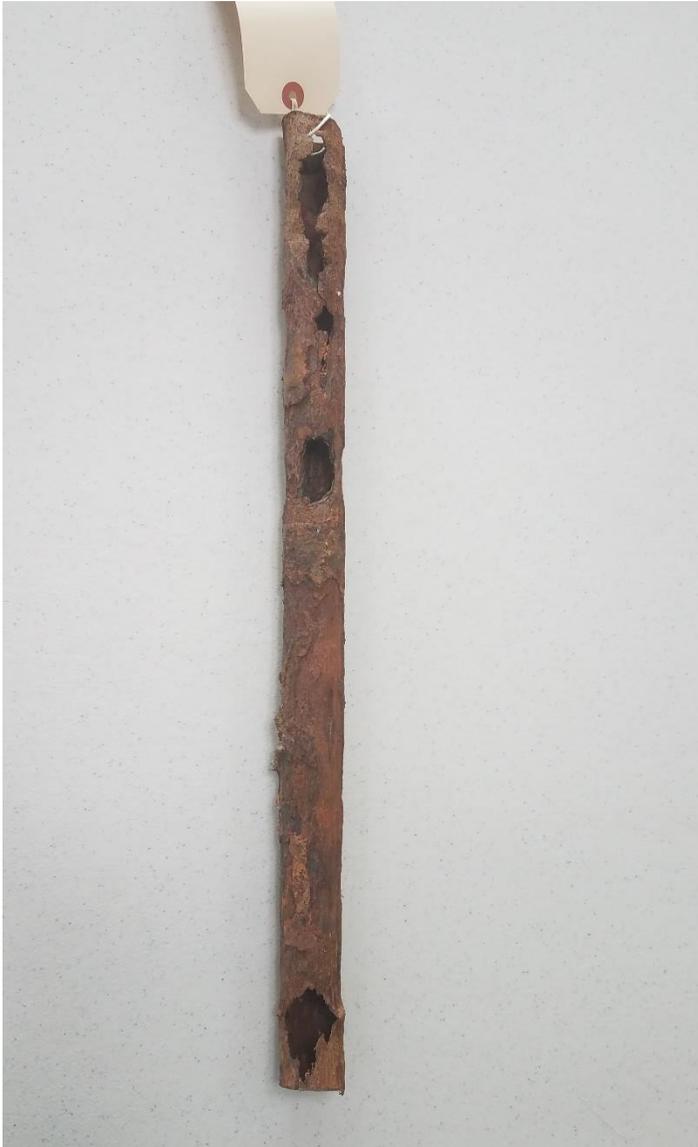
70-year old 1" Galvanized Steel Water Service Line

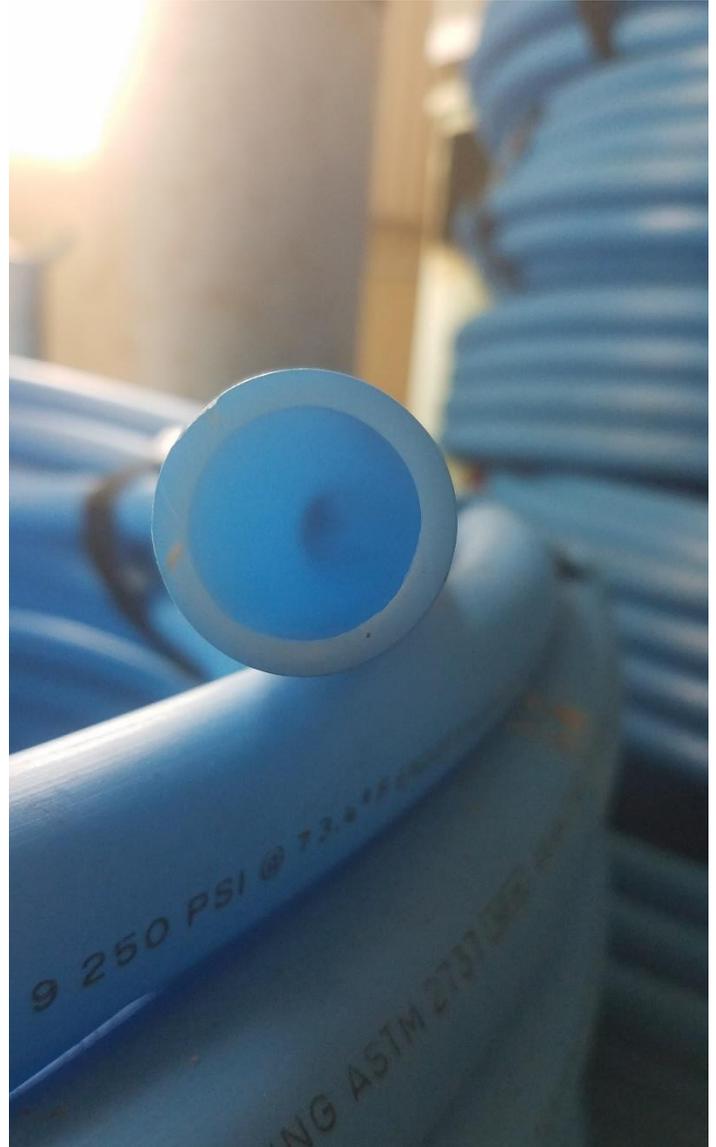
New 1" Polyethylene Water Service Line
