Integrated Water Resources Management Plan

TOWN OF SOMERSET, MA

JANUARY 2020

WRIGHT-PIERCE

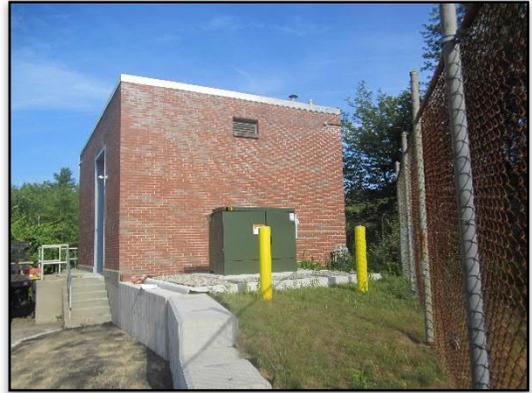
The pump station includes two vertically mounted end-suction centrifugal pumps each with a capacity of 11 MGD. While pumping in parallel the two pumps can produce approximately 15 MGD. Data on the pumps are presented in Table 2-1.

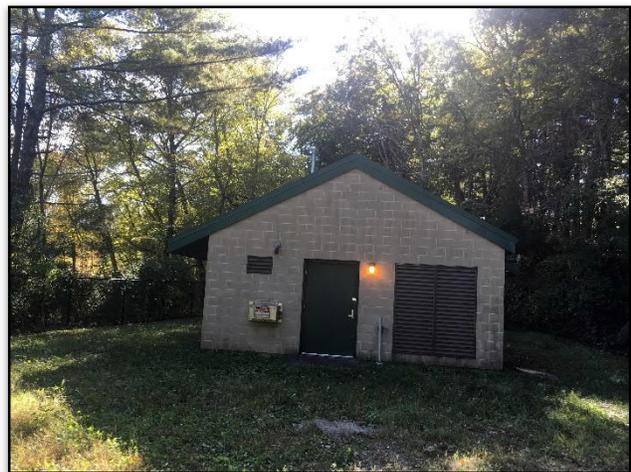
The third source of supply used by the Town of Somerset is the Gravel Packed Well No. 2 located in Dighton. This well was constructed in 1952 and has a safe yield of 0.58 MGD. The well is 12-inch diameter and 38-feet deep.

In 1996, the Town conducted upgrades to the Dighton Well facility which included redevelopment of the well and replacement of the well pump in kind. Due to issues encountered during the redevelopment of the well, the well facility was subsequently replaced in 2002 to rehabilitate the facility to proper condition. The 2002 replacement included the demolition of the existing structure and everything inside except for the well. The facility was replaced with a building that included a new well pump and motor for the existing well, a chemical storage room for sodium hydroxide, the installation of the UV disinfection unit, and a standby generator for back up power. In 2017, the well pump was replaced, and the well was cleaned through surging. In 2018, upgrades to the liquid chemical feed systems were completed.

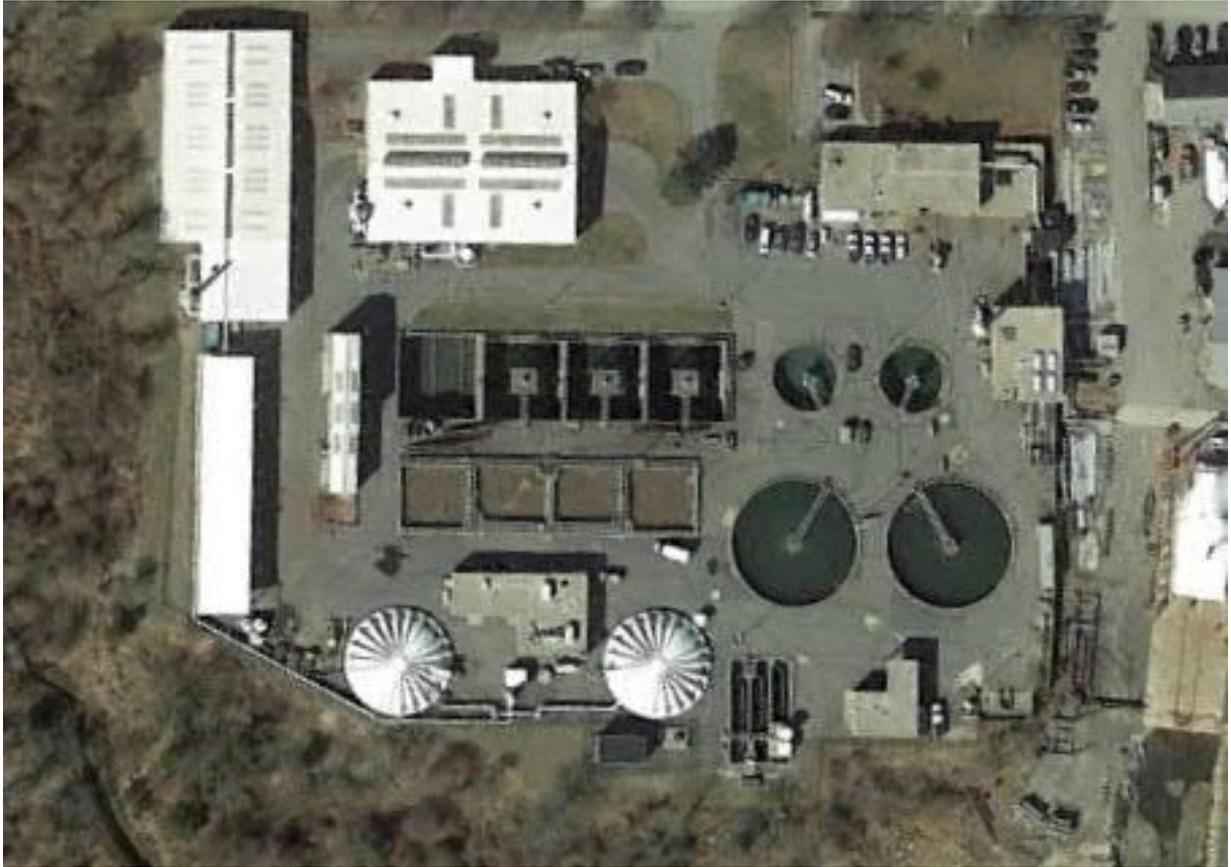
FIGURE 6-1
SOMERSET WATER POLLUTION CONTROL FACILITY

Under the 2004 NPDES Permit (NPDES #MA0100676), the Town of Somerset's WPCF has a permitted design flow of 4.2 MGD. **Figure 6-1** shows an aerial photo of the WPCF. A simplified process schematic is shown in **Figure 6-2**. A new draft NPDES permit is expected to be received by the Town soon. The permit is discussed in further detail later in this section. Currently (through 2018) the treatment facility has an annual average influent flow of 3.3 MGD.

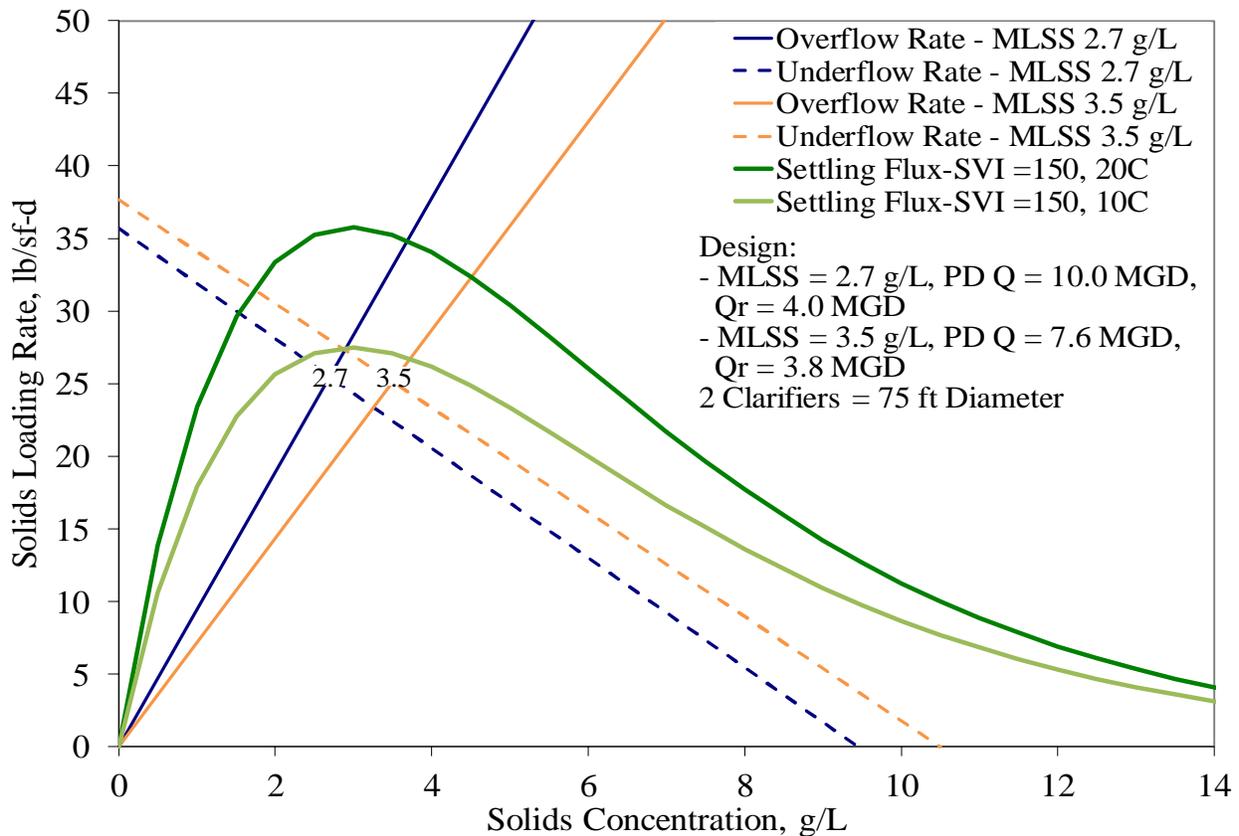
As shown in **Figure 6-11**, at operating MLSS concentrations between 2,700 and 3,500 mg/L, the secondary clarifiers will not be overloaded and therefore have sufficient capacity to settle the MLSS and comply with an effluent TSS limit of 30 mg/L. The performance analysis of the secondary clarifiers indicates that winter conditions are the limiting factor for their capacity. At a water temperature of 10 °C (Winter), the clarifiers can be operated at a peak daily flow of 7.6 MGD

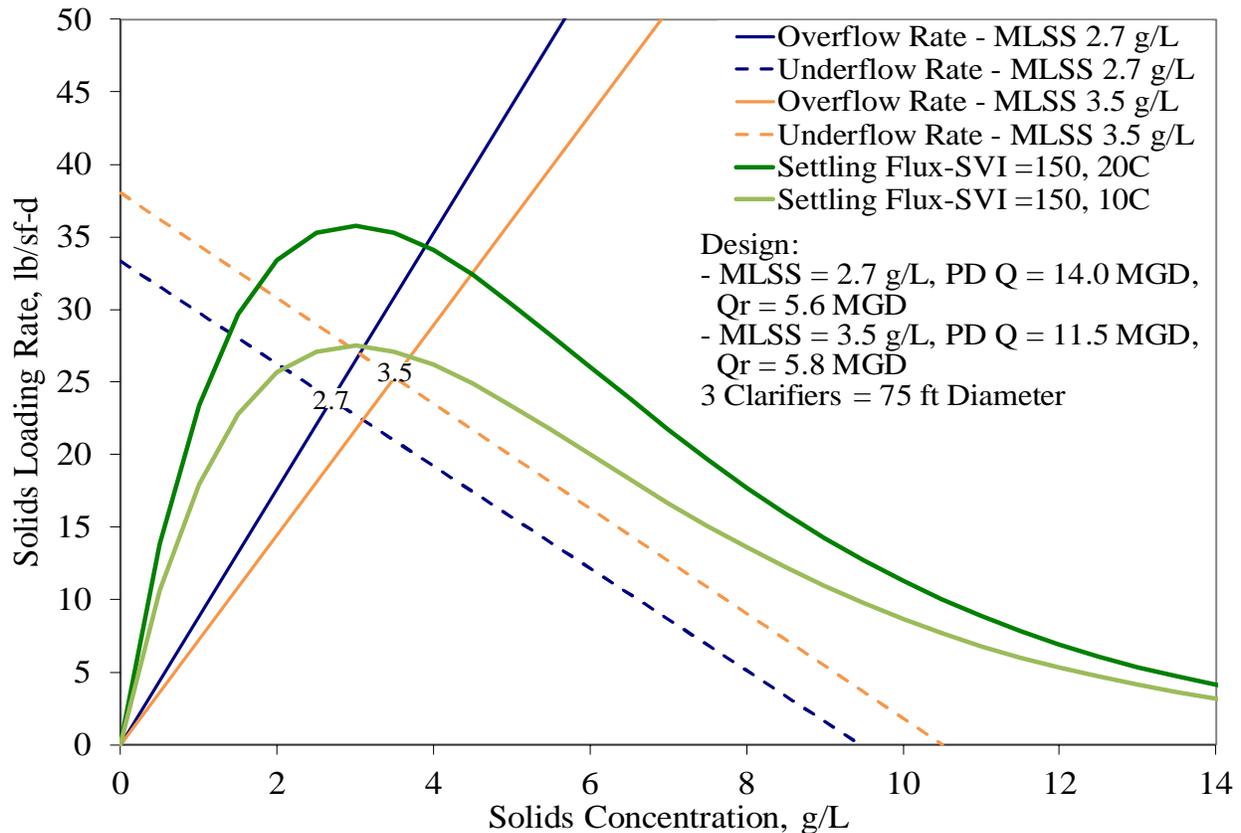
As shown in **Figure 6-14**, at operating MLSS concentrations between 2,700 and 3,500 mg/L, the secondary clarifiers will not be overloaded and therefore have sufficient capacity to settle the MLSS and comply with an effluent TSS limit of 30 mg/L. The clarifier performance analysis was done at water temperatures of 20 °C and 10 °C, and assuming an average Sludge Volume Index of 150 mL/g. The performance analysis of the secondary clarifiers indicates that winter conditions are the limiting factor for their capacity. At a water temperature of 10 °C, the clarifiers can be operated at a peak daily flow of 11.5 MGD and 14.0 MGD with a MLSS concentration of 3,500, and 2,700 mg/L, respectively. At a water temperature of 20 °C, the clarifiers can be operated up to a peak daily flow of 14.0 MGD with a MLSS concentration of 3,500 mg/L.

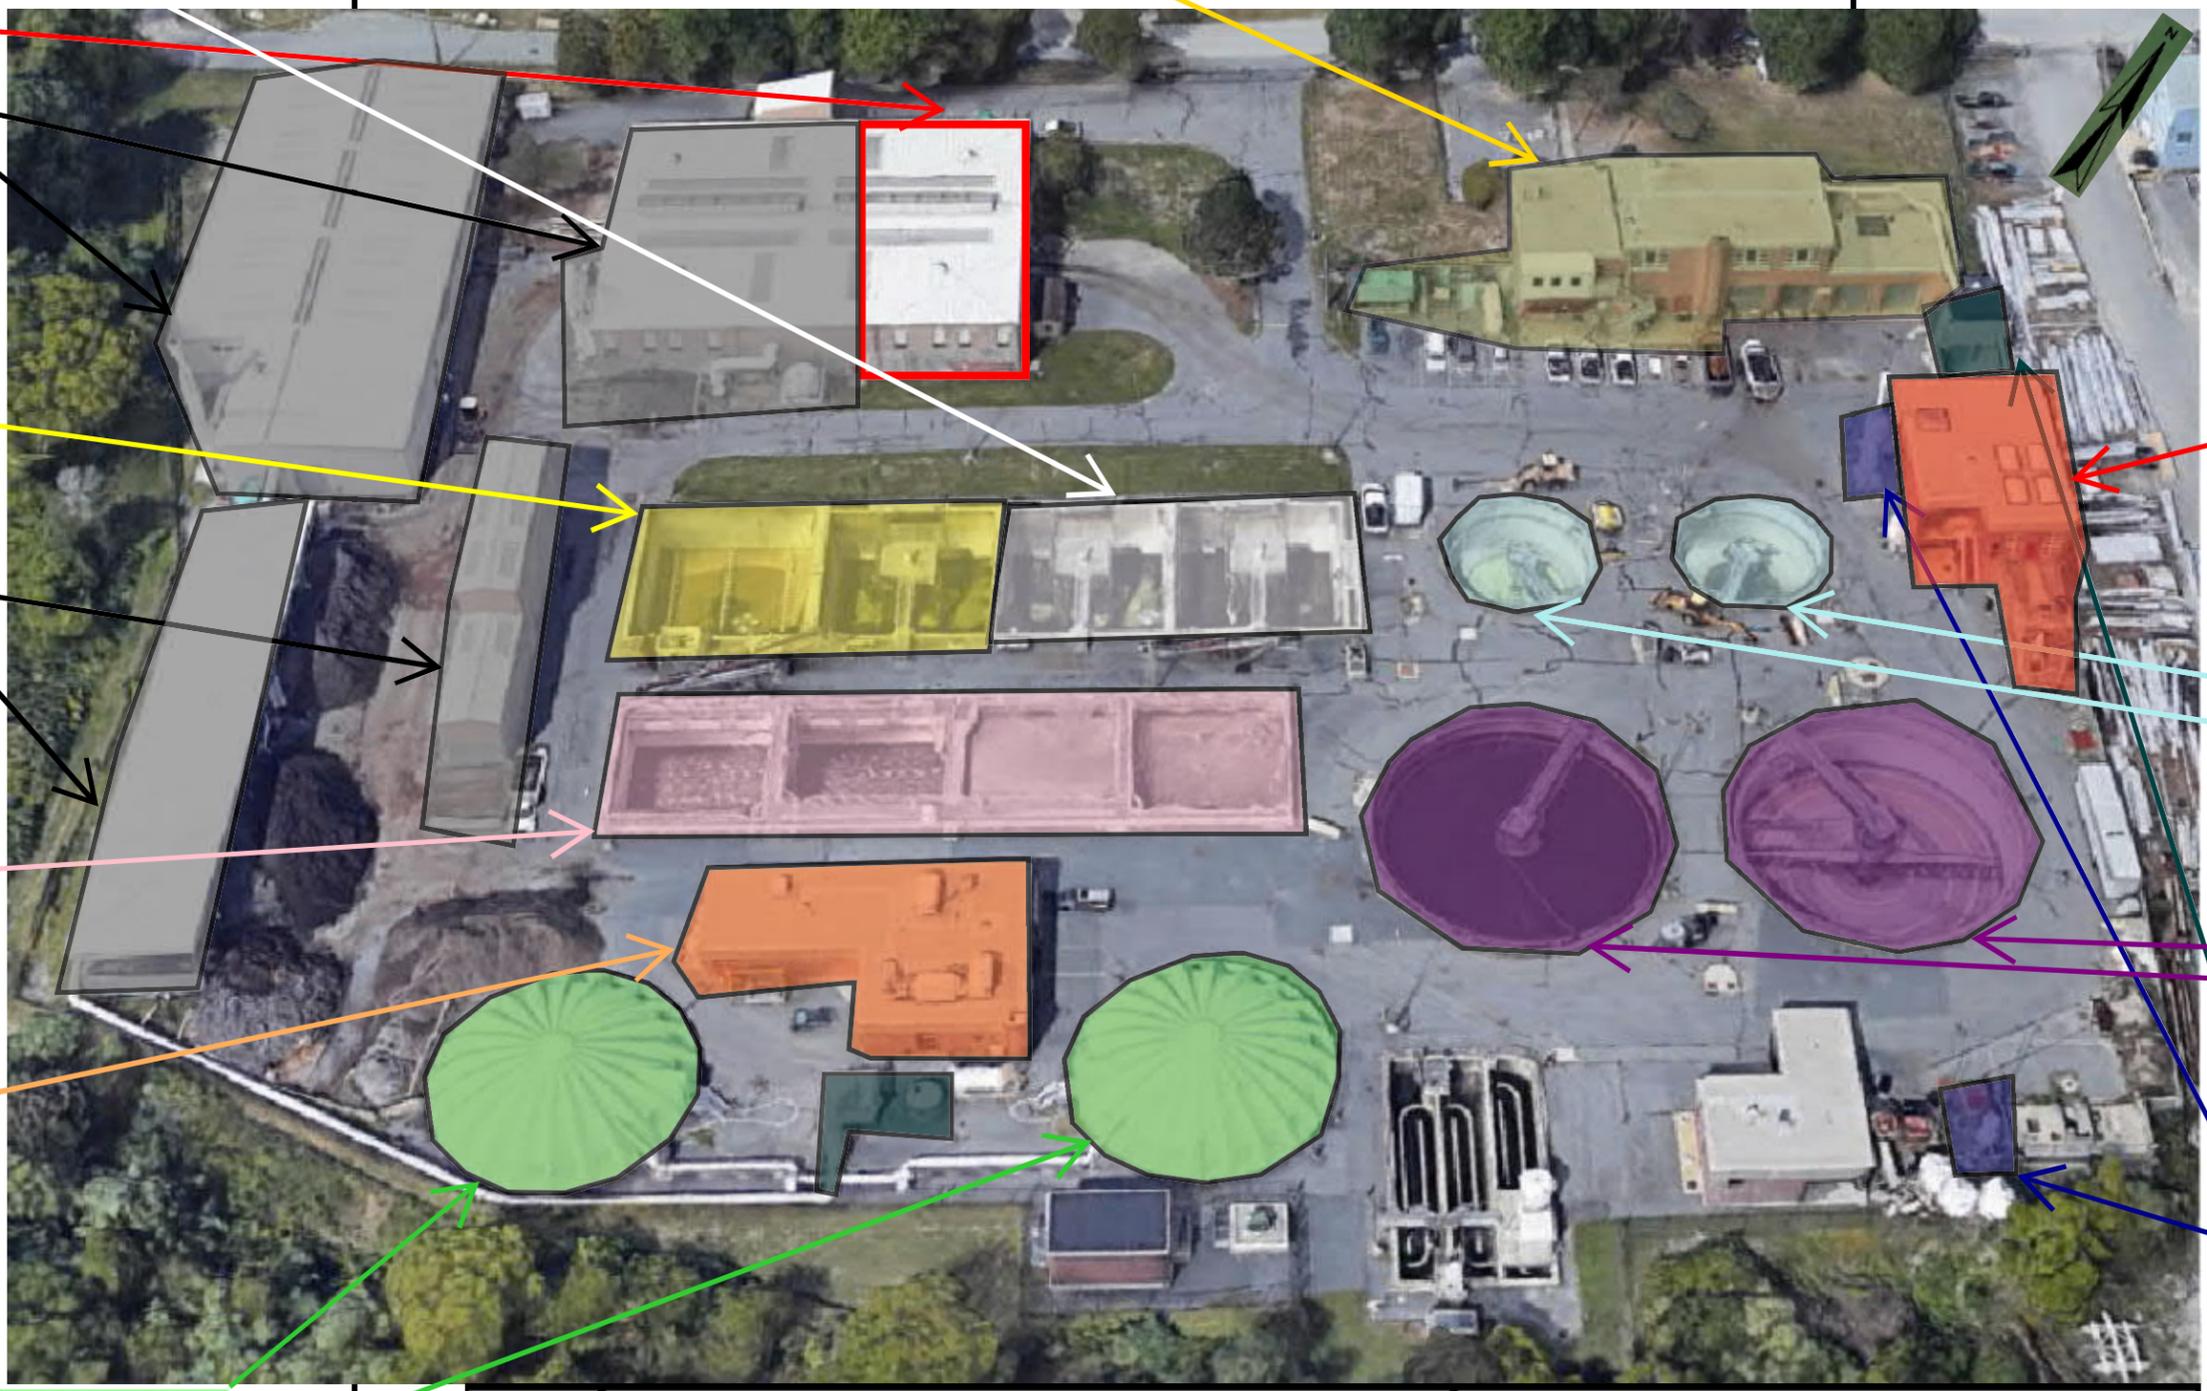
DRAWING
 FIG 6-20

Recommended Site Plan

The recommended process flow diagram is shown in Figure 6-13 and the recommended solids flow diagram is shown in Figure 6-17. The recommended site plan is shown in **Figure 6-20**.

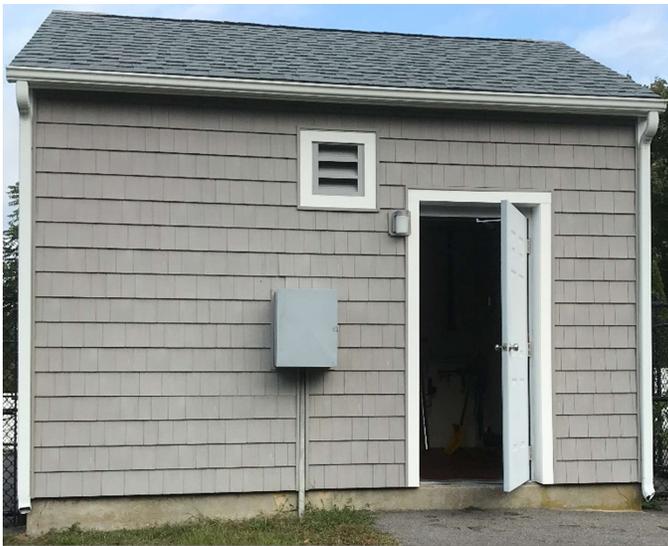
- The Angus St Pump Station is powered by a 277/480V 3phase, 4 wire, 60HZ underground electrical service from utility pole #4-30. The main circuit breaker is rated at 225 ampere and is manufactured by ITE Company which is no longer in service. This pump station was recently upgraded, however the main circuit breaker, which is located within the pump station, was never updated or replaced.

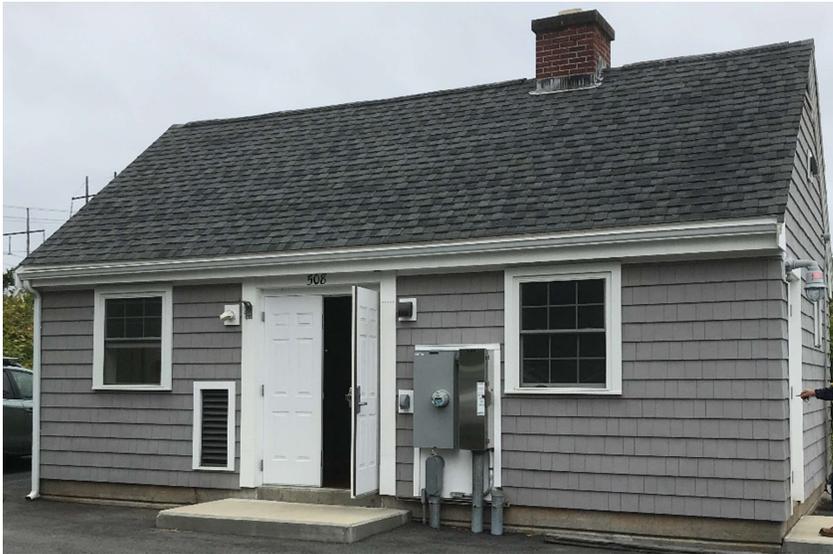
3. Lee's River Avenue Pump Station

- The Lee's River Ave PS is powered by a 277/480V 3-phase, 4 wire, 60Hz underground electrical service from the utility pole-mounted transformer. Emergency (stand-by) backup power is provided by a 180kW/225kVA Kohler 180REZXB natural gas generator with an 800A, ASCO automatic transfer switch. The incoming electrical service is supplied to a 400A MCB located outside of the entrance to the pump station. The pump station has two (2) - 75hp pumps operated by individual Eaton CRX9000 VFDs.
- The pump station is equipped with LED lighting fixtures, emergency lighting, and exit signs. The station has adequate receptacles and switches with GFCI outlets where appropriate. The conduit system is aluminum/RGS, and there are no NEMA classification issues. There is space for new equipment and any future equipment to be installed at this

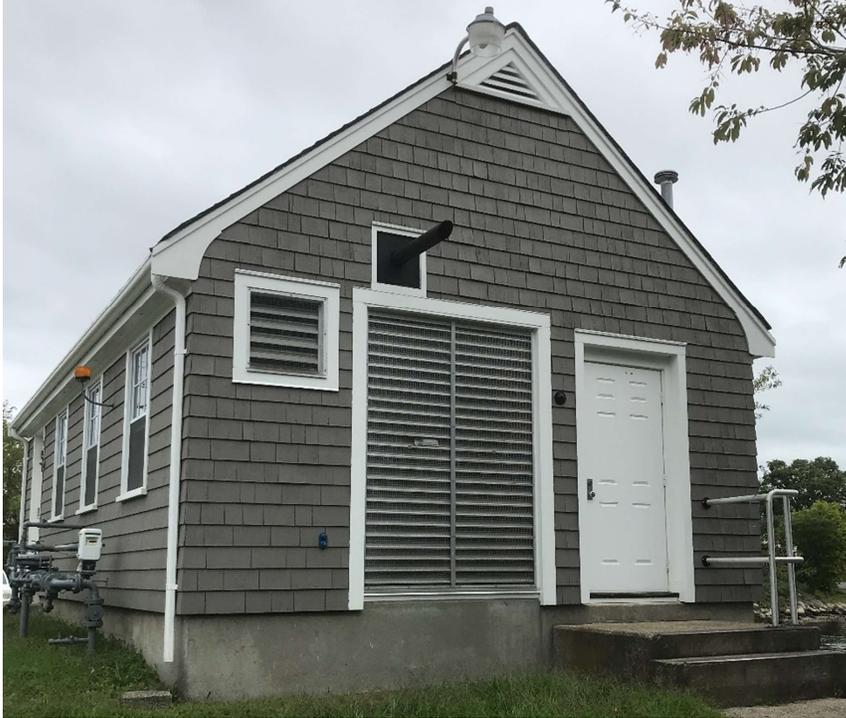
5. Foley Avenue Pump Station

- The Foley Ave PS is powered by a 277/480V 3phase, 4 wire, 60Hz overhead electrical service from the utility pole-mounted transformer. The incoming electric service is equipped with a 400A MCB located outside of the building along with the utility company metering cabinet and service meter. The station has three (3) -75hp pumps driven by Cutler-Hammer AF 5000+ VFDs. The VFDs are mounted in a GE 7700 series motor control center MCC.

- Backup power is provided by a 175kW/219kVA Waukesha natural gas generator with 400A ASCO automatic transfer switch. Both are located within the pump station building.

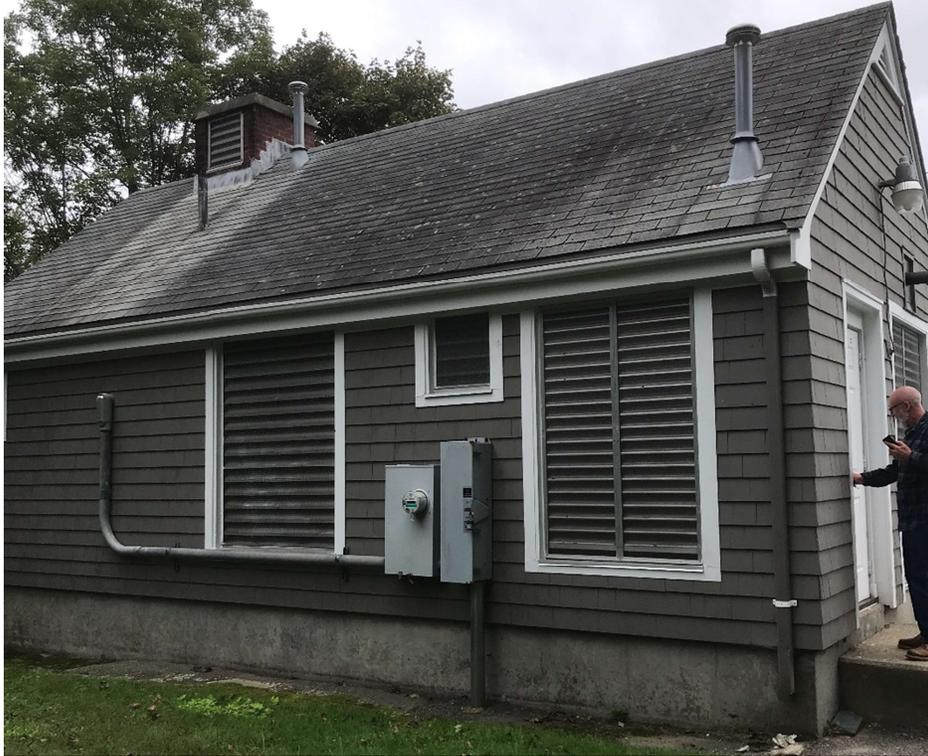
6. Luther Avenue Pump Station

- The Luther Ave PS is powered by a 277/480V 3phase, 4 wire, 60Hz underground electrical service from utility pole #98-30. The incoming electric service is equipped with a 400A MCB located outside of the building along with the utility company meter. The station has three (3) -75hp pumps driven by Cutler-Hammer AF 5000+ VFDs. The VFDs are mounted in a Square D motor control center MCC.

- Backup power is provided by a 175kW/219kVA Waukesha natural gas generator with 400A ASCO automatic transfer switch. Both are located within the pump station building.

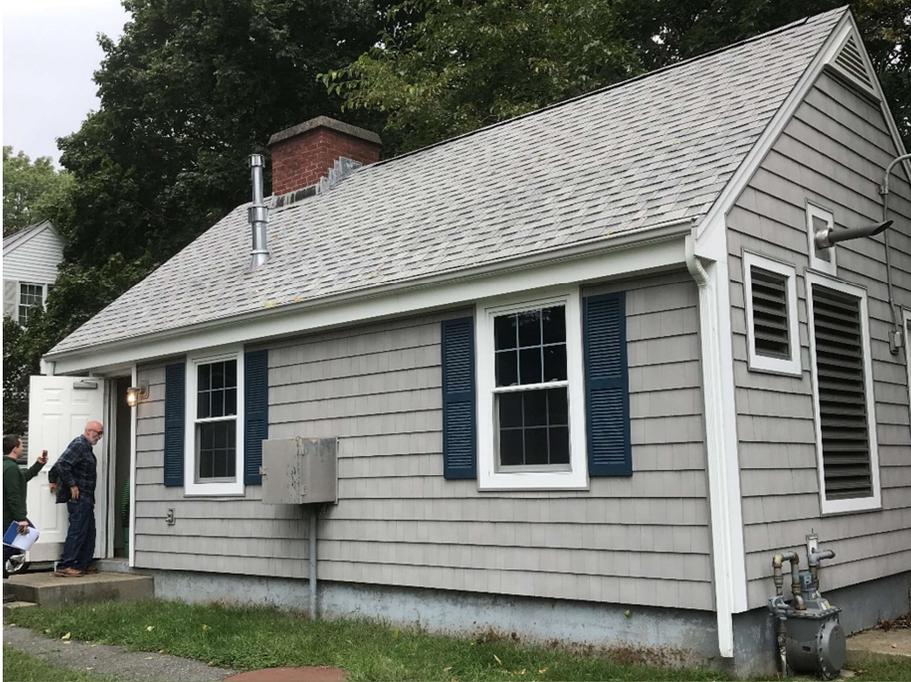
7. Grove Avenue Pump Station

- The Grove Ave PS is powered by a 277/480V 3phase, 4 wire, 60Hz underground electrical service from utility pole #1-30. The main circuit breaker is rated 225 ampere and is located within the motor control center MCC. The utility company meter is located outside of the building. The MCC is a Cutler-Hammer Freedom Series 2100 and the main bus rating is 600 ampere.

- Backup power is provided by a 75kW/93.75kVA continuous duty rated Cummins natural gas generator with 100 ampere, 42kAIC Eaton ATC-300 automatic transfer switch. The generator model number is GGHE-713361. Both are located within the pump station building.

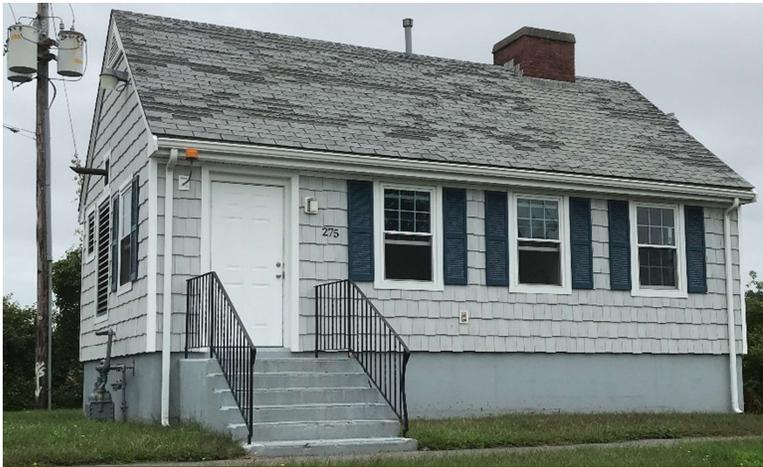
8. Dublin Street Pump Station

- The Dublin St PS is powered by a 480V 3phase, 3 wire, 60Hz closed delta, underground electrical service from utility pole #10-30. There is a 200A Siemens main service disconnect located outside and an Eaton 150 ampere MCB which feeds an Eaton 250 ampere main lug only main distribution panel located inside of the building. The utility meter is located outside of the building.

- Backup power is provided by a 60kW/75kVA Kohler 60RZG natural gas generator with MPAC 1500 Kohler automatic transfer switch. Both are located within the pump station building.

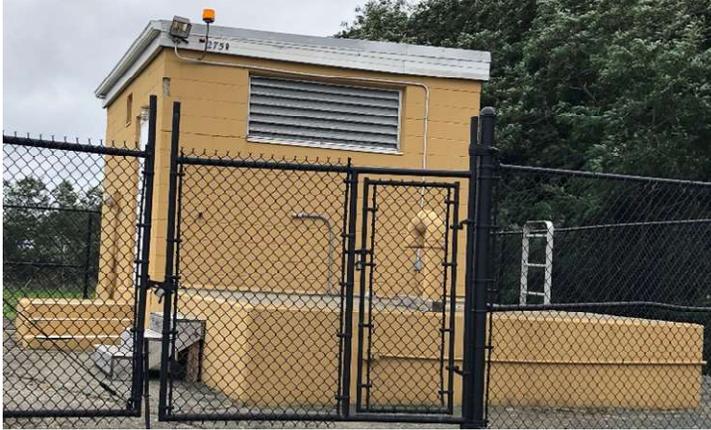
9. Main Street Pump Station

- The Main Street PS is powered by a 277/480V 3phase, 4 wire, 60Hz underground electrical service from the utility pole-mounted transformer. The incoming electric service is connected to a Westinghouse Company 225A MCB located within the building.

- Backup power is provided by a 45kW/56.25kVA Onan 45DEF diesel generator with ASCO Model 940, 125 ampere, automatic transfer switch. Both the generator and transfer switch are older equipment models.

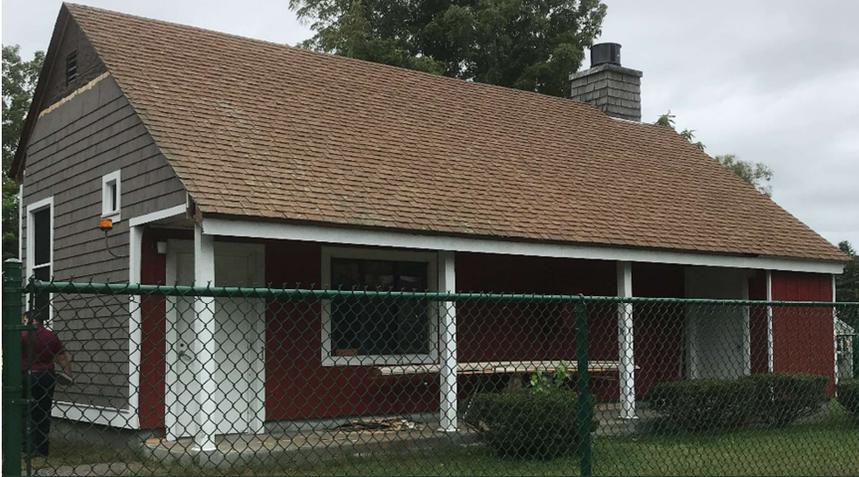
10. Pilot Drive Pump Station

- The Pilot Drive PS is powered by a 277/480V, 3phase, 4 wire, 60Hz underground electrical service from the utility pole #49-10. The incoming electric service is connected to a 200A main circuit breaker MCB located within the Sylvania Company motor control center inside of the pump station. This existing motor control center is no longer manufactured and the company is no longer in business. The utility company service meter is located on the outside of the building.

- Backup power is provided by a 50kW/62.5kVA Ferment 60DH continuous-duty rated generator with automatic transfer switch. There also is a fuel day tank located within the building for the generator. The generator, automatic transfer switch, and day tank are located within the building.

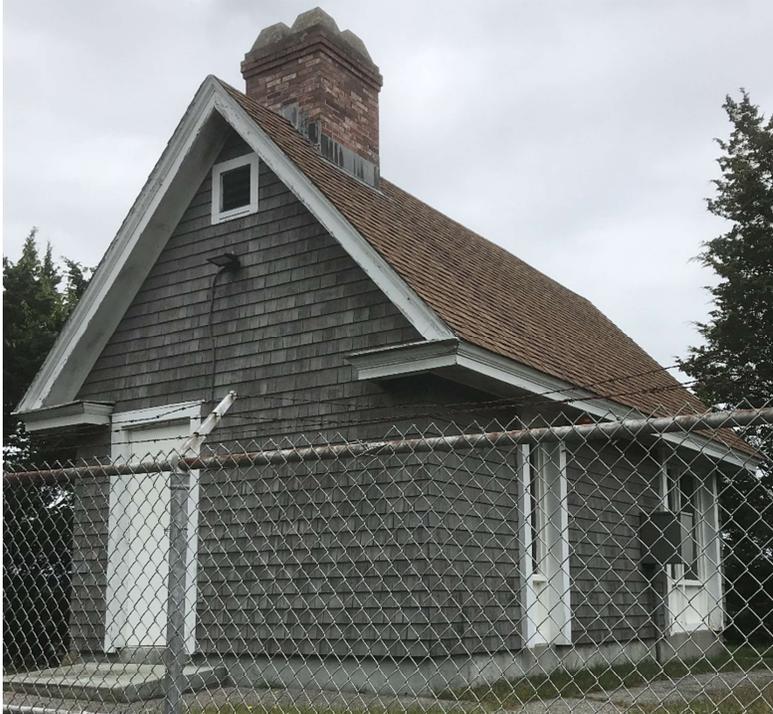
11. Pleasant Street Pump Station

- The Pleasant Street PS is powered by a 120/208VV 3phase, 4 wire, 60Hz electrical service from the utility pole #50. The incoming electric service is connected to a 200 ampere main circuit breaker MCB located within the Sylvania Company motor control center inside of the pump station. This existing motor control center is no longer manufactured and the company is no longer in business. The utility company service meter is located on the outside of the building. This station is similar to the Pilot Drive Pump Station.

- Backup power is provided by a 45kW/56.25kVA Fermont 45DH generator with automatic transfer switch. There also is a fuel day tank located within the building for the generator. The generator, automatic transfer switch, and day tank are located within the building.

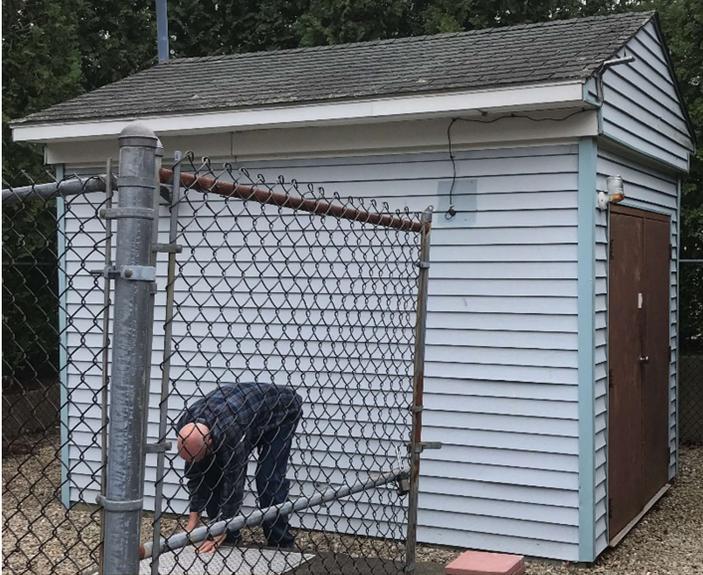
12. Lake Street Pump Station

- The Lake Street PS is powered by a 120/240V 1phase, 3 wire, 60Hz overhead electrical service from utility pole #4. The incoming electric service is connected to a 60A 2 pole, main circuit breaker MCB located inside of the building. The utility company meter is located outside of the building.

- The pump station has two (2) submersible pumps connected to a pull box inside the wet well with float controls. The ladder into the wet well is not accessible. The pumps are connected and controlled via a Boydco Corporation Pump Control Panel.

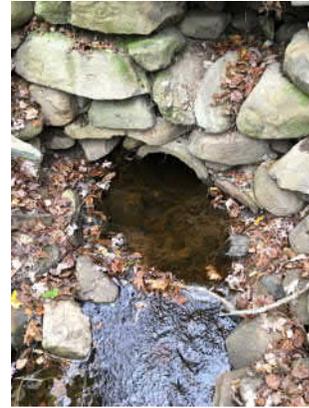
Outfall ID:	OF-0
Watershed:	TAUNTON
MS4:	Yes
Inspection Date:	11/9/2018
Street Name:	LEPES ROAD
Assumed Owner:	Town
Use:	Residential
Pipe Size:	18
Pipe Shape:	Round
Pipe Material:	RCP
Number of Pipes:	1
Outfall Type:	Headwall
Outfall Material:	Stone
Outfall Condition:	Good
Discharging To:	Stream
Sediment Accumulation	No
Scouring:	No
Floatables	No
Algae Growth:	Yes
Stressed Vegetation:	No

Staining:	No
Turbidity:	No
Discharging:	Yes
Discharge Amount:	Moderate
Discharge Color:	Clear
Oil Sheen:	No
Odor:	No
Structure Under Water:	Yes

Outfall Issue:	Suds
Inspection Notes:

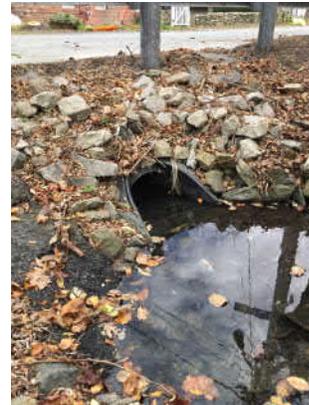
Outfall ID:	OF-10
Watershed:	MT HOPE BAY
MS4:	Yes
Inspection Date:	11/9/2018
Street Name:	CAREY STREET
Assumed Owner:	Town
Use:	Residential
Pipe Size:	12
Pipe Shape:	Round
Pipe Material:	HDPE
Number of Pipes:	1
Outfall Type:	Flared end
Outfall Material:	HDPE
Outfall Condition:	Good
Discharging To:	Stream
Sediment Accumulation	Yes
Scouring:	No
Floatables	No
Algae Growth:	No
Stressed Vegetation:	No

Staining:	No
Turbidity:	No
Discharging:	Yes
Discharge Amount:	Trickle
Discharge Color:	Clear
Oil Sheen:	No
Odor:	No
Structure Under Water:	Yes

Outfall Issue:	None
Inspection Notes:

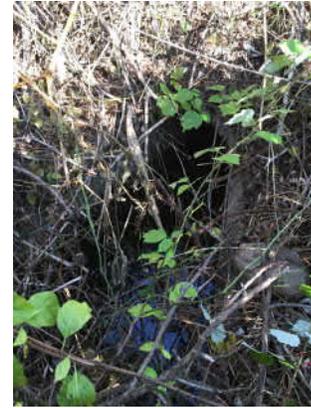
Outfall ID:	OF-31
Watershed:	TAUNTON
MS4:	Yes
Inspection Date:	11/12/2018
Street Name:	WILLIAMSON DRIVE
Assumed Owner:	Town
Use:	Residential
Pipe Size:	18
Pipe Shape:	Round
Pipe Material:	RCP
Number of Pipes:	1
Outfall Type:	Flared end
Outfall Material:	RCP
Outfall Condition:	Good
Discharging To:	Wetland
Sediment Accumulation	No
Scouring:	No
Floatables	No
Algae Growth:	No
Stressed Vegetation:	No

Staining:	No
Turbidity:	No
Discharging:	Yes
Discharge Amount:	Trickle
Discharge Color:	Clear
Oil Sheen:	No
Odor:	No
Structure Under Water:	No

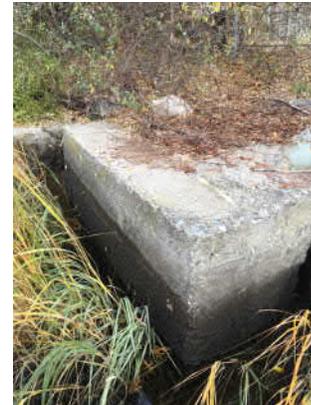
Outfall ID:	OF-34
Watershed:	MT HOPE BAY
MS4:	Yes
Inspection Date:	11/9/2018
Street Name:	GAR HIGHWAY
Assumed Owner:	Town
Use:	Residential
Pipe Size:	
Pipe Shape:	Unknown
Pipe Material:	Unknown
Number of Pipes:	0
Outfall Type:	Headwall
Outfall Material:	Concrete
Outfall Condition:	Fair
Discharging To:	River
Sediment Accumulation	No
Scouring:	No
Floatables	No
Algae Growth:	No
Stressed Vegetation:	No

Staining:	No
Turbidity:	No
Discharging:	Yes
Discharge Amount:	Moderate
Discharge Color:	Reddish
Oil Sheen:	No
Odor:	No
Structure Under Water:	Yes

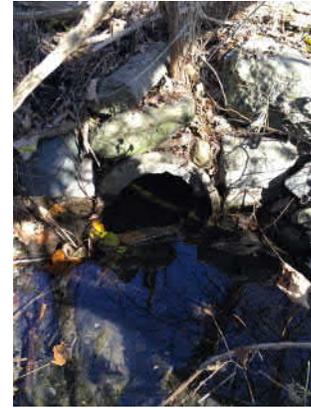
Outfall ID:	OF-40
Watershed:	MT HOPE BAY
MS4:	Yes
Inspection Date:	11/12/2018
Street Name:	CAREY STREET
Assumed Owner:	Town
Use:	Residential
Pipe Size:	15
Pipe Shape:	Round
Pipe Material:	RCP
Number of Pipes:	1
Outfall Type:	Headwall
Outfall Material:	Stone
Outfall Condition:	Good
Discharging To:	Land
Sediment Accumulation	No
Scouring:	No
Floatables	No
Algae Growth:	No
Stressed Vegetation:	No

Staining:	No
Turbidity:	No
Discharging:	Yes
Discharge Amount:	Trickle
Discharge Color:	Clear
Oil Sheen:	No
Odor:	No
Structure Under Water:	Yes

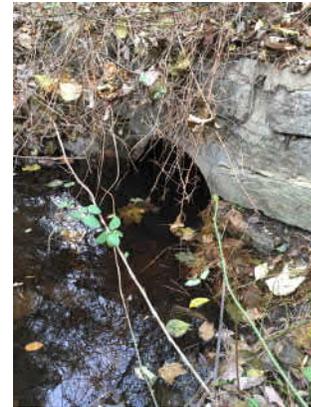
Outfall ID:	OF-96
Watershed:	TAUNTON
MS4:	Yes
Inspection Date:	11/15/2018
Street Name:	HENRI STREET
Assumed Owner:	Town
Use:	Residential
Pipe Size:	24
Pipe Shape:	Round
Pipe Material:	CMP
Number of Pipes:	1
Outfall Type:	Headwall
Outfall Material:	Stone
Outfall Condition:	Fair
Discharging To:	Swale
Sediment Accumulation	No
Scouring:	No
Floatables	No
Algae Growth:	No
Stressed Vegetation:	No

Staining:	No
Turbidity:	No
Discharging:	Yes
Discharge Amount:	Trickle
Discharge Color:	Red
Oil Sheen:	No
Odor:	No
Structure Under Water:	Yes

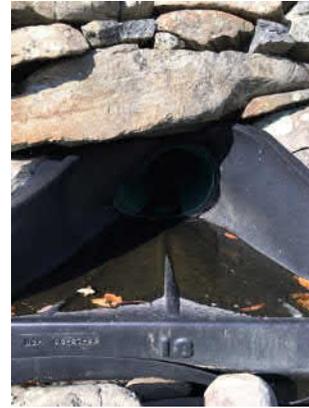
Outfall ID:	OF-116
Watershed:	MT HOPE BAY
MS4:	Yes
Inspection Date:	11/12/2018
Street Name:	OFF ROAD
Assumed Owner:	Town
Use:	Residential
Pipe Size:	18
Pipe Shape:	Round
Pipe Material:	Lined HDPE
Number of Pipes:	1
Outfall Type:	Flared end
Outfall Material:	Lined HDPE
Outfall Condition:	Fair
Discharging To:	River
Sediment Accumulation	No
Scouring:	No
Floatables	No
Algae Growth:	Yes
Stressed Vegetation:	No

Staining:	No
Turbidity:	NA
Discharging:	No
Discharge Amount:	None
Discharge Color:	NA
Oil Sheen:	No
Odor:	No
Structure Under Water:	No

Outfall Issue:	Damaged
Inspection Notes:

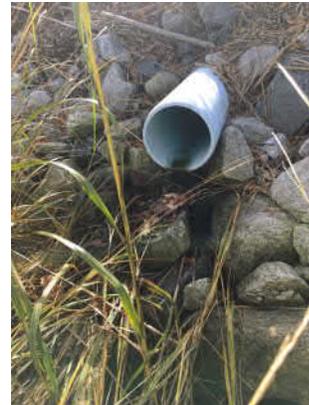
Outfall ID:	OF-146
Watershed:	TAUNTON
MS4:	Yes
Inspection Date:	11/8/2018
Street Name:	RIVERSIDE AVENUE
Assumed Owner:	Town
Use:	Residential
Pipe Size:	8
Pipe Shape:	Round
Pipe Material:	PVC
Number of Pipes:	1
Outfall Type:	Pipe end
Outfall Material:	PVC
Outfall Condition:	Good
Discharging To:	River
Sediment Accumulation	No
Scouring:	No
Floatables	No
Algae Growth:	Yes
Stressed Vegetation:	No

Staining:	No
Turbidity:	No
Discharging:	Yes
Discharge Amount:	Trickle
Discharge Color:	Clear
Oil Sheen:	No
Odor:	No
Structure Under Water:	No

Outfall Issue:	None
Inspection Notes:

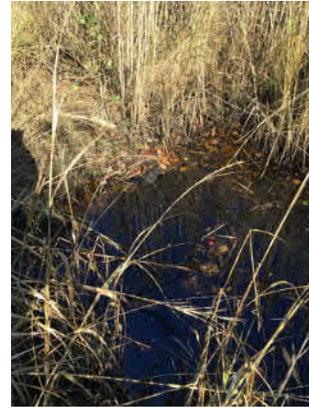
Outfall ID:	OF-208
Watershed:	TAUNTON
MS4:	Yes
Inspection Date:	11/12/2018
Street Name:	RIVERSIDE AVENUE
Assumed Owner:	Town
Use:	Residential
Pipe Size:	18
Pipe Shape:	Round
Pipe Material:	RCP
Number of Pipes:	1
Outfall Type:	Pipe end
Outfall Material:	RCP
Outfall Condition:	Fair
Discharging To:	River
Sediment Accumulation	No
Scouring:	No
Floatables	No
Algae Growth:	No
Stressed Vegetation:	No

Staining:	No
Turbidity:	NA
Discharging:	
Discharge Amount:	Unknown
Discharge Color:	NA
Oil Sheen:	Yes
Odor:	Sulfur
Structure Under Water:	Yes

Outfall Issue: Fully submerged, odor, oil sheen

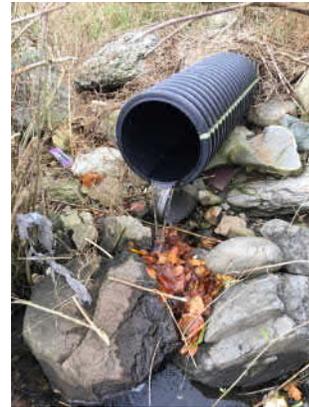
Outfall ID:	OF-211
Watershed:	TAUNTON
MS4:	Yes
Inspection Date:	11/15/2018
Street Name:	RIVERSIDE AVENUE
Assumed Owner:	Town
Use:	Residential
Pipe Size:	12
Pipe Shape:	Round
Pipe Material:	HDPE
Number of Pipes:	1
Outfall Type:	Pipe end
Outfall Material:	HDPE
Outfall Condition:	Good
Discharging To:	River
Sediment Accumulation	No
Scouring:	No
Floatables	No
Algae Growth:	No
Stressed Vegetation:	No

Staining:	No
Turbidity:	No
Discharging:	Yes
Discharge Amount:	Moderate
Discharge Color:	Clear
Oil Sheen:	No
Odor:	No
Structure Under Water:	No

Outfall Issue: None

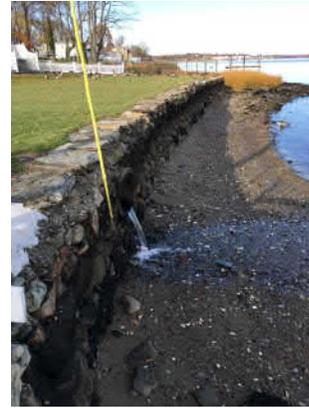
Outfall ID:	OF-213
Watershed:	TAUNTON
MS4:	Yes
Inspection Date:	11/8/2018
Street Name:	WARREN STREET
Assumed Owner:	Town
Use:	Residential
Pipe Size:	24
Pipe Shape:	Round
Pipe Material:	RCP
Number of Pipes:	1
Outfall Type:	Headwall
Outfall Material:	Stone
Outfall Condition:	Good
Discharging To:	River
Sediment Accumulation	No
Scouring:	Yes
Floatables	No
Algae Growth:	No
Stressed Vegetation:	No

Staining:	No
Turbidity:	No
Discharging:	Yes
Discharge Amount:	Substantial
Discharge Color:	Clear
Oil Sheen:	No
Odor:	No
Structure Under Water:	No

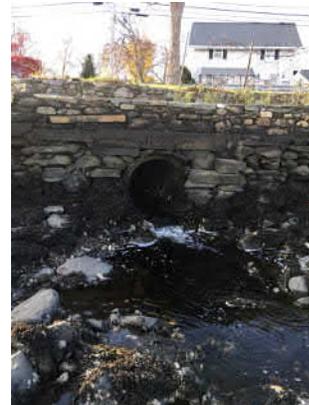
Outfall ID:	OF-217
Watershed:	TAUNTON
MS4:	Yes
Inspection Date:	11/8/2018
Street Name:	RIVERSIDE AVENUE
Assumed Owner:	Town
Use:	Residential
Pipe Size:	36
Pipe Shape:	Round
Pipe Material:	RCP
Number of Pipes:	1
Outfall Type:	Headwall
Outfall Material:	Stone
Outfall Condition:	Good
Discharging To:	River
Sediment Accumulation	No
Scouring:	No
Floatables	No
Algae Growth:	No
Stressed Vegetation:	No

Staining:	No
Turbidity:	No
Discharging:	Yes
Discharge Amount:	Substantial
Discharge Color:	Clear
Oil Sheen:	No
Odor:	No
Structure Under Water:	No

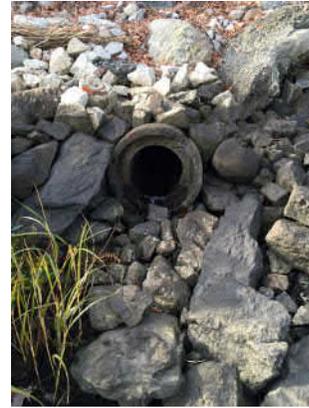
Outfall ID:	OF-220
Watershed:	TAUNTON
MS4:	Yes
Inspection Date:	11/8/2018
Street Name:	RIVERSIDE AVENUE
Assumed Owner:	Town
Use:	Residential
Pipe Size:	12
Pipe Shape:	Round
Pipe Material:	RCP
Number of Pipes:	1
Outfall Type:	Pipe end
Outfall Material:	RCP
Outfall Condition:	Good
Discharging To:	River
Sediment Accumulation	No
Scouring:	No
Floatables	No
Algae Growth:	No
Stressed Vegetation:	No

Staining:	No
Turbidity:	No
Discharging:	Yes
Discharge Amount:	Moderate
Discharge Color:	Clear
Oil Sheen:	No
Odor:	No
Structure Under Water:	No

Outfall Issue:	None
Inspection Notes:

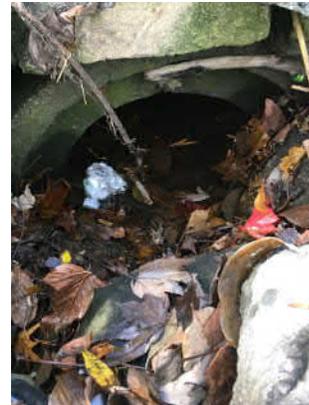
Outfall ID:	OF-222
Watershed:	TAUNTON
MS4:	Yes
Inspection Date:	11/8/2018
Street Name:	RIVERSIDE AVENUE
Assumed Owner:	Town
Use:	Residential
Pipe Size:	18
Pipe Shape:	Round
Pipe Material:	RCP
Number of Pipes:	1
Outfall Type:	Pipe end
Outfall Material:	RCP
Outfall Condition:	Unknown
Discharging To:	River
Sediment Accumulation	Yes
Scouring:	No
Floatables	No
Algae Growth:	No
Stressed Vegetation:	No

Staining:	No
Turbidity:	No
Discharging:	Yes
Discharge Amount:	Moderate
Discharge Color:	Clear
Oil Sheen:	No
Odor:	No
Structure Under Water:	No

Outfall Issue:	Buried structure, debris
Inspection Notes:	Size approximate

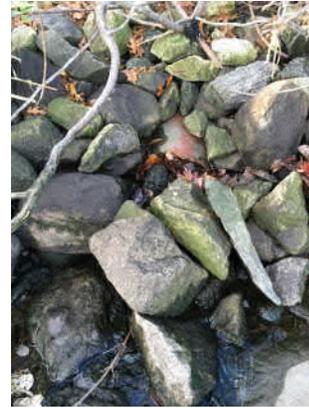
Outfall ID:	OF-224
Watershed:	TAUNTON
MS4:	Yes
Inspection Date:	11/8/2018
Street Name:	RIVERSIDE AVENUE
Assumed Owner:	Town
Use:	Residential
Pipe Size:	12
Pipe Shape:	Round
Pipe Material:	VC
Number of Pipes:	1
Outfall Type:	Pipe end
Outfall Material:	VC
Outfall Condition:	Unknown
Discharging To:	River
Sediment Accumulation	Yes
Scouring:	No
Floatables	No
Algae Growth:	No
Stressed Vegetation:	No

Staining:	No
Turbidity:	No
Discharging:	Yes
Discharge Amount:	Moderate
Discharge Color:	Clear
Oil Sheen:	No
Odor:	No
Structure Under Water:	No

Outfall Issue: Major blockage

Inspection Notes: Size approximate

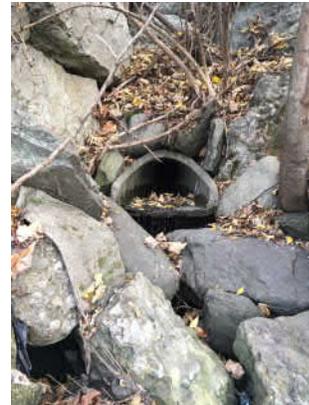
Outfall ID:	OF-225
Watershed:	MT HOPE BAY
MS4:	Yes
Inspection Date:	11/9/2018
Street Name:	OFF ROAD
Assumed Owner:	Town
Use:	Residential
Pipe Size:	12
Pipe Shape:	Flaired
Pipe Material:	RCP
Number of Pipes:	1
Outfall Type:	Flared end
Outfall Material:	RCP
Outfall Condition:	Fair
Discharging To:	River
Sediment Accumulation	No
Scouring:	No
Floatables	No
Algae Growth:	Yes
Stressed Vegetation:	No

Staining:	No
Turbidity:	No
Discharging:	Yes
Discharge Amount:	Trickle
Discharge Color:	Clear
Oil Sheen:	No
Odor:	No
Structure Under Water:	No

Outfall Issue: Cracking

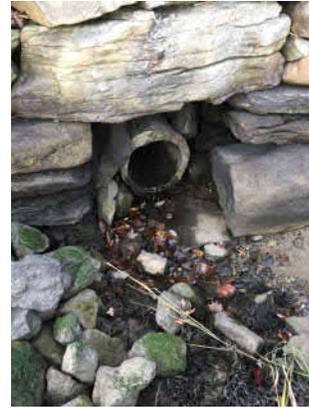
Outfall ID:	OF-226
Watershed:	TAUNTON
MS4:	Yes
Inspection Date:	11/8/2018
Street Name:	RIVERSIDE AVENUE
Assumed Owner:	Town
Use:	Residential
Pipe Size:	12
Pipe Shape:	Round
Pipe Material:	RCP
Number of Pipes:	1
Outfall Type:	Headwall
Outfall Material:	Stone
Outfall Condition:	Fair
Discharging To:	River
Sediment Accumulation	No
Scouring:	No
Floatables	No
Algae Growth:	No
Stressed Vegetation:	No

Staining:	No
Turbidity:	No
Discharging:	Yes
Discharge Amount:	Trickle
Discharge Color:	Clear
Oil Sheen:	No
Odor:	No
Structure Under Water:	No

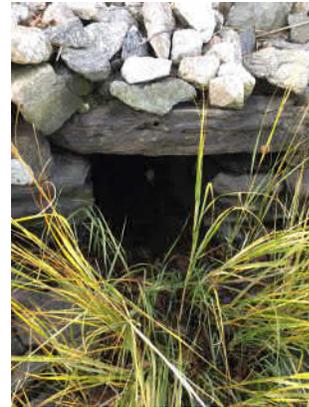
Outfall ID:	OF-228
Watershed:	TAUNTON
MS4:	Yes
Inspection Date:	11/8/2018
Street Name:	RIVERSIDE AVENUE
Assumed Owner:	Town
Use:	Residential
Pipe Size:	24
Pipe Shape:	Irregular
Pipe Material:	Stone
Number of Pipes:	1
Outfall Type:	Headwall
Outfall Material:	Stone
Outfall Condition:	Good
Discharging To:	River
Sediment Accumulation	No
Scouring:	No
Floatables	No
Algae Growth:	No
Stressed Vegetation:	No

Staining:	No
Turbidity:	No
Discharging:	Yes
Discharge Amount:	Moderate
Discharge Color:	Clear
Oil Sheen:	No
Odor:	No
Structure Under Water:	No

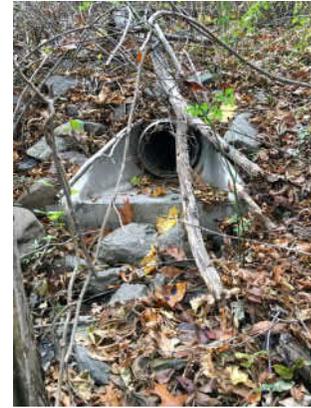
Outfall ID:	OF-238
Watershed:	MT HOPE BAY
MS4:	Yes
Inspection Date:	11/9/2018
Street Name:	OFF ROAD
Assumed Owner:	Town
Use:	Open Space
Pipe Size:	12
Pipe Shape:	Round
Pipe Material:	CMP
Number of Pipes:	1
Outfall Type:	Flared end
Outfall Material:	Metal
Outfall Condition:	Good
Discharging To:	Land
Sediment Accumulation	No
Scouring:	No
Floatables	No
Algae Growth:	No
Stressed Vegetation:	No

Staining:	No
Turbidity:	No
Discharging:	Yes
Discharge Amount:	Drip
Discharge Color:	Clear
Oil Sheen:	No
Odor:	No
Structure Under Water:	No

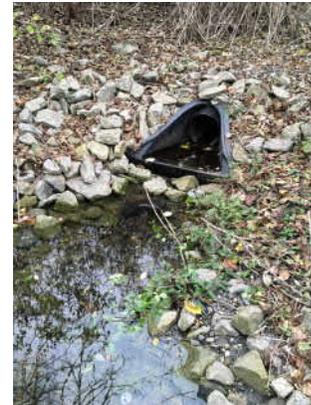
Outfall ID:	OF-240
Watershed:	MT HOPE BAY
MS4:	Yes
Inspection Date:	11/15/2018
Street Name:	OFF ROAD
Assumed Owner:	Town
Use:	Open Space
Pipe Size:	12
Pipe Shape:	Round
Pipe Material:	HDPE
Number of Pipes:	1
Outfall Type:	Flared end
Outfall Material:	HDPE
Outfall Condition:	Good
Discharging To:	Stream
Sediment Accumulation	No
Scouring:	No
Floatables	Suds
Algae Growth:	Yes
Stressed Vegetation:	No

Staining:	No
Turbidity:	No
Discharging:	Yes
Discharge Amount:	Trickle
Discharge Color:	Clear
Oil Sheen:	No
Odor:	No
Structure Under Water:	No

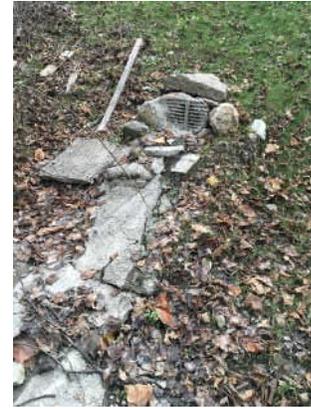
Outfall ID:	OF-241
Watershed:	MT HOPE BAY
MS4:	Yes
Inspection Date:	11/15/2018
Street Name:	OFF ROAD
Assumed Owner:	Town
Use:	Commercial
Pipe Size:	0
Pipe Shape:	Round
Pipe Material:	Unknown
Number of Pipes:	0
Outfall Type:	Pipe end
Outfall Material:	Unknown
Outfall Condition:	Poor
Discharging To:	Stream
Sediment Accumulation	No
Scouring:	No
Floatables	No
Algae Growth:	No
Stressed Vegetation:	No

Staining:	No
Turbidity:	NA
Discharging:	No
Discharge Amount:	None
Discharge Color:	NA
Oil Sheen:	No
Odor:	No
Structure Under Water:	No

Outfall Issue: Covered in concrete

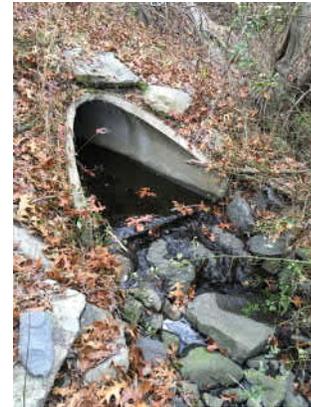
Outfall ID:	OF-245
Watershed:	MT HOPE BAY
MS4:	Yes
Inspection Date:	11/15/2018
Street Name:	OFF ROAD
Assumed Owner:	Town
Use:	Open Space
Pipe Size:	24
Pipe Shape:	Round
Pipe Material:	RCP
Number of Pipes:	1
Outfall Type:	Flared end
Outfall Material:	RCP
Outfall Condition:	Good
Discharging To:	Stream
Sediment Accumulation	No
Scouring:	No
Floatables	Suds
Algae Growth:	Yes
Stressed Vegetation:	No

Staining:	No
Turbidity:	No
Discharging:	Yes
Discharge Amount:	Moderate
Discharge Color:	Clear
Oil Sheen:	No
Odor:	No
Structure Under Water:	No

Outfall Issue: Suds

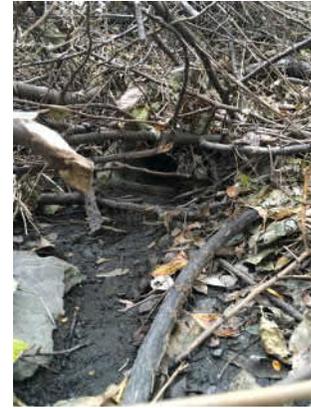
Outfall ID:	OF-246
Watershed:	MT HOPE BAY
MS4:	Yes
Inspection Date:	11/15/2018
Street Name:	OFF ROAD
Assumed Owner:	Town
Use:	Open Space
Pipe Size:	12
Pipe Shape:	Round
Pipe Material:	CMP
Number of Pipes:	1
Outfall Type:	Flared end
Outfall Material:	CMP
Outfall Condition:	Good
Discharging To:	Stream
Sediment Accumulation	No
Scouring:	No
Floatables	No
Algae Growth:	No
Stressed Vegetation:	No

Staining:	No
Turbidity:	NA
Discharging:	No
Discharge Amount:	None
Discharge Color:	NA
Oil Sheen:	No
Odor:	No
Structure Under Water:	No

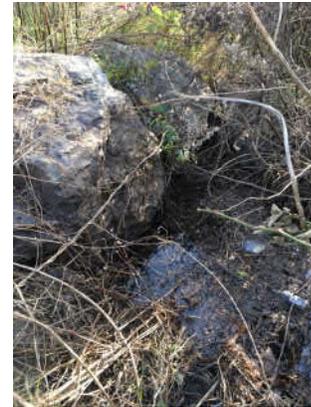
Outfall ID:	OF-249
Watershed:	MT HOPE BAY
MS4:	No
Inspection Date:	11/12/2018
Street Name:	SLADE STREET
Assumed Owner:	Town
Use:	Residential
Pipe Size:	0
Pipe Shape:	Unknown
Pipe Material:	Unknown
Number of Pipes:	
Outfall Type:	Flared end
Outfall Material:	RCP
Outfall Condition:	Unknown
Discharging To:	Land
Sediment Accumulation	No
Scouring:	No
Floatables	No
Algae Growth:	No
Stressed Vegetation:	No

Staining:	No
Turbidity:	No
Discharging:	Yes
Discharge Amount:	Trickle
Discharge Color:	Clear
Oil Sheen:	No
Odor:	No
Structure Under Water:	Yes

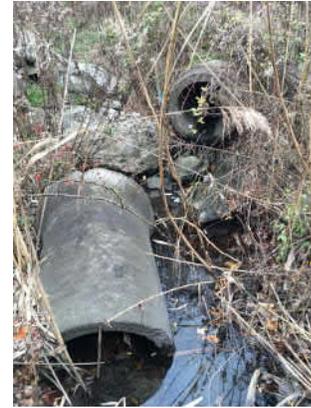
Outfall ID:	OF-251
Watershed:	MT HOPE BAY
MS4:	Yes
Inspection Date:	11/9/2018
Street Name:	WILBUR AVENUE
Assumed Owner:	Town
Use:	Open Space
Pipe Size:	24
Pipe Shape:	Round
Pipe Material:	RCP
Number of Pipes:	1
Outfall Type:	Pipe end
Outfall Material:	Concrete
Outfall Condition:	Fair
Discharging To:	Wetland
Sediment Accumulation	No
Scouring:	No
Floatables	No
Algae Growth:	No
Stressed Vegetation:	No

Staining:	No
Turbidity:	No
Discharging:	Yes
Discharge Amount:	Trickle
Discharge Color:	Clear
Oil Sheen:	No
Odor:	No
Structure Under Water:	No

Outfall Issue:	Pipe end segment has fallen off rest of pipe
Inspection Notes:

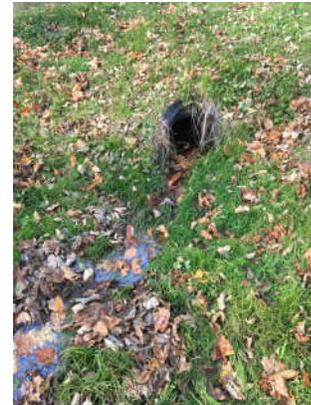
Outfall ID:	OF-254
Watershed:	MT HOPE BAY
MS4:	Yes
Inspection Date:	11/12/2018
Street Name:	OFF ROAD
Assumed Owner:	Town
Use:	Residential
Pipe Size:	12
Pipe Shape:	Round
Pipe Material:	HDPE
Number of Pipes:	1
Outfall Type:	Flared end
Outfall Material:	HDPE
Outfall Condition:	Good
Discharging To:	Detention basin
Sediment Accumulation	No
Scouring:	No
Floatables	No
Algae Growth:	No
Stressed Vegetation:	No

Staining:	No
Turbidity:	NA
Discharging:	No
Discharge Amount:	None
Discharge Color:	NA
Oil Sheen:	Yes
Odor:	No
Structure Under Water:	No

Outfall Issue:	Oil sheen
Inspection Notes:

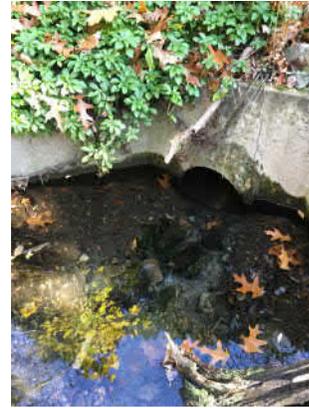
Outfall ID:	OF-259
Watershed:	TAUNTON
MS4:	Yes
Inspection Date:	11/12/2018
Street Name:	OFF ROAD
Assumed Owner:	Town
Use:	Mixed
Pipe Size:	15
Pipe Shape:	Round
Pipe Material:	RCP
Number of Pipes:	1
Outfall Type:	Wingwall
Outfall Material:	Concrete
Outfall Condition:	Good
Discharging To:	Wetland
Sediment Accumulation	No
Scouring:	No
Floatables	No
Algae Growth:	No
Stressed Vegetation:	No

Staining:	No
Turbidity:	No
Discharging:	Yes
Discharge Amount:	Moderate
Discharge Color:	Clear
Oil Sheen:	No
Odor:	No
Structure Under Water:	Yes

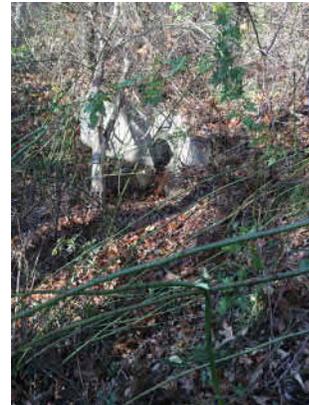
Outfall ID:	OF-264
Watershed:	TAUNTON
MS4:	Yes
Inspection Date:	11/12/2018
Street Name:	OFF ROAD
Assumed Owner:	Town
Use:	Residential
Pipe Size:	15
Pipe Shape:	Round
Pipe Material:	RCP
Number of Pipes:	1
Outfall Type:	Wingwall
Outfall Material:	Concrete
Outfall Condition:	Good
Discharging To:	Wetland
Sediment Accumulation	No
Scouring:	Yes
Floatables	No
Algae Growth:	No
Stressed Vegetation:	No

Staining:	No
Turbidity:	No
Discharging:	Yes
Discharge Amount:	Drip
Discharge Color:	Clear
Oil Sheen:	No
Odor:	No
Structure Under Water:	No

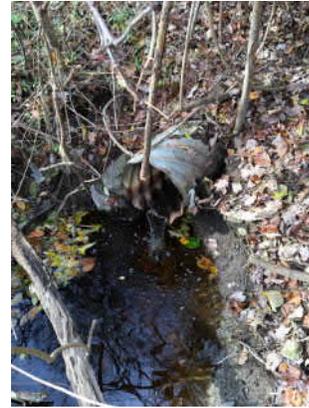
Outfall ID:	OF-268
Watershed:	TAUNTON
MS4:	Yes
Inspection Date:	11/8/2018
Street Name:	REGAN ROAD
Assumed Owner:	Town
Use:	Residential
Pipe Size:	12
Pipe Shape:	Round
Pipe Material:	CMP
Number of Pipes:	1
Outfall Type:	Pipe end
Outfall Material:	CMP
Outfall Condition:	Fair
Discharging To:	Stream
Sediment Accumulation	No
Scouring:	No
Floatables	No
Algae Growth:	No
Stressed Vegetation:	No

Staining:	No
Turbidity:	Yes
Discharging:	Yes
Discharge Amount:	Moderate
Discharge Color:	Clear
Oil Sheen:	No
Odor:	No
Structure Under Water:	No

Outfall Issue: Beginning to rust out, turbidity
