Integrated Water Resources Management Plan

TOWN OF SOMERSET, MA

JANUARY 2020

WRIGHT-PIERCE

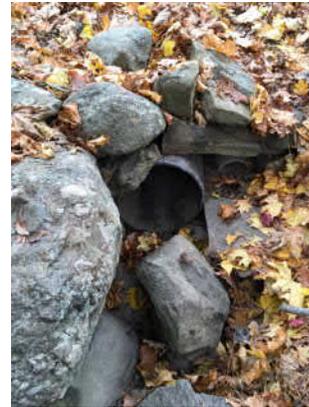
Outfall ID:	OF-269
Watershed:	TAUNTON
MS4:	Yes
Inspection Date:	11/15/2018
Street Name:	MAPLE STREET
Assumed Owner:	Town
Use:	Residential
Pipe Size:	12
Pipe Shape:	Round
Pipe Material:	PVC
Number of Pipes:	1
Outfall Type:	Pipe end
Outfall Material:	PVC
Outfall Condition:	Good
Discharging To:	Land
Sediment Accumulation	No
Scouring:	No
Floatables	No
Algae Growth:	No
Stressed Vegetation:	No

Staining:	No
Turbidity:	NA
Discharging:	No
Discharge Amount:	None
Discharge Color:	NA
Oil Sheen:	No
Odor:	No
Structure Under Water:	No

Outfall Issue: None

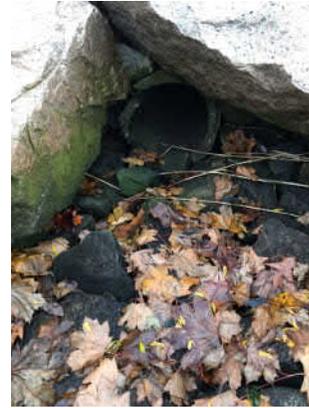
Outfall ID:	OF-271
Watershed:	TAUNTON
MS4:	Yes
Inspection Date:	11/5/2018
Street Name:	ANCHOR DRIVE
Assumed Owner:	Town
Use:	Residential
Pipe Size:	12
Pipe Shape:	Round
Pipe Material:	RCP
Number of Pipes:	1
Outfall Type:	Pipe end
Outfall Material:	RCP
Outfall Condition:	Fair
Discharging To:	River
Sediment Accumulation	No
Scouring:	No
Floatables	No
Algae Growth:	No
Stressed Vegetation:	No

Staining:	No
Turbidity:	NA
Discharging:	No
Discharge Amount:	None
Discharge Color:	NA
Oil Sheen:	No
Odor:	No
Structure Under Water:	No

Outfall Issue:	Damaged
Inspection Notes:

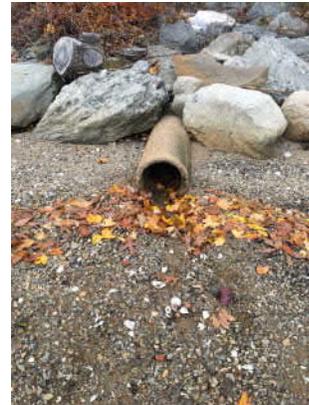
Outfall ID:	OF-272
Watershed:	TAUNTON
MS4:	Yes
Inspection Date:	11/5/2018
Street Name:	ANCHOR DRIVE
Assumed Owner:	Town
Use:	Residential
Pipe Size:	12
Pipe Shape:	Round
Pipe Material:	RCP
Number of Pipes:	1
Outfall Type:	Pipe end
Outfall Material:	RCP
Outfall Condition:	Good
Discharging To:	River
Sediment Accumulation	No
Scouring:	No
Floatables	No
Algae Growth:	No
Stressed Vegetation:	No

Staining:	No
Turbidity:	NA
Discharging:	No
Discharge Amount:	None
Discharge Color:	NA
Oil Sheen:	No
Odor:	No
Structure Under Water:	No

Outfall Issue:	None
Inspection Notes:

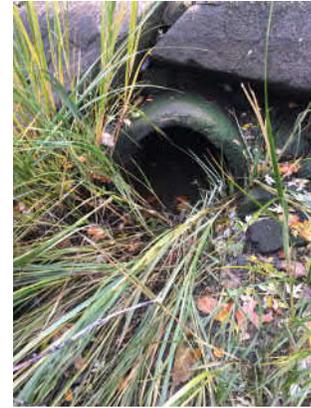
Outfall ID:	OF-273
Watershed:	TAUNTON
MS4:	Yes
Inspection Date:	11/5/2018
Street Name:	ANCHOR DRIVE
Assumed Owner:	Town
Use:	Residential
Pipe Size:	24
Pipe Shape:	Round
Pipe Material:	RCP
Number of Pipes:	1
Outfall Type:	Pipe end
Outfall Material:	RCP
Outfall Condition:	Good
Discharging To:	River
Sediment Accumulation	No
Scouring:	No
Floatables	No
Algae Growth:	No
Stressed Vegetation:	No

Staining:	No
Turbidity:	No
Discharging:	Yes
Discharge Amount:	Moderate
Discharge Color:	Clear
Oil Sheen:	No
Odor:	No
Structure Under Water:	No

Outfall Issue:	None
Inspection Notes:

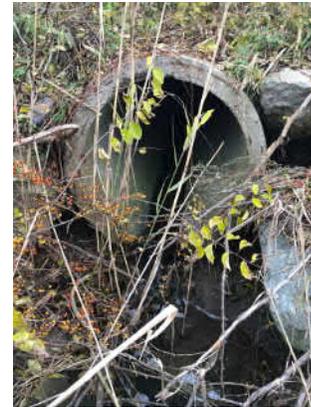
Outfall ID:	OF-274
Watershed:	TAUNTON
MS4:	Yes
Inspection Date:	11/5/2018
Street Name:	OFF ROAD
Assumed Owner:	Town
Use:	Residential
Pipe Size:	36
Pipe Shape:	Round
Pipe Material:	RCP
Number of Pipes:	1
Outfall Type:	Pipe end
Outfall Material:	RCP
Outfall Condition:	Good
Discharging To:	River
Sediment Accumulation	No
Scouring:	No
Floatables	No
Algae Growth:	No
Stressed Vegetation:	No

Staining:	No
Turbidity:	No
Discharging:	Yes
Discharge Amount:	Moderate
Discharge Color:	Clear
Oil Sheen:	No
Odor:	No
Structure Under Water:	No

Outfall Issue:	None
Inspection Notes:

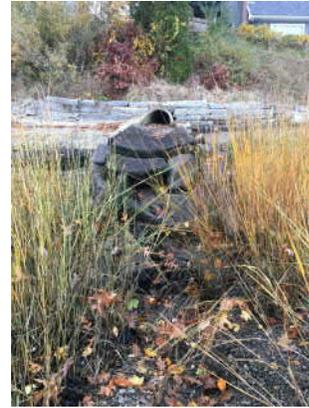
Outfall ID:	OF-275
Watershed:	TAUNTON
MS4:	Yes
Inspection Date:	11/5/2018
Street Name:	OFF ROAD
Assumed Owner:	Town
Use:	Residential
Pipe Size:	15
Pipe Shape:	Round
Pipe Material:	RCP
Number of Pipes:	1
Outfall Type:	Flared end
Outfall Material:	RCP
Outfall Condition:	Good
Discharging To:	River
Sediment Accumulation	No
Scouring:	Yes
Floatables	No
Algae Growth:	Yes
Stressed Vegetation:	No

Staining:	Yes
Turbidity:	NA
Discharging:	No
Discharge Amount:	None
Discharge Color:	NA
Oil Sheen:	No
Odor:	No
Structure Under Water:	No

Outfall Issue:	Staining
Inspection Notes:	Swale downstream of outfall deteriorated

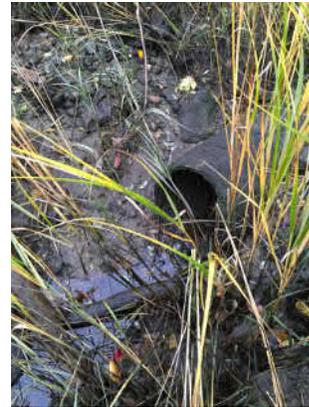
Outfall ID:	OF-276
Watershed:	TAUNTON
MS4:	Yes
Inspection Date:	11/5/2018
Street Name:	NORTH STREET
Assumed Owner:	Town
Use:	Residential
Pipe Size:	15
Pipe Shape:	Round
Pipe Material:	RCP
Number of Pipes:	1
Outfall Type:	Pipe end
Outfall Material:	RCP
Outfall Condition:	Fair
Discharging To:	River
Sediment Accumulation	No
Scouring:	No
Floatables	No
Algae Growth:	No
Stressed Vegetation:	No

Staining:	No
Turbidity:	No
Discharging:	Yes
Discharge Amount:	Drip
Discharge Color:	Clear
Oil Sheen:	No
Odor:	No
Structure Under Water:	No

Outfall Issue:	None
Inspection Notes:

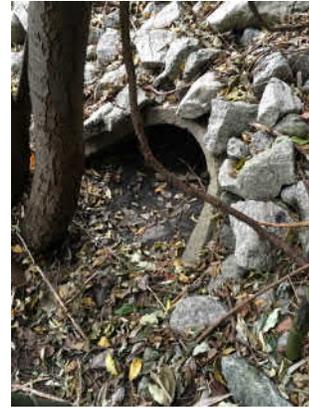
Outfall ID:	OF-279
Watershed:	TAUNTON
MS4:	Yes
Inspection Date:	11/5/2018
Street Name:	OFF ROAD
Assumed Owner:	Town
Use:	Residential
Pipe Size:	15
Pipe Shape:	Round
Pipe Material:	RCP
Number of Pipes:	1
Outfall Type:	Flared end
Outfall Material:	RCP
Outfall Condition:	Good
Discharging To:	Land
Sediment Accumulation	Yes
Scouring:	No
Floatables	No
Algae Growth:	No
Stressed Vegetation:	No

Staining:	No
Turbidity:	NA
Discharging:	No
Discharge Amount:	None
Discharge Color:	NA
Oil Sheen:	No
Odor:	No
Structure Under Water:	No

Outfall Issue: Major blockage

Inspection Notes: Swampy land

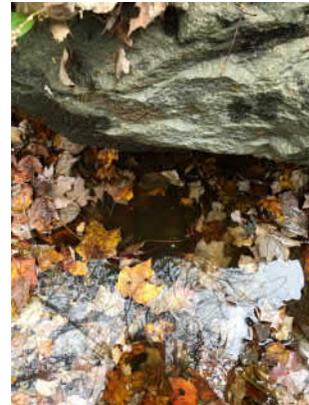
Outfall ID:	OF-285
Watershed:	TAUNTON
MS4:	Yes
Inspection Date:	11/5/2018
Street Name:	RANGER ROAD
Assumed Owner:	Town
Use:	Residential
Pipe Size:	15
Pipe Shape:	Round
Pipe Material:	RCP
Number of Pipes:	1
Outfall Type:	Pipe end
Outfall Material:	RCP
Outfall Condition:	Unknown
Discharging To:	Wetland
Sediment Accumulation	No
Scouring:	Yes
Floatables	No
Algae Growth:	No
Stressed Vegetation:	No

Staining:	No
Turbidity:	NA
Discharging:	No
Discharge Amount:	None
Discharge Color:	NA
Oil Sheen:	Yes
Odor:	No
Structure Under Water:	Yes

Outfall Issue: Fully submerged, oil sheen

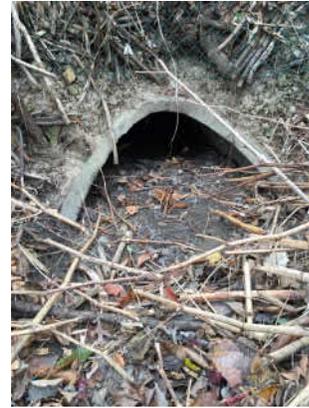
Outfall ID:	OF-288
Watershed:	TAUNTON
MS4:	No
Inspection Date:	11/15/2018
Street Name:	BROAD COVE STREET
Assumed Owner:	Town
Use:	Residential
Pipe Size:	18
Pipe Shape:	Round
Pipe Material:	RCP
Number of Pipes:	1
Outfall Type:	Flared end
Outfall Material:	RCP
Outfall Condition:	Good
Discharging To:	Detention basin
Sediment Accumulation	No
Scouring:	No
Floatables	No
Algae Growth:	No
Stressed Vegetation:	No

Staining:	No
Turbidity:	NA
Discharging:	No
Discharge Amount:	None
Discharge Color:	NA
Oil Sheen:	No
Odor:	No
Structure Under Water:	No

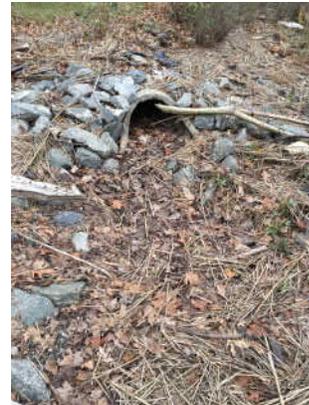
Outfall ID:	OF-294
Watershed:	TAUNTON
MS4:	Yes
Inspection Date:	11/5/2018
Street Name:	MAIN STREET
Assumed Owner:	Town
Use:	Industrial
Pipe Size:	12
Pipe Shape:	Round
Pipe Material:	RCP
Number of Pipes:	1
Outfall Type:	Flared end
Outfall Material:	RCP
Outfall Condition:	Good
Discharging To:	River
Sediment Accumulation	Yes
Scouring:	No
Floatables	No
Algae Growth:	No
Stressed Vegetation:	No

Staining:	No
Turbidity:	NA
Discharging:	No
Discharge Amount:	None
Discharge Color:	NA
Oil Sheen:	No
Odor:	No
Structure Under Water:	No

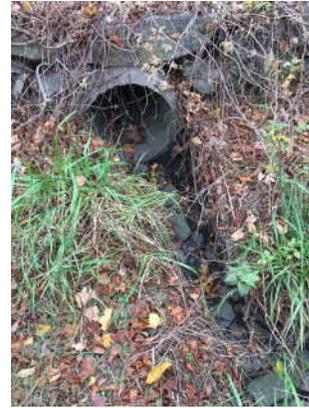
Outfall ID:	OF-295
Watershed:	TAUNTON
MS4:	Yes
Inspection Date:	11/5/2018
Street Name:	MAIN STREET
Assumed Owner:	Town
Use:	Residential
Pipe Size:	24
Pipe Shape:	Round
Pipe Material:	RCP
Number of Pipes:	1
Outfall Type:	Headwall
Outfall Material:	Stone
Outfall Condition:	Good
Discharging To:	River
Sediment Accumulation	No
Scouring:	Yes
Floatables	No
Algae Growth:	No
Stressed Vegetation:	No

Staining:	No
Turbidity:	NA
Discharging:	No
Discharge Amount:	None
Discharge Color:	NA
Oil Sheen:	No
Odor:	No
Structure Under Water:	No

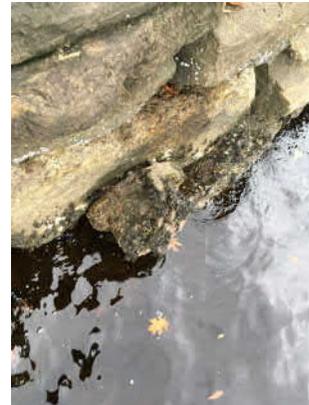
Outfall ID:	OF-296
Watershed:	TAUNTON
MS4:	Yes
Inspection Date:	11/5/2018
Street Name:	OFF ROAD
Assumed Owner:	Town
Use:	Open Space
Pipe Size:	15
Pipe Shape:	Round
Pipe Material:	CI
Number of Pipes:	1
Outfall Type:	Pipe end
Outfall Material:	CI
Outfall Condition:	Good
Discharging To:	River
Sediment Accumulation	No
Scouring:	No
Floatables	No
Algae Growth:	No
Stressed Vegetation:	No

Staining:	No
Turbidity:	NA
Discharging:	No
Discharge Amount:	None
Discharge Color:	NA
Oil Sheen:	No
Odor:	No
Structure Under Water:	No

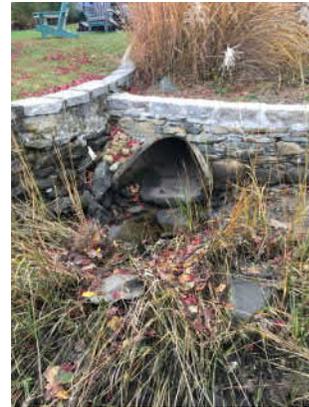
Outfall ID:	OF-298
Watershed:	TAUNTON
MS4:	Yes
Inspection Date:	11/5/2018
Street Name:	MAIN STREET
Assumed Owner:	Town
Use:	Residential
Pipe Size:	18
Pipe Shape:	Round
Pipe Material:	RCP
Number of Pipes:	1
Outfall Type:	Flared end
Outfall Material:	RCP
Outfall Condition:	Fair
Discharging To:	River
Sediment Accumulation	No
Scouring:	No
Floatables	No
Algae Growth:	No
Stressed Vegetation:	No

Staining:	No
Turbidity:	NA
Discharging:	No
Discharge Amount:	None
Discharge Color:	NA
Oil Sheen:	No
Odor:	No
Structure Under Water:	No

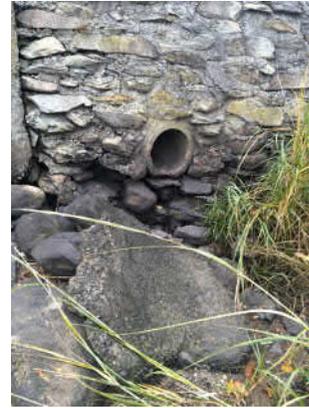
Outfall ID:	OF-300
Watershed:	TAUNTON
MS4:	Yes
Inspection Date:	11/5/2018
Street Name:	CLARK STREET
Assumed Owner:	Town
Use:	Residential
Pipe Size:	15
Pipe Shape:	Round
Pipe Material:	RCP
Number of Pipes:	1
Outfall Type:	Headwall
Outfall Material:	Stone
Outfall Condition:	Fair
Discharging To:	River
Sediment Accumulation	No
Scouring:	Yes
Floatables	No
Algae Growth:	No
Stressed Vegetation:	No

Staining:	No
Turbidity:	NA
Discharging:	No
Discharge Amount:	None
Discharge Color:	NA
Oil Sheen:	No
Odor:	No
Structure Under Water:	No

Outfall Issue: **Damaged**

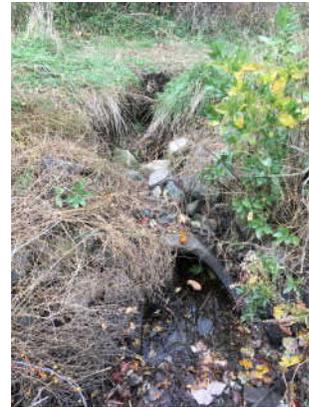
Outfall ID:	OF-301
Watershed:	TAUNTON
MS4:	Yes
Inspection Date:	11/5/2018
Street Name:	SIMMS AVENUE
Assumed Owner:	Town
Use:	Residential
Pipe Size:	15
Pipe Shape:	Round
Pipe Material:	CMP
Number of Pipes:	1
Outfall Type:	Pipe end
Outfall Material:	CMP
Outfall Condition:	Poor
Discharging To:	River
Sediment Accumulation	Yes
Scouring:	Yes
Floatables	No
Algae Growth:	No
Stressed Vegetation:	No

Staining:	No
Turbidity:	NA
Discharging:	No
Discharge Amount:	None
Discharge Color:	NA
Oil Sheen:	No
Odor:	No
Structure Under Water:	No

Outfall Issue: **Ground collapse**

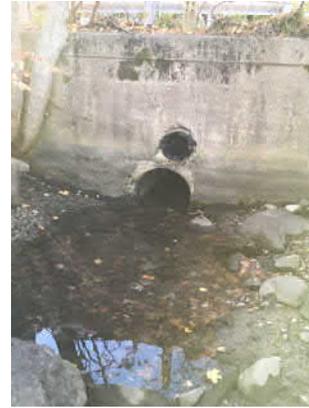
Outfall ID:	OF-302
Watershed:	TAUNTON
MS4:	Yes
Inspection Date:	11/8/2018
Street Name:	RIVERSIDE AVENUE
Assumed Owner:	Town
Use:	Residential
Pipe Size:	12
Pipe Shape:	Round
Pipe Material:	HDPE
Number of Pipes:	1
Outfall Type:	Headwall
Outfall Material:	Concrete
Outfall Condition:	Good
Discharging To:	Stream
Sediment Accumulation	Yes
Scouring:	No
Floatables	No
Algae Growth:	No
Stressed Vegetation:	No

Staining:	No
Turbidity:	NA
Discharging:	No
Discharge Amount:	None
Discharge Color:	NA
Oil Sheen:	No
Odor:	No
Structure Under Water:	No

Outfall Issue:	None
Inspection Notes:

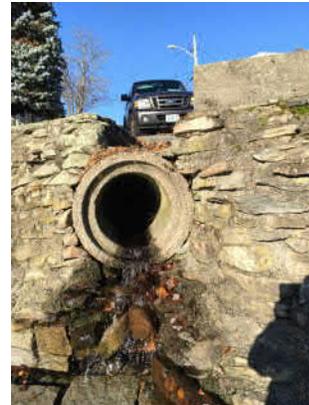
Outfall ID:	OF-339
Watershed:	TAUNTON
MS4:	Yes
Inspection Date:	11/9/2018
Street Name:	OWEN AVENUE
Assumed Owner:	Town
Use:	Residential
Pipe Size:	24
Pipe Shape:	Round
Pipe Material:	RCP
Number of Pipes:	1
Outfall Type:	Pipe end
Outfall Material:	RCP
Outfall Condition:	Good
Discharging To:	River
Sediment Accumulation	No
Scouring:	No
Floatables	No
Algae Growth:	No
Stressed Vegetation:	No

Staining:	No
Turbidity:	No
Discharging:	Yes
Discharge Amount:	Moderate
Discharge Color:	Clear
Oil Sheen:	No
Odor:	No
Structure Under Water:	No

Outfall Issue:	None
Inspection Notes:

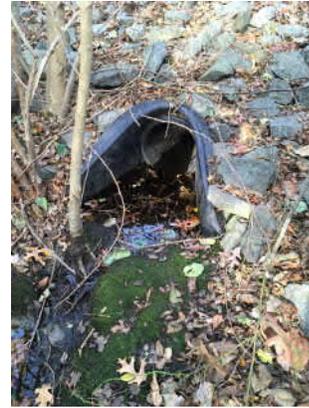
Outfall ID:	OF-389
Watershed:	MT HOPE BAY
MS4:	No
Inspection Date:	11/12/2018
Street Name:	OFF ROAD
Assumed Owner:	Town
Use:	Residential
Pipe Size:	12
Pipe Shape:	Round
Pipe Material:	HDPE
Number of Pipes:	1
Outfall Type:	Flared end
Outfall Material:	HDPE
Outfall Condition:	Good
Discharging To:	Detention basin
Sediment Accumulation	No
Scouring:	No
Floatables	No
Algae Growth:	No
Stressed Vegetation:	No

Staining:	No
Turbidity:	No
Discharging:	Yes
Discharge Amount:	Trickle
Discharge Color:	Clear
Oil Sheen:	No
Odor:	No
Structure Under Water:	No

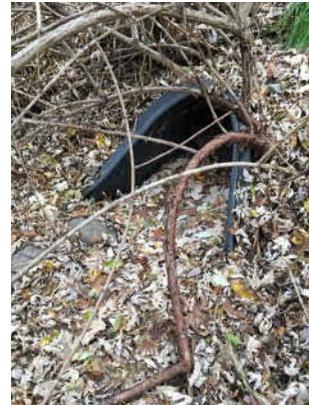
Outfall ID:	OF-507
Watershed:	TAUNTON
MS4:	Yes
Inspection Date:	11/15/2018
Street Name:	SOUTH STREET
Assumed Owner:	Town
Use:	Residential
Pipe Size:	12
Pipe Shape:	Round
Pipe Material:	HDPE
Number of Pipes:	1
Outfall Type:	Flared end
Outfall Material:	HDPE
Outfall Condition:	Good
Discharging To:	Land
Sediment Accumulation	No
Scouring:	No
Floatables	No
Algae Growth:	No
Stressed Vegetation:	No

Staining:	No
Turbidity:	NA
Discharging:	No
Discharge Amount:	None
Discharge Color:	NA
Oil Sheen:	No
Odor:	No
Structure Under Water:	No

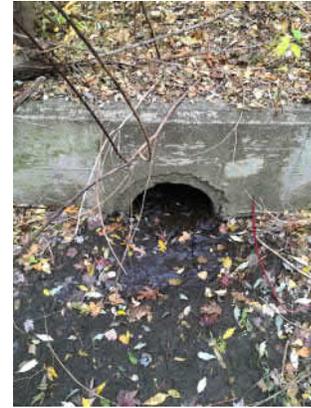
Outfall ID:	OF-516
Watershed:	TAUNTON
MS4:	Yes
Inspection Date:	11/5/2018
Street Name:	OFF ROAD
Assumed Owner:	Town
Use:	Residential
Pipe Size:	18
Pipe Shape:	Round
Pipe Material:	RCP
Number of Pipes:	1
Outfall Type:	Headwall
Outfall Material:	Concrete
Outfall Condition:	Good
Discharging To:	Wetland
Sediment Accumulation	Yes
Scouring:	No
Floatables	No
Algae Growth:	No
Stressed Vegetation:	No

Staining:	No
Turbidity:	NA
Discharging:	No
Discharge Amount:	None
Discharge Color:	NA
Oil Sheen:	No
Odor:	No
Structure Under Water:	No

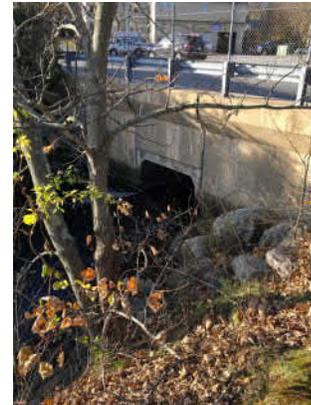
Outfall ID:	OF-523
Watershed:	TAUNTON
MS4:	Yes
Inspection Date:	11/8/2018
Street Name:	RIVERSIDE AVENUE
Assumed Owner:	Town
Use:	Mixed
Pipe Size:	96
Pipe Shape:	Box
Pipe Material:	Concrete
Number of Pipes:	1
Outfall Type:	Box culvert
Outfall Material:	Concrete
Outfall Condition:	Good
Discharging To:	Stream
Sediment Accumulation	No
Scouring:	No
Floatables	No
Algae Growth:	No
Stressed Vegetation:	No

Staining:	No
Turbidity:	No
Discharging:	Yes
Discharge Amount:	Substantial
Discharge Color:	Red
Oil Sheen:	No
Odor:	No
Structure Under Water:	Yes

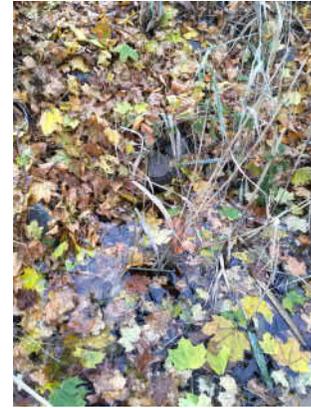
Outfall ID:	OF-525
Watershed:	TAUNTON
MS4:	Yes
Inspection Date:	11/5/2018
Street Name:	RIVERSIDE AVENUE
Assumed Owner:	Town
Use:	Residential
Pipe Size:	24
Pipe Shape:	Round
Pipe Material:	RCP
Number of Pipes:	1
Outfall Type:	Pipe end
Outfall Material:	RCP
Outfall Condition:	Good
Discharging To:	River
Sediment Accumulation	No
Scouring:	No
Floatables	No
Algae Growth:	No
Stressed Vegetation:	No

Staining:	No
Turbidity:	NA
Discharging:	No
Discharge Amount:	None
Discharge Color:	NA
Oil Sheen:	No
Odor:	No
Structure Under Water:	Yes

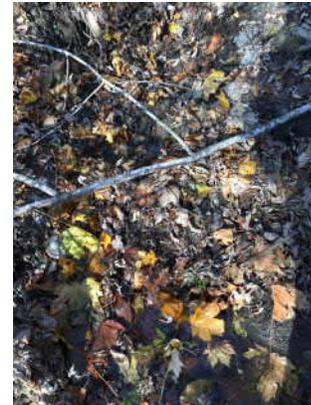
Outfall ID:	OF-530
Watershed:	TAUNTON
MS4:	No
Inspection Date:	11/12/2018
Street Name:	ELLENWOOD AVENUE
Assumed Owner:	Town
Use:	Municipal
Pipe Size:	0
Pipe Shape:	Unknown
Pipe Material:	Unknown
Number of Pipes:	0
Outfall Type:	Unknown
Outfall Material:	Unknown
Outfall Condition:	Unknown
Discharging To:	Land
Sediment Accumulation	Yes
Scouring:	No
Floatables	No
Algae Growth:	No
Stressed Vegetation:	No

Staining:	No
Turbidity:	No
Discharging:	Yes
Discharge Amount:	Trickle
Discharge Color:	Clear
Oil Sheen:	No
Odor:	No
Structure Under Water:	No

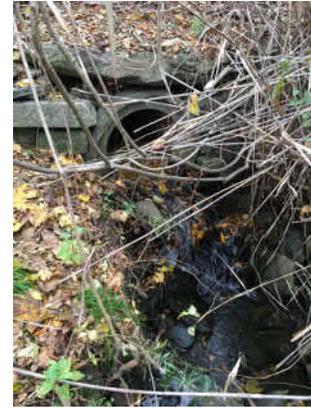
Outfall ID:	OF-539
Watershed:	TAUNTON
MS4:	Yes
Inspection Date:	11/5/2018
Street Name:	RIVERSIDE AVENUE
Assumed Owner:	Town
Use:	Residential
Pipe Size:	24
Pipe Shape:	Round
Pipe Material:	RCP
Number of Pipes:	1
Outfall Type:	Headwall
Outfall Material:	Stone
Outfall Condition:	Good
Discharging To:	River
Sediment Accumulation	No
Scouring:	Yes
Floatables	No
Algae Growth:	No
Stressed Vegetation:	No

Staining:	No
Turbidity:	No
Discharging:	Yes
Discharge Amount:	Substantial
Discharge Color:	Clear
Oil Sheen:	No
Odor:	No
Structure Under Water:	No

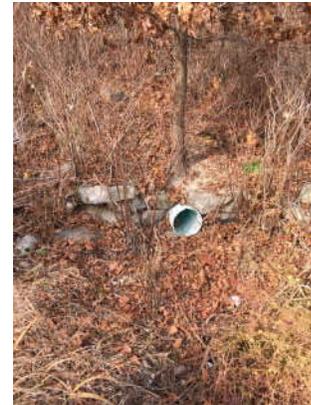
Outfall ID:	OF-651
Watershed:	TAUNTON
MS4:	Yes
Inspection Date:	11/8/2018
Street Name:	LINDA LANE
Assumed Owner:	Town
Use:	Open Space
Pipe Size:	12
Pipe Shape:	Round
Pipe Material:	PVC
Number of Pipes:	1
Outfall Type:	Headwall
Outfall Material:	Stone
Outfall Condition:	Good
Discharging To:	River
Sediment Accumulation	No
Scouring:	No
Floatables	No
Algae Growth:	No
Stressed Vegetation:	No

Staining:	No
Turbidity:	NA
Discharging:	No
Discharge Amount:	None
Discharge Color:	NA
Oil Sheen:	No
Odor:	No
Structure Under Water:	No

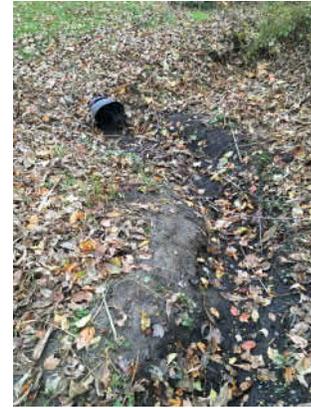
Outfall ID:	OF-662
Watershed:	TAUNTON
MS4:	Yes
Inspection Date:	11/5/2018
Street Name:	CHERRY STREET
Assumed Owner:	Town
Use:	Residential
Pipe Size:	12
Pipe Shape:	Round
Pipe Material:	HDPE
Number of Pipes:	1
Outfall Type:	Pipe end
Outfall Material:	HDPE
Outfall Condition:	Good
Discharging To:	Wetland
Sediment Accumulation	No
Scouring:	Yes
Floatables	No
Algae Growth:	No
Stressed Vegetation:	No

Staining:	No
Turbidity:	NA
Discharging:	No
Discharge Amount:	None
Discharge Color:	NA
Oil Sheen:	No
Odor:	No
Structure Under Water:	No

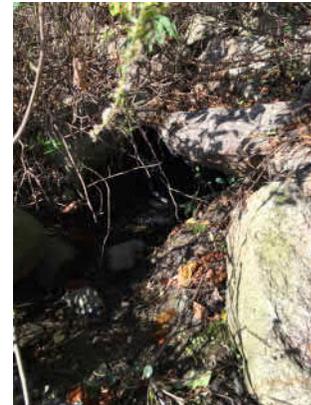
Outfall ID:	OF-701
Watershed:	TAUNTON
MS4:	Yes
Inspection Date:	11/9/2018
Street Name:	RIVERSIDE AVENUE
Assumed Owner:	Town
Use:	Industrial
Pipe Size:	12
Pipe Shape:	Round
Pipe Material:	HDPE
Number of Pipes:	1
Outfall Type:	Pipe end
Outfall Material:	HDPE
Outfall Condition:	Fair
Discharging To:	River
Sediment Accumulation	No
Scouring:	No
Floatables	No
Algae Growth:	Yes
Stressed Vegetation:	No

Staining:	No
Turbidity:	No
Discharging:	Yes
Discharge Amount:	Moderate
Discharge Color:	Clear
Oil Sheen:	No
Odor:	No
Structure Under Water:	No

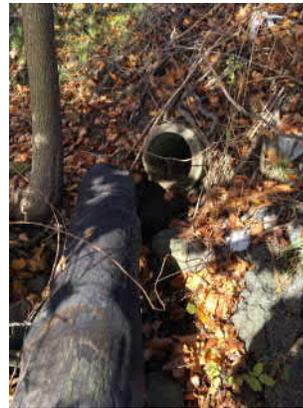
Outfall ID:	OF-702
Watershed:	TAUNTON
MS4:	Yes
Inspection Date:	11/9/2018
Street Name:	RIVERSIDE AVENUE
Assumed Owner:	Town
Use:	Industrial
Pipe Size:	12
Pipe Shape:	Round
Pipe Material:	RCP
Number of Pipes:	1
Outfall Type:	Pipe end
Outfall Material:	Concrete
Outfall Condition:	Good
Discharging To:	River
Sediment Accumulation	No
Scouring:	Yes
Floatables	No
Algae Growth:	No
Stressed Vegetation:	No

Staining:	No
Turbidity:	NA
Discharging:	
Discharge Amount:	None
Discharge Color:	NA
Oil Sheen:	No
Odor:	No
Structure Under Water:	No

Outfall Issue:	None
Inspection Notes:

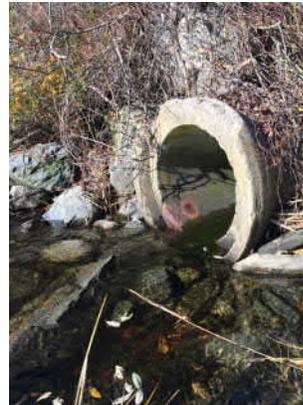
Outfall ID:	OF-703
Watershed:	TAUNTON
MS4:	Yes
Inspection Date:	11/9/2018
Street Name:	RIVERSIDE AVENUE
Assumed Owner:	Town
Use:	Commercial
Pipe Size:	24
Pipe Shape:	Round
Pipe Material:	RCP
Number of Pipes:	1
Outfall Type:	Pipe end
Outfall Material:	RCP
Outfall Condition:	Fair
Discharging To:	River
Sediment Accumulation	No
Scouring:	No
Floatables	No
Algae Growth:	Yes
Stressed Vegetation:	No

Staining:	No
Turbidity:	No
Discharging:	Yes
Discharge Amount:	Moderate
Discharge Color:	Clear
Oil Sheen:	No
Odor:	No
Structure Under Water:	No

Outfall Issue:	None
Inspection Notes:

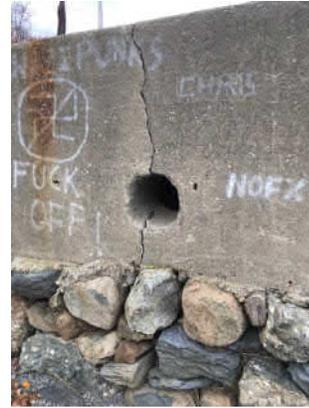
Outfall ID:	OF-705
Watershed:	TAUNTON
MS4:	Yes
Inspection Date:	11/9/2018
Street Name:	RIVERSIDE AVENUE
Assumed Owner:	Town
Use:	Mixed
Pipe Size:	12
Pipe Shape:	Round
Pipe Material:	VC
Number of Pipes:	1
Outfall Type:	Headwall
Outfall Material:	Concrete
Outfall Condition:	Fair
Discharging To:	River
Sediment Accumulation	No
Scouring:	No
Floatables	No
Algae Growth:	No
Stressed Vegetation:	No

Staining:	No
Turbidity:	NA
Discharging:	
Discharge Amount:	None
Discharge Color:	NA
Oil Sheen:	No
Odor:	No
Structure Under Water:	No

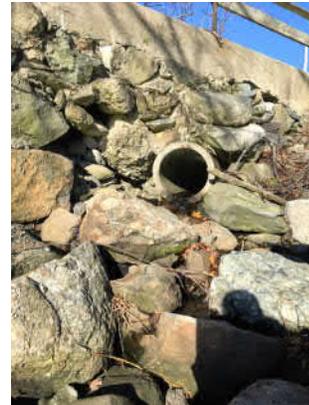
Outfall ID:	OF-706
Watershed:	TAUNTON
MS4:	Yes
Inspection Date:	11/9/2018
Street Name:	RIVERSIDE AVENUE
Assumed Owner:	Town
Use:	Residential
Pipe Size:	18
Pipe Shape:	Round
Pipe Material:	RCP
Number of Pipes:	1
Outfall Type:	Pipe end
Outfall Material:	RCP
Outfall Condition:	Good
Discharging To:	River
Sediment Accumulation	No
Scouring:	No
Floatables	No
Algae Growth:	No
Stressed Vegetation:	No

Staining:	No
Turbidity:	No
Discharging:	Yes
Discharge Amount:	Moderate
Discharge Color:	Clear
Oil Sheen:	No
Odor:	No
Structure Under Water:	No

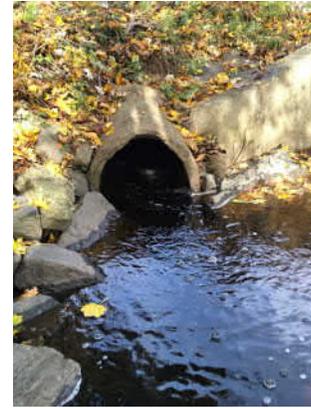
Outfall ID:	OF-781
Watershed:	TAUNTON
MS4:	Yes
Inspection Date:	11/8/2018
Street Name:	CHACE STREET
Assumed Owner:	Town
Use:	Residential
Pipe Size:	24
Pipe Shape:	Round
Pipe Material:	RCP
Number of Pipes:	1
Outfall Type:	Pipe end
Outfall Material:	RCP
Outfall Condition:	Fair
Discharging To:	Stream
Sediment Accumulation	No
Scouring:	No
Floatables	No
Algae Growth:	No
Stressed Vegetation:	No

Staining:	No
Turbidity:	No
Discharging:	Yes
Discharge Amount:	Substantial
Discharge Color:	Red
Oil Sheen:	No
Odor:	No
Structure Under Water:	Yes

Outfall Issue:	None
Inspection Notes:

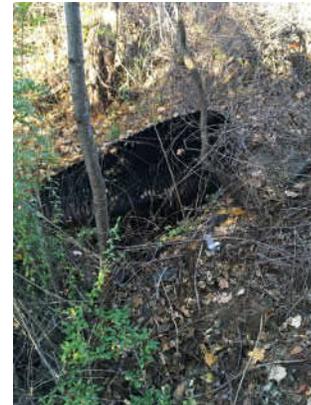
Outfall ID:	OF-881
Watershed:	TAUNTON
MS4:	Yes
Inspection Date:	11/9/2018
Street Name:	PROSPECT STREET
Assumed Owner:	Town
Use:	Residential
Pipe Size:	96
Pipe Shape:	Round
Pipe Material:	CMP
Number of Pipes:	1
Outfall Type:	Flared end
Outfall Material:	CMP
Outfall Condition:	Good
Discharging To:	Stream
Sediment Accumulation	No
Scouring:	No
Floatables	No
Algae Growth:	No
Stressed Vegetation:	No

Staining:	No
Turbidity:	No
Discharging:	Yes
Discharge Amount:	Substantial
Discharge Color:	Reddish tinge
Oil Sheen:	No
Odor:	No
Structure Under Water:	Yes

Outfall Issue:	None
Inspection Notes:

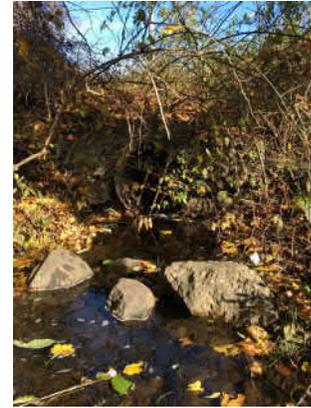
Outfall ID:	OF-1083
Watershed:	TAUNTON
MS4:	Yes
Inspection Date:	11/9/2018
Street Name:	LEAHY AVENUE
Assumed Owner:	Town
Use:	Residential
Pipe Size:	30
Pipe Shape:	Round
Pipe Material:	CMP
Number of Pipes:	1
Outfall Type:	Headwall
Outfall Material:	Stone
Outfall Condition:	Fair
Discharging To:	Stream
Sediment Accumulation	No
Scouring:	No
Floatables	Suds
Algae Growth:	No
Stressed Vegetation:	No

Staining:	No
Turbidity:	No
Discharging:	Yes
Discharge Amount:	Moderate
Discharge Color:	Clear
Oil Sheen:	No
Odor:	No
Structure Under Water:	No

Outfall Issue: Suds

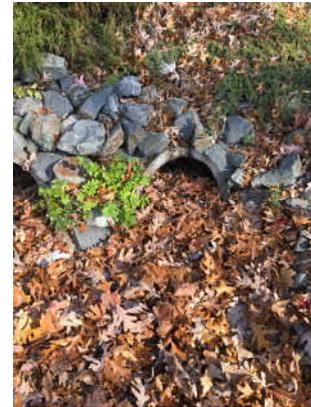
Outfall ID:	OF-1108
Watershed:	TAUNTON
MS4:	Yes
Inspection Date:	11/12/2018
Street Name:	COUNTY STREET
Assumed Owner:	Town
Use:	Commercial
Pipe Size:	15
Pipe Shape:	Round
Pipe Material:	RCP
Number of Pipes:	1
Outfall Type:	Flared end
Outfall Material:	RCP
Outfall Condition:	Good
Discharging To:	Land
Sediment Accumulation	Yes
Scouring:	No
Floatables	No
Algae Growth:	No
Stressed Vegetation:	No

Staining:	No
Turbidity:	NA
Discharging:	No
Discharge Amount:	None
Discharge Color:	NA
Oil Sheen:	No
Odor:	No
Structure Under Water:	No

Outfall Issue: None

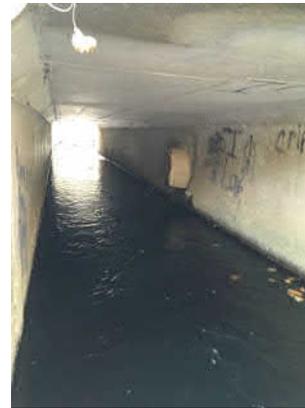
Outfall ID:	OF-1184
Watershed:	TAUNTON
MS4:	Yes
Inspection Date:	11/8/2018
Street Name:	MIDLAND ROAD
Assumed Owner:	Town
Use:	Residential
Pipe Size:	18
Pipe Shape:	Round
Pipe Material:	RCP
Number of Pipes:	1
Outfall Type:	Pipe end
Outfall Material:	RCP
Outfall Condition:	Fair
Discharging To:	Stream
Sediment Accumulation	No
Scouring:	No
Floatables	No
Algae Growth:	No
Stressed Vegetation:	No

Staining:	No
Turbidity:	No
Discharging:	Yes
Discharge Amount:	Trickle
Discharge Color:	Clear
Oil Sheen:	No
Odor:	No
Structure Under Water:	No

Outfall Issue:	None
Inspection Notes:	No access

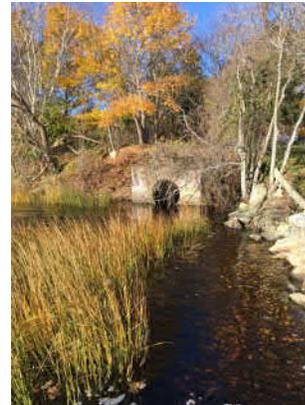
Outfall ID:	OF-1207
Watershed:	TAUNTON
MS4:	Yes
Inspection Date:	11/9/2018
Street Name:	BEACH AVENUE
Assumed Owner:	Town
Use:	Residential
Pipe Size:	48
Pipe Shape:	Round
Pipe Material:	RCP
Number of Pipes:	1
Outfall Type:	Headwall
Outfall Material:	Concrete
Outfall Condition:	Good
Discharging To:	River
Sediment Accumulation	No
Scouring:	No
Floatables	No
Algae Growth:	No
Stressed Vegetation:	No

Staining:	No
Turbidity:	No
Discharging:	Yes
Discharge Amount:	Moderate
Discharge Color:	Red
Oil Sheen:	No
Odor:	No
Structure Under Water:	Yes

Outfall Issue:	None
Inspection Notes:

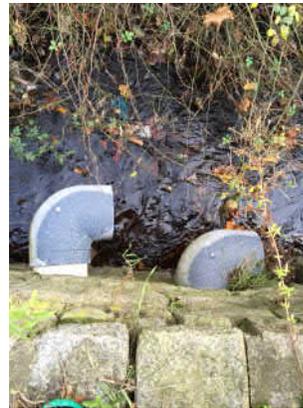
Outfall ID:	OF-1210
Watershed:	TAUNTON
MS4:	Yes
Inspection Date:	11/8/2018
Street Name:	FENO COURT
Assumed Owner:	Town
Use:	Residential
Pipe Size:	10
Pipe Shape:	Round
Pipe Material:	PVC
Number of Pipes:	2
Outfall Type:	Pipe end
Outfall Material:	PVC
Outfall Condition:	Good
Discharging To:	Stream
Sediment Accumulation	No
Scouring:	No
Floatables	No
Algae Growth:	No
Stressed Vegetation:	No

Staining:	No
Turbidity:	NA
Discharging:	No
Discharge Amount:	None
Discharge Color:	NA
Oil Sheen:	No
Odor:	No
Structure Under Water:	No

Outfall Issue:	None
Inspection Notes:	No access

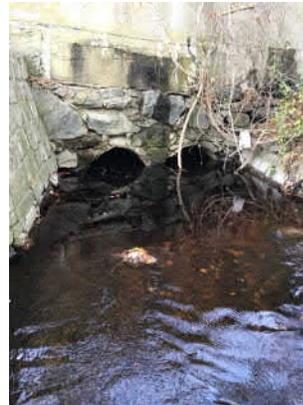
Outfall ID:	OF-1213
Watershed:	TAUNTON
MS4:	Yes
Inspection Date:	11/8/2018
Street Name:	FENO COURT
Assumed Owner:	Town
Use:	Residential
Pipe Size:	48
Pipe Shape:	Round
Pipe Material:	CMP
Number of Pipes:	2
Outfall Type:	Headwall
Outfall Material:	Stone
Outfall Condition:	Fair
Discharging To:	Stream
Sediment Accumulation	No
Scouring:	No
Floatables	No
Algae Growth:	No
Stressed Vegetation:	No

Staining:	No
Turbidity:	No
Discharging:	Yes
Discharge Amount:	Substantial
Discharge Color:	Red
Oil Sheen:	No
Odor:	No
Structure Under Water:	Yes

Outfall Issue:	None
Inspection Notes:	Outfall may be culvert outlet

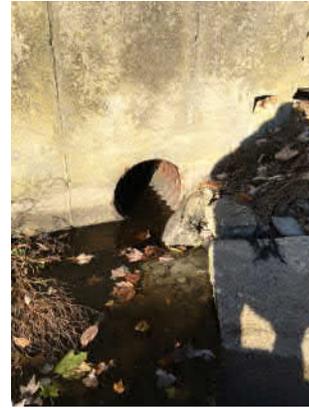
Outfall ID:	OF-1243
Watershed:	TAUNTON
MS4:	Yes
Inspection Date:	11/9/2018
Street Name:	BEACH AVENUE
Assumed Owner:	Town
Use:	Residential
Pipe Size:	15
Pipe Shape:	Round
Pipe Material:	CMP
Number of Pipes:	1
Outfall Type:	Headwall
Outfall Material:	Concrete
Outfall Condition:	Good
Discharging To:	River
Sediment Accumulation	No
Scouring:	No
Floatables	No
Algae Growth:	No
Stressed Vegetation:	No

Staining:	No
Turbidity:	NA
Discharging:	
Discharge Amount:	None
Discharge Color:	NA
Oil Sheen:	No
Odor:	No
Structure Under Water:	Yes

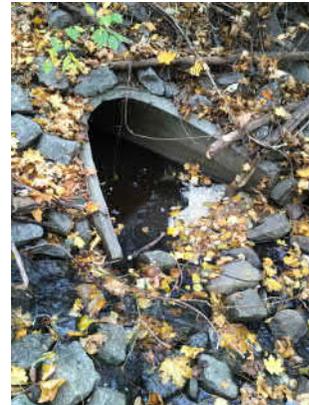
Outfall ID:	OF-1273
Watershed:	TAUNTON
MS4:	Yes
Inspection Date:	11/9/2018
Street Name:	RIVERSIDE AVENUE
Assumed Owner:	Town
Use:	Commercial
Pipe Size:	24
Pipe Shape:	Round
Pipe Material:	RCP
Number of Pipes:	1
Outfall Type:	Flared end
Outfall Material:	RCP
Outfall Condition:	Good
Discharging To:	River
Sediment Accumulation	No
Scouring:	No
Floatables	Suds
Algae Growth:	No
Stressed Vegetation:	No

Staining:	Yes
Turbidity:	Yes
Discharging:	Yes
Discharge Amount:	Trickle
Discharge Color:	Red
Oil Sheen:	No
Odor:	No
Structure Under Water:	No

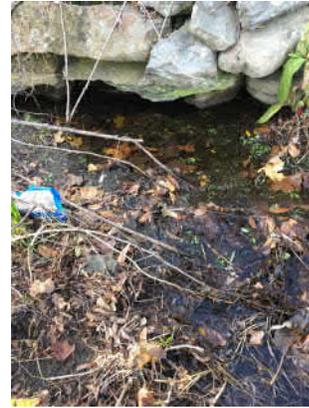
Outfall ID:	OF-1316
Watershed:	TAUNTON
MS4:	Yes
Inspection Date:	11/8/2018
Street Name:	RIVERSIDE AVENUE
Assumed Owner:	Town
Use:	Residential
Pipe Size:	0
Pipe Shape:	Unknown
Pipe Material:	Unknown
Number of Pipes:	0
Outfall Type:	Headwall
Outfall Material:	Stone
Outfall Condition:	Poor
Discharging To:	River
Sediment Accumulation	Yes
Scouring:	No
Floatables	No
Algae Growth:	No
Stressed Vegetation:	No

Staining:	No
Turbidity:	No
Discharging:	Yes
Discharge Amount:	Trickle
Discharge Color:	Clear
Oil Sheen:	No
Odor:	No
Structure Under Water:	Yes

Outfall Issue: Buried structure, possibly collapsed

Inspection Notes: Resident says pipe collapsed during road construct

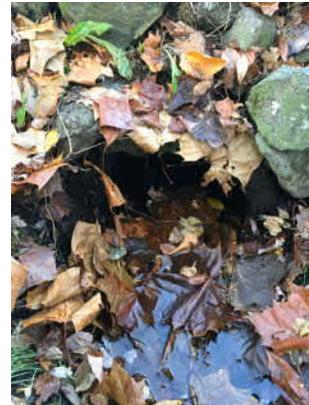
Outfall ID:	OF-1355
Watershed:	TAUNTON
MS4:	Yes
Inspection Date:	11/9/2018
Street Name:	COLONIAL DRIVE
Assumed Owner:	Town
Use:	Residential
Pipe Size:	15
Pipe Shape:	Round
Pipe Material:	RCP
Number of Pipes:	1
Outfall Type:	Pipe end
Outfall Material:	RCP
Outfall Condition:	Fair
Discharging To:	Stream
Sediment Accumulation	No
Scouring:	No
Floatables	No
Algae Growth:	No
Stressed Vegetation:	No

Staining:	No
Turbidity:	NA
Discharging:	
Discharge Amount:	None
Discharge Color:	NA
Oil Sheen:	No
Odor:	No
Structure Under Water:	Yes

Outfall Issue: None

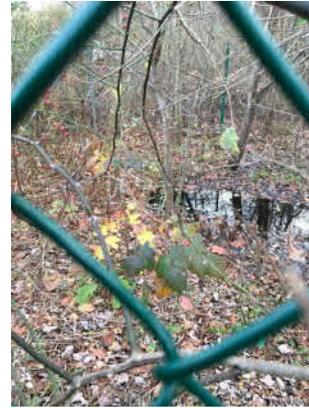
Outfall ID:	OF-1386
Watershed:	TAUNTON
MS4:	No
Inspection Date:	11/12/2018
Street Name:	TULIP AVENUE
Assumed Owner:	Town
Use:	Residential
Pipe Size:	0
Pipe Shape:	Unknown
Pipe Material:	Unknown
Number of Pipes:	
Outfall Type:	Unknown
Outfall Material:	Unknown
Outfall Condition:	Unknown
Discharging To:	Detention basin
Sediment Accumulation	No
Scouring:	No
Floatables	No
Algae Growth:	No
Stressed Vegetation:	No

Staining:	No
Turbidity:	NA
Discharging:	
Discharge Amount:	Unknown
Discharge Color:	NA
Oil Sheen:	No
Odor:	No
Structure Under Water:	Yes

Outfall Issue: Fully submerged, no access

Inspection Notes: Discharges to assumed detention basin

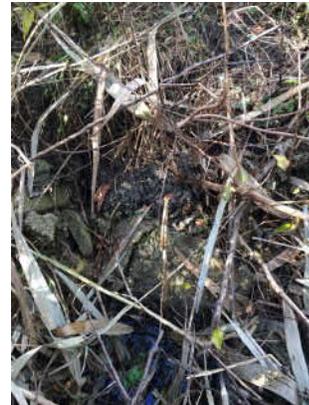
Outfall ID:	OF-1535
Watershed:	MT HOPE BAY
MS4:	Yes
Inspection Date:	11/9/2018
Street Name:	WALDORF STREET
Assumed Owner:	Town
Use:	Residential
Pipe Size:	0
Pipe Shape:	Round
Pipe Material:	RCP
Number of Pipes:	1
Outfall Type:	Pipe end
Outfall Material:	Concrete
Outfall Condition:	Fair
Discharging To:	Wetland
Sediment Accumulation	Yes
Scouring:	No
Floatables	No
Algae Growth:	No
Stressed Vegetation:	No

Staining:	No
Turbidity:	NA
Discharging:	
Discharge Amount:	None
Discharge Color:	NA
Oil Sheen:	Yes
Odor:	No
Structure Under Water:	Yes

Outfall Issue: Major blockage, fully submerged, oil sheen

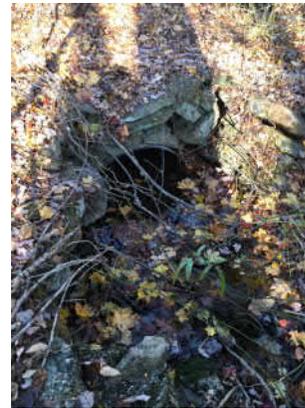
Outfall ID:	OF-1543
Watershed:	TAUNTON
MS4:	Yes
Inspection Date:	11/12/2018
Street Name:	OFF ROAD
Assumed Owner:	Town
Use:	Open Space
Pipe Size:	24
Pipe Shape:	Round
Pipe Material:	CMP
Number of Pipes:	1
Outfall Type:	Headwall
Outfall Material:	Stone
Outfall Condition:	Fair
Discharging To:	Wetland
Sediment Accumulation	Yes
Scouring:	No
Floatables	No
Algae Growth:	No
Stressed Vegetation:	No

Staining:	No
Turbidity:	No
Discharging:	Yes
Discharge Amount:	Moderate
Discharge Color:	Clear
Oil Sheen:	No
Odor:	No
Structure Under Water:	Yes

Outfall Issue: **Headwall collapsing**

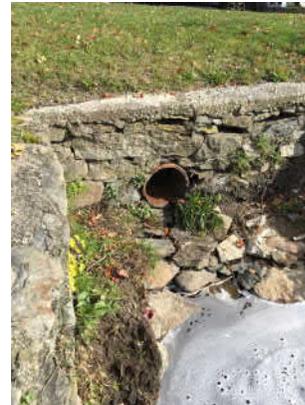
Outfall ID:	OF-1604
Watershed:	TAUNTON
MS4:	Yes
Inspection Date:	11/8/2018
Street Name:	WEST COUNTY STREET
Assumed Owner:	Town
Use:	Commercial
Pipe Size:	12
Pipe Shape:	Round
Pipe Material:	VC
Number of Pipes:	1
Outfall Type:	Headwall
Outfall Material:	Stone
Outfall Condition:	Fair
Discharging To:	Stream
Sediment Accumulation	No
Scouring:	No
Floatables	No
Algae Growth:	No
Stressed Vegetation:	No

Staining:	No
Turbidity:	NA
Discharging:	No
Discharge Amount:	None
Discharge Color:	NA
Oil Sheen:	No
Odor:	No
Structure Under Water:	No

Outfall Issue: **Damaged**

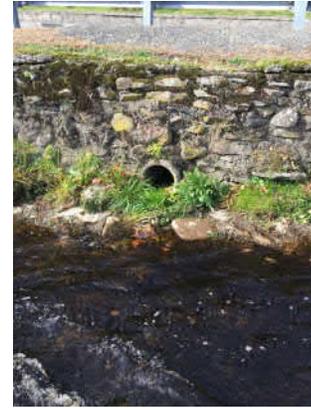
Outfall ID:	OF-1607
Watershed:	TAUNTON
MS4:	Yes
Inspection Date:	11/8/2018
Street Name:	WEST COUNTY STREET
Assumed Owner:	Town
Use:	Commercial
Pipe Size:	12
Pipe Shape:	Round
Pipe Material:	RCP
Number of Pipes:	1
Outfall Type:	Headwall
Outfall Material:	Stone
Outfall Condition:	Good
Discharging To:	Stream
Sediment Accumulation	Yes
Scouring:	No
Floatables	No
Algae Growth:	No
Stressed Vegetation:	No

Staining:	No
Turbidity:	No
Discharging:	Yes
Discharge Amount:	Trickle
Discharge Color:	Clear
Oil Sheen:	No
Odor:	No
Structure Under Water:	No

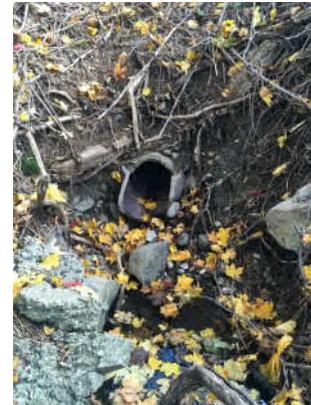
Outfall ID:	OF-1618
Watershed:	MT HOPE BAY
MS4:	Yes
Inspection Date:	11/9/2018
Street Name:	ENTERPRISE DRIVE
Assumed Owner:	Town
Use:	Residential
Pipe Size:	12
Pipe Shape:	Round
Pipe Material:	VC, RCP
Number of Pipes:	1
Outfall Type:	Pipe end
Outfall Material:	VC, RCP
Outfall Condition:	Fair
Discharging To:	River
Sediment Accumulation	No
Scouring:	Yes
Floatables	Suds
Algae Growth:	No
Stressed Vegetation:	No

Staining:	No
Turbidity:	No
Discharging:	Yes
Discharge Amount:	Trickle
Discharge Color:	Clear
Oil Sheen:	No
Odor:	No
Structure Under Water:	No

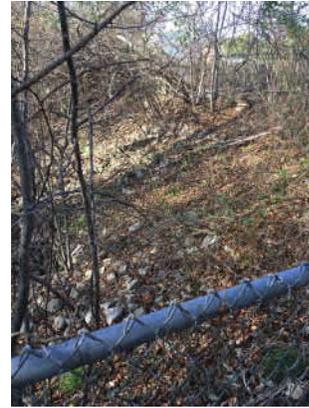
Outfall ID:	OF-1688
Watershed:	MT HOPE BAY
MS4:	No
Inspection Date:	11/12/2018
Street Name:	OFF ROAD
Assumed Owner:	Town
Use:	Residential
Pipe Size:	18
Pipe Shape:	Round
Pipe Material:	RCP
Number of Pipes:	1
Outfall Type:	Flared end
Outfall Material:	RCP
Outfall Condition:	Good
Discharging To:	Detention basin
Sediment Accumulation	No
Scouring:	No
Floatables	No
Algae Growth:	No
Stressed Vegetation:	No

Staining:	No
Turbidity:	NA
Discharging:	No
Discharge Amount:	None
Discharge Color:	NA
Oil Sheen:	No
Odor:	No
Structure Under Water:	No

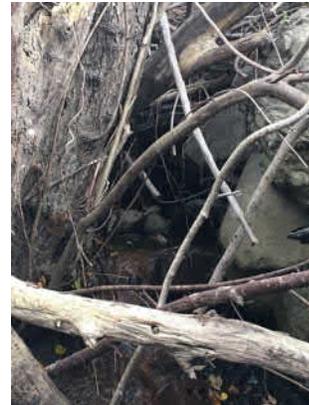
Outfall ID:	OF-1713
Watershed:	MT HOPE BAY
MS4:	Yes
Inspection Date:	11/9/2018
Street Name:	LEES RIVER AVENUE
Assumed Owner:	Town
Use:	Residential
Pipe Size:	18
Pipe Shape:	Round
Pipe Material:	RCP
Number of Pipes:	1
Outfall Type:	Pipe end
Outfall Material:	RCP
Outfall Condition:	Fair
Discharging To:	Stream
Sediment Accumulation	Yes
Scouring:	No
Floatables	No
Algae Growth:	Yes
Stressed Vegetation:	No

Staining:	No
Turbidity:	No
Discharging:	Yes
Discharge Amount:	Moderate
Discharge Color:	Red
Oil Sheen:	No
Odor:	No
Structure Under Water:	No

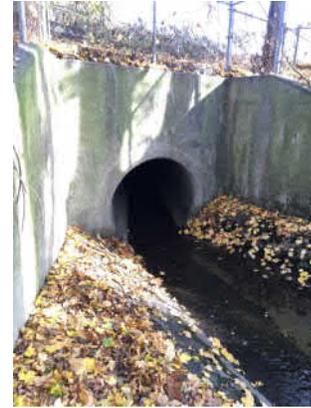
Outfall ID:	OF-2080
Watershed:	MT HOPE BAY
MS4:	Yes
Inspection Date:	11/12/2018
Street Name:	READ STREET
Assumed Owner:	Town
Use:	Residential
Pipe Size:	60
Pipe Shape:	Round
Pipe Material:	RCP
Number of Pipes:	1
Outfall Type:	Wingwall
Outfall Material:	Concrete
Outfall Condition:	Good
Discharging To:	Swale
Sediment Accumulation	No
Scouring:	No
Floatables	No
Algae Growth:	No
Stressed Vegetation:	No

Staining:	Yes
Turbidity:	No
Discharging:	Yes
Discharge Amount:	Substantial
Discharge Color:	Clear
Oil Sheen:	No
Odor:	No
Structure Under Water:	Yes

Outfall Issue:	Staining
Inspection Notes:

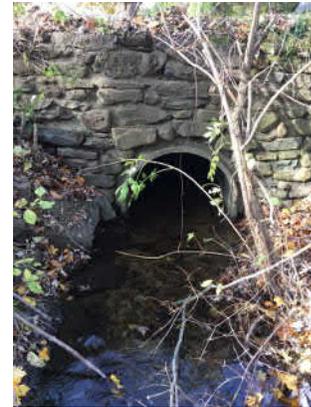
Outfall ID:	OF-2113
Watershed:	MT HOPE BAY
MS4:	Yes
Inspection Date:	11/12/2018
Street Name:	VALLEY ROAD
Assumed Owner:	Town
Use:	Residential
Pipe Size:	36
Pipe Shape:	Round
Pipe Material:	RCP
Number of Pipes:	1
Outfall Type:	Headwall
Outfall Material:	Stone
Outfall Condition:	Good
Discharging To:	Stream
Sediment Accumulation	No
Scouring:	No
Floatables	No
Algae Growth:	No
Stressed Vegetation:	No

Staining:	No
Turbidity:	No
Discharging:	Yes
Discharge Amount:	Substantial
Discharge Color:	Clear
Oil Sheen:	No
Odor:	No
Structure Under Water:	Yes

Outfall Issue:	None
Inspection Notes:

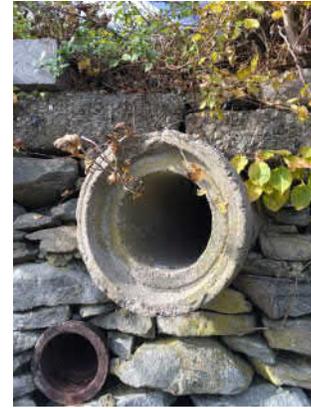
Outfall ID:	OF-2310
Watershed:	TAUNTON
MS4:	Yes
Inspection Date:	11/8/2018
Street Name:	RIVERSIDE AVENUE
Assumed Owner:	Town
Use:	Residential
Pipe Size:	12
Pipe Shape:	Round
Pipe Material:	RCP
Number of Pipes:	1
Outfall Type:	Headwall
Outfall Material:	Stone
Outfall Condition:	Good
Discharging To:	Stream
Sediment Accumulation	No
Scouring:	No
Floatables	No
Algae Growth:	No
Stressed Vegetation:	No

Staining:	No
Turbidity:	NA
Discharging:	No
Discharge Amount:	None
Discharge Color:	NA
Oil Sheen:	No
Odor:	No
Structure Under Water:	No

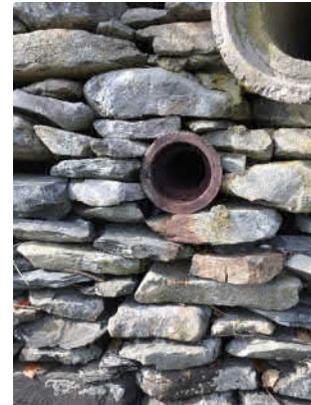
Outfall ID:	OF-2311
Watershed:	TAUNTON
MS4:	Yes
Inspection Date:	11/8/2018
Street Name:	RIVERSIDE AVENUE
Assumed Owner:	Town
Use:	Residential
Pipe Size:	6
Pipe Shape:	Round
Pipe Material:	CI
Number of Pipes:	1
Outfall Type:	Headwall
Outfall Material:	Stone
Outfall Condition:	Good
Discharging To:	Stream
Sediment Accumulation	No
Scouring:	No
Floatables	No
Algae Growth:	No
Stressed Vegetation:	No

Staining:	No
Turbidity:	NA
Discharging:	No
Discharge Amount:	None
Discharge Color:	NA
Oil Sheen:	No
Odor:	No
Structure Under Water:	No

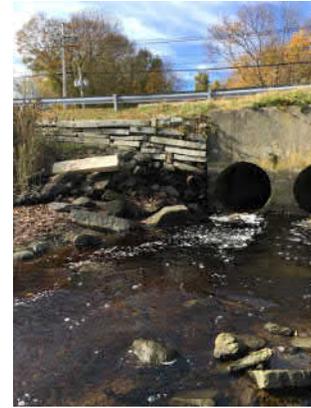
Outfall ID:	OF-2312
Watershed:	TAUNTON
MS4:	Yes
Inspection Date:	11/8/2018
Street Name:	RIVERSIDE AVENUE
Assumed Owner:	Town
Use:	Residential
Pipe Size:	15
Pipe Shape:	Round
Pipe Material:	RCP
Number of Pipes:	1
Outfall Type:	Headwall
Outfall Material:	Stone
Outfall Condition:	Poor
Discharging To:	Stream
Sediment Accumulation	No
Scouring:	No
Floatables	No
Algae Growth:	No
Stressed Vegetation:	No

Staining:	No
Turbidity:	NA
Discharging:	No
Discharge Amount:	None
Discharge Color:	NA
Oil Sheen:	No
Odor:	No
Structure Under Water:	No

Outfall Issue: **Headwall collapse, pipe joint separating**

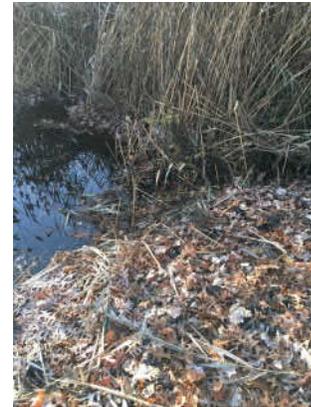
Outfall ID:	OF-2486
Watershed:	TAUNTON
MS4:	Yes
Inspection Date:	11/12/2018
Street Name:	PALMER STREET
Assumed Owner:	Town
Use:	Residential
Pipe Size:	18
Pipe Shape:	Round
Pipe Material:	RCP
Number of Pipes:	1
Outfall Type:	Unknown
Outfall Material:	RCP
Outfall Condition:	Poor
Discharging To:	Stream
Sediment Accumulation	No
Scouring:	No
Floatables	No
Algae Growth:	No
Stressed Vegetation:	No

Staining:	No
Turbidity:	NA
Discharging:	
Discharge Amount:	Unknown
Discharge Color:	NA
Oil Sheen:	No
Odor:	No
Structure Under Water:	Yes

Outfall Issue: **Damaged, fully submerged**

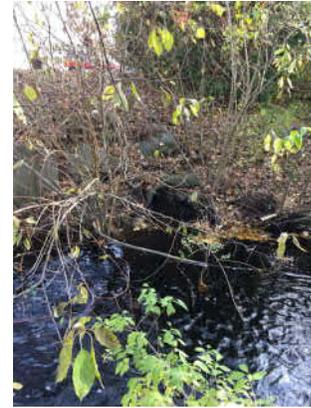
Outfall ID:	OF-2552
Watershed:	TAUNTON
MS4:	Yes
Inspection Date:	11/8/2018
Street Name:	WOOD STREET
Assumed Owner:	Town
Use:	Residential
Pipe Size:	15
Pipe Shape:	Round
Pipe Material:	RCP
Number of Pipes:	1
Outfall Type:	Pipe end
Outfall Material:	RCP
Outfall Condition:	Good
Discharging To:	Stream
Sediment Accumulation	No
Scouring:	No
Floatables	No
Algae Growth:	No
Stressed Vegetation:	No

Staining:	No
Turbidity:	No
Discharging:	Yes
Discharge Amount:	Moderate
Discharge Color:	Clear
Oil Sheen:	No
Odor:	No
Structure Under Water:	No

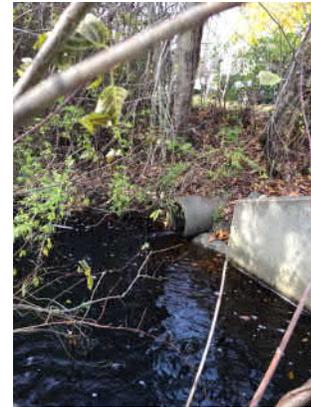
Outfall ID:	OF-2553
Watershed:	TAUNTON
MS4:	Yes
Inspection Date:	11/8/2018
Street Name:	WOOD STREET
Assumed Owner:	Town
Use:	Residential
Pipe Size:	15
Pipe Shape:	Round
Pipe Material:	RCP
Number of Pipes:	1
Outfall Type:	Pipe end
Outfall Material:	RCP
Outfall Condition:	Good
Discharging To:	Stream
Sediment Accumulation	No
Scouring:	No
Floatables	No
Algae Growth:	No
Stressed Vegetation:	No

Staining:	No
Turbidity:	No
Discharging:	Yes
Discharge Amount:	Moderate
Discharge Color:	Clear
Oil Sheen:	No
Odor:	No
Structure Under Water:	No

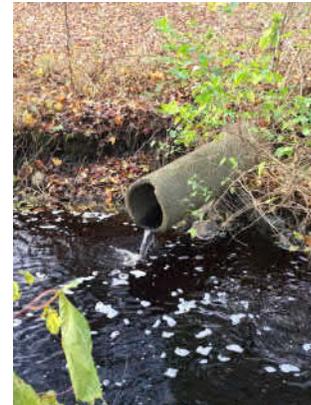
Outfall ID:	OF-2622
Watershed:	TAUNTON
MS4:	Yes
Inspection Date:	11/8/2018
Street Name:	ALLARDICE ROAD
Assumed Owner:	Town
Use:	Residential
Pipe Size:	12
Pipe Shape:	Round
Pipe Material:	RCP
Number of Pipes:	1
Outfall Type:	Pipe end
Outfall Material:	RCP
Outfall Condition:	Fair
Discharging To:	Stream
Sediment Accumulation	No
Scouring:	No
Floatables	No
Algae Growth:	No
Stressed Vegetation:	No

Staining:	No
Turbidity:	No
Discharging:	Yes
Discharge Amount:	Moderate
Discharge Color:	Clear
Oil Sheen:	No
Odor:	No
Structure Under Water:	No

Outfall Issue:	None
Inspection Notes:

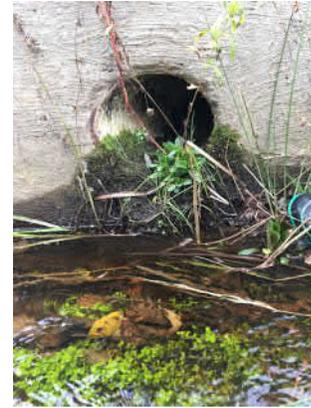
Outfall ID:	OF-2627
Watershed:	TAUNTON
MS4:	Yes
Inspection Date:	11/8/2018
Street Name:	ALMY ROAD
Assumed Owner:	Town
Use:	Residential
Pipe Size:	8
Pipe Shape:	Round
Pipe Material:	RCP
Number of Pipes:	1
Outfall Type:	Headwall
Outfall Material:	Concrete
Outfall Condition:	Good
Discharging To:	Stream
Sediment Accumulation	Yes
Scouring:	No
Floatables	No
Algae Growth:	No
Stressed Vegetation:	No

Staining:	No
Turbidity:	NA
Discharging:	No
Discharge Amount:	None
Discharge Color:	NA
Oil Sheen:	No
Odor:	No
Structure Under Water:	No

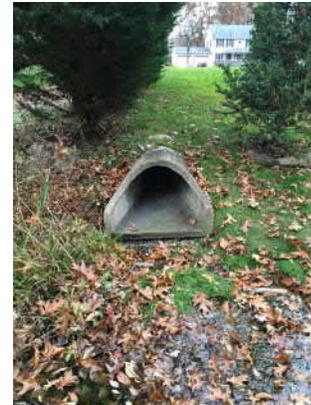
Outfall ID:	OF-2633
Watershed:	MT HOPE BAY
MS4:	No
Inspection Date:	11/9/2018
Street Name:	FAWN ROAD
Assumed Owner:	Town
Use:	Residential
Pipe Size:	24
Pipe Shape:	Round
Pipe Material:	RCP
Number of Pipes:	1
Outfall Type:	Flared end
Outfall Material:	RCP
Outfall Condition:	Good
Discharging To:	Land
Sediment Accumulation	No
Scouring:	No
Floatables	No
Algae Growth:	No
Stressed Vegetation:	No

Staining:	No
Turbidity:	NA
Discharging:	
Discharge Amount:	None
Discharge Color:	NA
Oil Sheen:	No
Odor:	No
Structure Under Water:	No

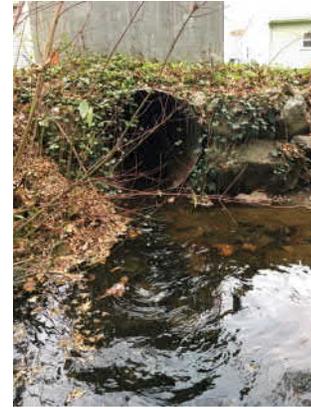
Outfall ID:	OF-2648
Watershed:	MT HOPE BAY
MS4:	Yes
Inspection Date:	11/9/2018
Street Name:	BUTTERNUT ROAD
Assumed Owner:	Town
Use:	Residential
Pipe Size:	36
Pipe Shape:	Round
Pipe Material:	CMP
Number of Pipes:	1
Outfall Type:	Headwall
Outfall Material:	Stone
Outfall Condition:	Fair
Discharging To:	Stream
Sediment Accumulation	No
Scouring:	No
Floatables	No
Algae Growth:	No
Stressed Vegetation:	No

Staining:	No
Turbidity:	No
Discharging:	Yes
Discharge Amount:	Moderate
Discharge Color:	Clear
Oil Sheen:	No
Odor:	No
Structure Under Water:	Yes

Outfall Issue:	None
Inspection Notes:

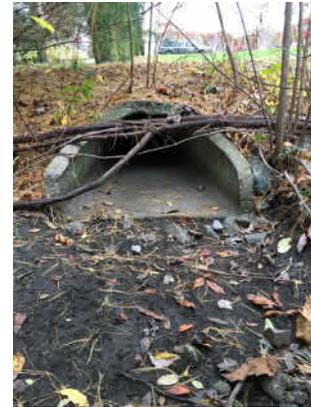
Outfall ID:	OF-2692
Watershed:	MT HOPE BAY
MS4:	No
Inspection Date:	11/9/2018
Street Name:	OFF ROAD
Assumed Owner:	Town
Use:	Residential
Pipe Size:	18
Pipe Shape:	Round
Pipe Material:	RCP
Number of Pipes:	1
Outfall Type:	Flared end
Outfall Material:	RCP
Outfall Condition:	Good
Discharging To:	Land
Sediment Accumulation	No
Scouring:	No
Floatables	No
Algae Growth:	No
Stressed Vegetation:	No

Staining:	No
Turbidity:	NA
Discharging:	
Discharge Amount:	None
Discharge Color:	NA
Oil Sheen:	No
Odor:	No
Structure Under Water:	No

Outfall Issue:	None
Inspection Notes:

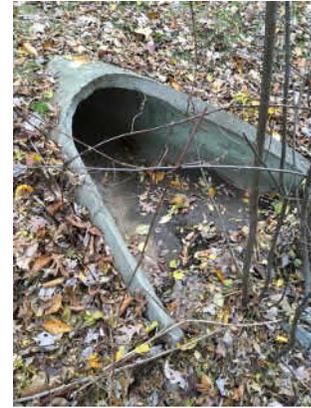
Outfall ID:	OF-2697
Watershed:	MT HOPE BAY
MS4:	No
Inspection Date:	11/9/2018
Street Name:	OFF ROAD
Assumed Owner:	Town
Use:	Residential
Pipe Size:	24
Pipe Shape:	Round
Pipe Material:	RCP
Number of Pipes:	1
Outfall Type:	Flared end
Outfall Material:	RCP
Outfall Condition:	Good
Discharging To:	Land
Sediment Accumulation	No
Scouring:	No
Floatables	No
Algae Growth:	No
Stressed Vegetation:	No

Staining:	No
Turbidity:	NA
Discharging:	
Discharge Amount:	None
Discharge Color:	NA
Oil Sheen:	No
Odor:	No
Structure Under Water:	No

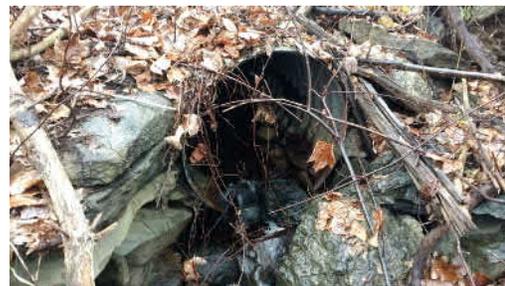
Outfall ID:	OF-2737
Watershed:	TAUNTON
MS4:	Yes
Inspection Date:	11/20/2018
Street Name:	EAST COUNTY STREET
Assumed Owner:	Town
Use:	Residential
Pipe Size:	24
Pipe Shape:	Round
Pipe Material:	CMP
Number of Pipes:	1
Outfall Type:	Headwall
Outfall Material:	Stone
Outfall Condition:	Poor
Discharging To:	Land
Sediment Accumulation	No
Scouring:	No
Floatables	Suds
Algae Growth:	No
Stressed Vegetation:	No

Staining:	No
Turbidity:	No
Discharging:	Yes
Discharge Amount:	Moderate
Discharge Color:	Clear
Oil Sheen:	No
Odor:	No
Structure Under Water:	No

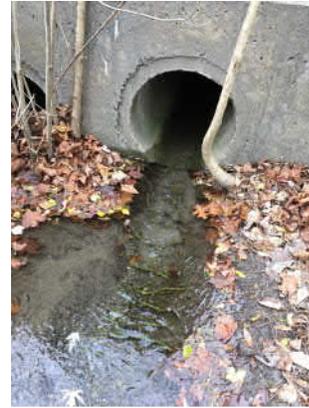
Outfall ID:	OF-2759
Watershed:	TAUNTON
MS4:	Yes
Inspection Date:	11/15/2018
Street Name:	OFF ROAD
Assumed Owner:	Town
Use:	Residential
Pipe Size:	24
Pipe Shape:	Round
Pipe Material:	RCP
Number of Pipes:	1
Outfall Type:	Wingwall
Outfall Material:	Concrete
Outfall Condition:	Good
Discharging To:	Swale
Sediment Accumulation	No
Scouring:	Yes
Floatables	No
Algae Growth:	No
Stressed Vegetation:	No

Staining:	No
Turbidity:	No
Discharging:	Yes
Discharge Amount:	Moderate
Discharge Color:	Clear
Oil Sheen:	No
Odor:	No
Structure Under Water:	No

Outfall Issue:	None
Inspection Notes:

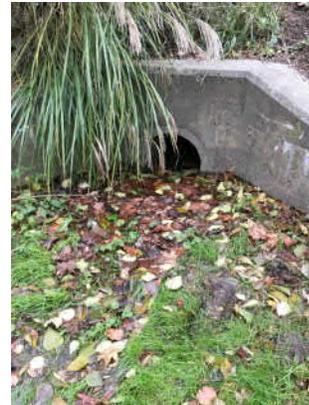
Outfall ID:	OF-2762
Watershed:	TAUNTON
MS4:	Yes
Inspection Date:	11/15/2018
Street Name:	OFF ROAD
Assumed Owner:	Town
Use:	Residential
Pipe Size:	15
Pipe Shape:	Round
Pipe Material:	RCP
Number of Pipes:	1
Outfall Type:	Wingwall
Outfall Material:	Concrete
Outfall Condition:	Good
Discharging To:	Swale
Sediment Accumulation	No
Scouring:	No
Floatables	No
Algae Growth:	No
Stressed Vegetation:	No

Staining:	No
Turbidity:	No
Discharging:	Yes
Discharge Amount:	Trickle
Discharge Color:	Clear
Oil Sheen:	No
Odor:	No
Structure Under Water:	No

Outfall Issue:	None
Inspection Notes:

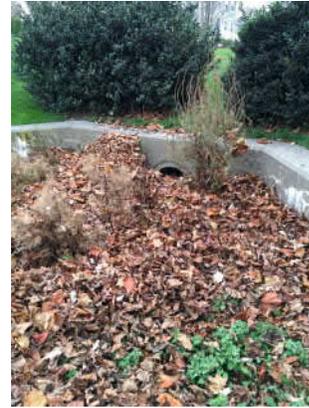
Outfall ID:	OF-2764
Watershed:	TAUNTON
MS4:	Yes
Inspection Date:	11/15/2018
Street Name:	OFF ROAD
Assumed Owner:	Town
Use:	Residential
Pipe Size:	24
Pipe Shape:	Round
Pipe Material:	RCP
Number of Pipes:	1
Outfall Type:	Wingwall
Outfall Material:	Concrete
Outfall Condition:	Good
Discharging To:	Swale
Sediment Accumulation	No
Scouring:	No
Floatables	No
Algae Growth:	No
Stressed Vegetation:	No

Staining:	No
Turbidity:	No
Discharging:	Yes
Discharge Amount:	Trickle
Discharge Color:	Clear
Oil Sheen:	No
Odor:	No
Structure Under Water:	No

Outfall Issue: Minor blockage

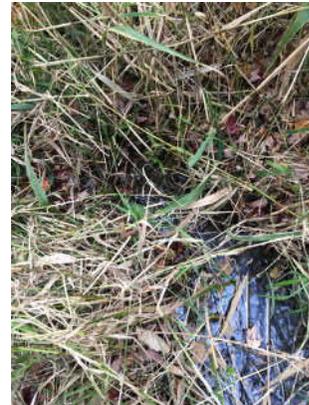
Outfall ID:	OF-2879
Watershed:	TAUNTON
MS4:	Yes
Inspection Date:	11/5/2018
Street Name:	KENMAR DRIVE
Assumed Owner:	Town
Use:	Residential
Pipe Size:	0
Pipe Shape:	Unknown
Pipe Material:	Unknown
Number of Pipes:	
Outfall Type:	Unknown
Outfall Material:	Unknown
Outfall Condition:	Unknown
Discharging To:	Wetland
Sediment Accumulation	Yes
Scouring:	No
Floatables	No
Algae Growth:	No
Stressed Vegetation:	No

Staining:	No
Turbidity:	No
Discharging:	Yes
Discharge Amount:	Trickle
Discharge Color:	Clear
Oil Sheen:	Yes
Odor:	No
Structure Under Water:	Yes

Outfall Issue: Buried structure, turbidity, oil sheen

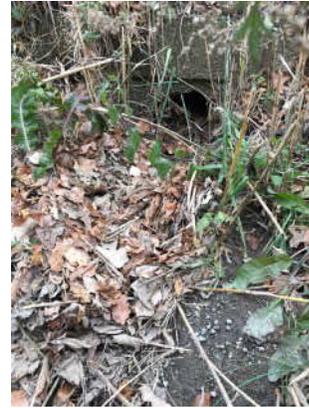
Outfall ID:	OF-2976
Watershed:	TAUNTON
MS4:	Yes
Inspection Date:	11/15/2018
Street Name:	COUNTY STREET
Assumed Owner:	Town
Use:	Mixed
Pipe Size:	15
Pipe Shape:	Round
Pipe Material:	RCP
Number of Pipes:	1
Outfall Type:	Headwall
Outfall Material:	Concrete
Outfall Condition:	Good
Discharging To:	Land
Sediment Accumulation	Yes
Scouring:	No
Floatables	No
Algae Growth:	No
Stressed Vegetation:	No

Staining:	No
Turbidity:	NA
Discharging:	No
Discharge Amount:	None
Discharge Color:	NA
Oil Sheen:	No
Odor:	No
Structure Under Water:	No

Outfall Issue:	Minor blockage
Inspection Notes:

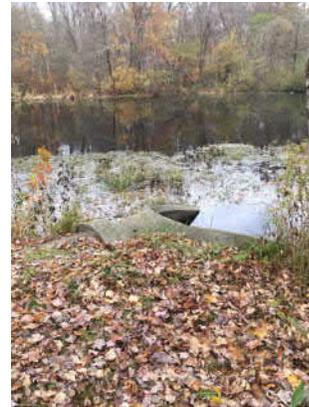
Outfall ID:	OF-3048
Watershed:	TAUNTON
MS4:	Yes
Inspection Date:	11/5/2018
Street Name:	WINDMILL LANE
Assumed Owner:	Town
Use:	Residential
Pipe Size:	24
Pipe Shape:	Round
Pipe Material:	RCP
Number of Pipes:	1
Outfall Type:	Flared end
Outfall Material:	RCP
Outfall Condition:	Good
Discharging To:	Pond
Sediment Accumulation	No
Scouring:	No
Floatables	No
Algae Growth:	No
Stressed Vegetation:	No

Staining:	No
Turbidity:	NA
Discharging:	No
Discharge Amount:	None
Discharge Color:	NA
Oil Sheen:	No
Odor:	No
Structure Under Water:	Yes

Outfall Issue:	None
Inspection Notes:

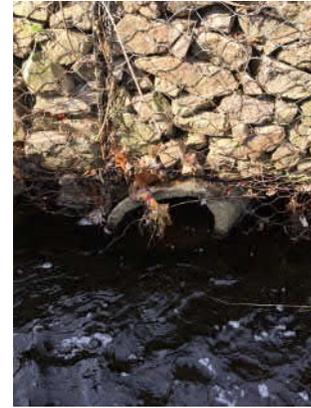
Outfall ID:	OF-3140
Watershed:	TAUNTON
MS4:	Yes
Inspection Date:	11/8/2018
Street Name:	WASHINGTON AVENUE
Assumed Owner:	Town
Use:	Residential
Pipe Size:	15
Pipe Shape:	Round
Pipe Material:	RCP
Number of Pipes:	1
Outfall Type:	Pipe end
Outfall Material:	RCP
Outfall Condition:	Good
Discharging To:	Stream
Sediment Accumulation	No
Scouring:	No
Floatables	No
Algae Growth:	No
Stressed Vegetation:	No

Staining:	No
Turbidity:	NA
Discharging:	No
Discharge Amount:	None
Discharge Color:	NA
Oil Sheen:	No
Odor:	No
Structure Under Water:	Yes

Outfall Issue:	None
Inspection Notes:

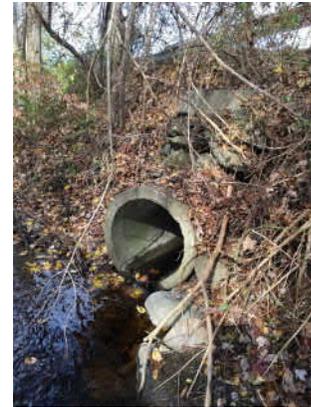
Outfall ID:	OF-3143
Watershed:	TAUNTON
MS4:	Yes
Inspection Date:	11/8/2018
Street Name:	FOREST AVENUE
Assumed Owner:	Town
Use:	Residential
Pipe Size:	24
Pipe Shape:	Round
Pipe Material:	RCP
Number of Pipes:	1
Outfall Type:	Headwall
Outfall Material:	Stone
Outfall Condition:	Fair
Discharging To:	Stream
Sediment Accumulation	No
Scouring:	No
Floatables	No
Algae Growth:	No
Stressed Vegetation:	No

Staining:	No
Turbidity:	No
Discharging:	Yes
Discharge Amount:	Trickle
Discharge Color:	Clear
Oil Sheen:	No
Odor:	No
Structure Under Water:	No

Outfall Issue:	None
Inspection Notes:

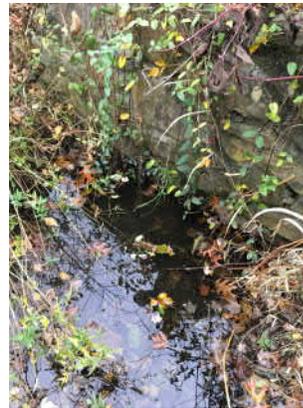
Outfall ID:	OF-3206
Watershed:	TAUNTON
MS4:	Yes
Inspection Date:	11/5/2018
Street Name:	WHETSTONE HILL ROAD
Assumed Owner:	Town
Use:	Mixed
Pipe Size:	15
Pipe Shape:	Round
Pipe Material:	RCP
Number of Pipes:	1
Outfall Type:	Headwall
Outfall Material:	Stone
Outfall Condition:	Good
Discharging To:	Stream
Sediment Accumulation	No
Scouring:	No
Floatables	No
Algae Growth:	No
Stressed Vegetation:	No

Staining:	No
Turbidity:	NA
Discharging:	No
Discharge Amount:	None
Discharge Color:	NA
Oil Sheen:	No
Odor:	No
Structure Under Water:	Yes

Outfall Issue:	Fully submerged
Inspection Notes:	Submerged, size approximate

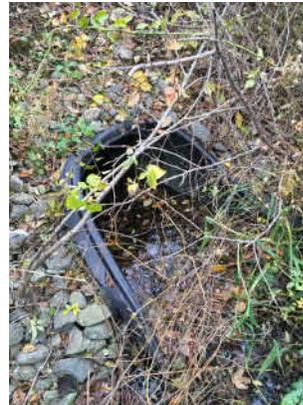
Outfall ID:	OF-3291
Watershed:	TAUNTON
MS4:	Yes
Inspection Date:	11/5/2018
Street Name:	WHETSTONE HILL ROAD
Assumed Owner:	Town
Use:	Municipal
Pipe Size:	24
Pipe Shape:	Round
Pipe Material:	HDPE
Number of Pipes:	1
Outfall Type:	Flared end
Outfall Material:	HDPE
Outfall Condition:	Good
Discharging To:	Land
Sediment Accumulation	No
Scouring:	No
Floatables	No
Algae Growth:	No
Stressed Vegetation:	No

Staining:	No
Turbidity:	NA
Discharging:	No
Discharge Amount:	Unknown
Discharge Color:	NA
Oil Sheen:	No
Odor:	No
Structure Under Water:	No

Outfall Issue:	None
Inspection Notes:	Swampy land
