Integrated Water Resources Management Plan

TOWN OF SOMERSET, MA

JANUARY 2020

WRIGHT-PIERCE

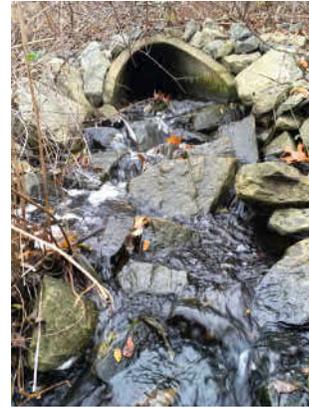
Outfall ID:	OF-3329
Watershed:	TAUNTON
MS4:	Yes
Inspection Date:	11/15/2018
Street Name:	OFF ROAD
Assumed Owner:	Town
Use:	Residential
Pipe Size:	12
Pipe Shape:	Round
Pipe Material:	RCP
Number of Pipes:	1
Outfall Type:	Flared end
Outfall Material:	RCP
Outfall Condition:	Good
Discharging To:	Land
Sediment Accumulation	No
Scouring:	No
Floatables	Suds
Algae Growth:	Yes
Stressed Vegetation:	No

Staining:	No
Turbidity:	No
Discharging:	Yes
Discharge Amount:	Substantial
Discharge Color:	Clear
Oil Sheen:	No
Odor:	Sulfur
Structure Under Water:	No

Outfall Issue: Suds, odor

Inspection Notes: Swampy land

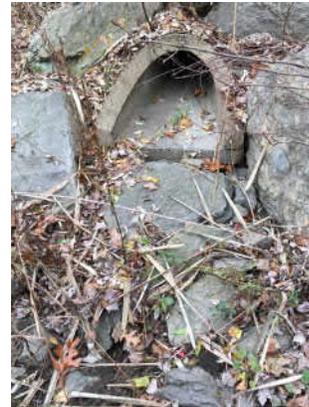
Outfall ID:	OF-3332
Watershed:	TAUNTON
MS4:	Yes
Inspection Date:	11/15/2018
Street Name:	OFF ROAD
Assumed Owner:	Town
Use:	Residential
Pipe Size:	12
Pipe Shape:	Round
Pipe Material:	RCP
Number of Pipes:	1
Outfall Type:	Flared end
Outfall Material:	RCP
Outfall Condition:	Good
Discharging To:	Land
Sediment Accumulation	No
Scouring:	No
Floatables	No
Algae Growth:	No
Stressed Vegetation:	No

Staining:	No
Turbidity:	NA
Discharging:	No
Discharge Amount:	None
Discharge Color:	NA
Oil Sheen:	No
Odor:	No
Structure Under Water:	No

Outfall Issue: None

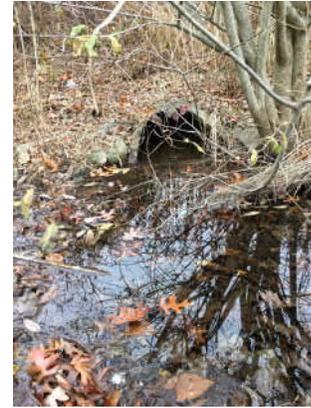
Outfall ID:	OF-3337
Watershed:	TAUNTON
MS4:	Yes
Inspection Date:	11/15/2018
Street Name:	OFF ROAD
Assumed Owner:	Town
Use:	Residential
Pipe Size:	12
Pipe Shape:	Round
Pipe Material:	RCP
Number of Pipes:	1
Outfall Type:	Flared end
Outfall Material:	RCP
Outfall Condition:	Good
Discharging To:	Land
Sediment Accumulation	No
Scouring:	No
Floatables	No
Algae Growth:	No
Stressed Vegetation:	No

Staining:	No
Turbidity:	NA
Discharging:	No
Discharge Amount:	None
Discharge Color:	NA
Oil Sheen:	No
Odor:	No
Structure Under Water:	Yes

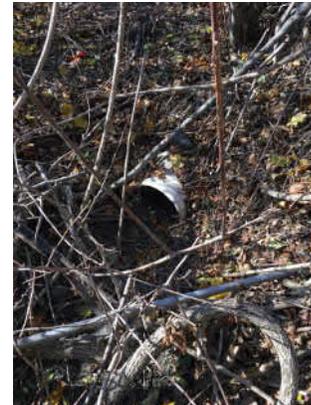
Outfall ID:	OF-3338
Watershed:	MT HOPE BAY
MS4:	No
Inspection Date:	11/12/2018
Street Name:	KATHLEEN AVENUE
Assumed Owner:	Town
Use:	Residential
Pipe Size:	12
Pipe Shape:	Round
Pipe Material:	PVC
Number of Pipes:	1
Outfall Type:	Pipe end
Outfall Material:	PVC
Outfall Condition:	Good
Discharging To:	Land
Sediment Accumulation	Yes
Scouring:	No
Floatables	No
Algae Growth:	No
Stressed Vegetation:	No

Staining:	No
Turbidity:	NA
Discharging:	No
Discharge Amount:	None
Discharge Color:	NA
Oil Sheen:	No
Odor:	No
Structure Under Water:	No

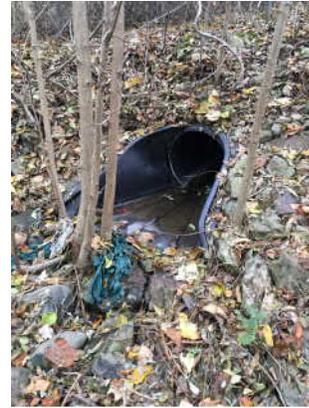
Staining:	No
Turbidity:	NA
Discharging:	No
Discharge Amount:	None
Discharge Color:	NA
Oil Sheen:	Yes
Odor:	No
Structure Under Water:	No

Outfall Issue: Oil sheen

Inspection Notes: Oil sheen in detention basin

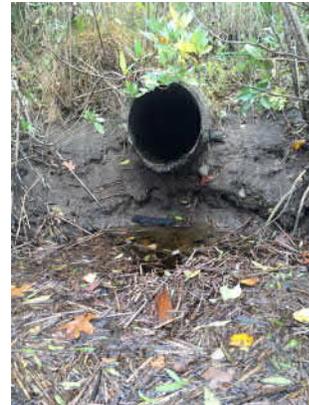
Staining:	No
Turbidity:	No
Discharging:	Yes
Discharge Amount:	Drip
Discharge Color:	Clear
Oil Sheen:	No
Odor:	No
Structure Under Water:	No

Outfall Issue: Damaged

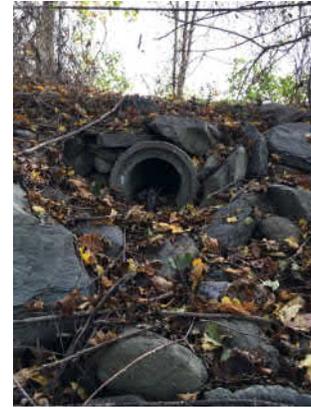
Staining:	No
Turbidity:	No
Discharging:	Yes
Discharge Amount:	Trickle
Discharge Color:	Clear
Oil Sheen:	No
Odor:	No
Structure Under Water:	No

Outfall Issue:	Debris
Inspection Notes:

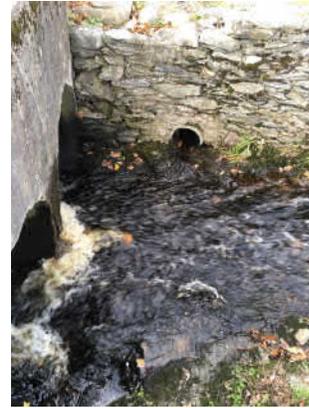
Staining:	No
Turbidity:	No
Discharging:	Yes
Discharge Amount:	Moderate
Discharge Color:	Clear
Oil Sheen:	No
Odor:	No
Structure Under Water:	No

Outfall Issue:	Damaged
Inspection Notes:

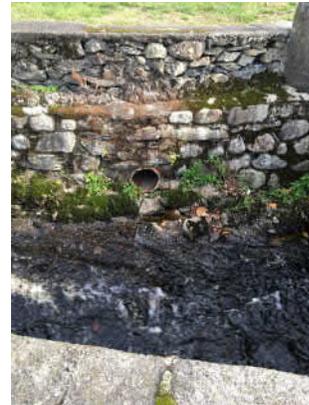
Staining:	No
Turbidity:	NA
Discharging:	No
Discharge Amount:	None
Discharge Color:	NA
Oil Sheen:	No
Odor:	No
Structure Under Water:	No

Outfall Issue:	Damaged
Inspection Notes:

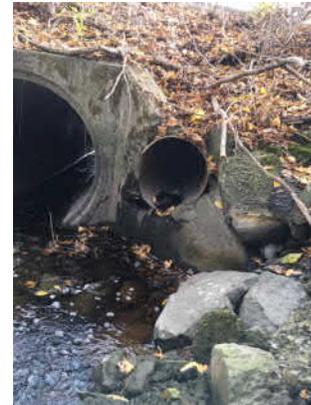
Staining:	No
Turbidity:	NA
Discharging:	No
Discharge Amount:	None
Discharge Color:	NA
Oil Sheen:	No
Odor:	No
Structure Under Water:	No

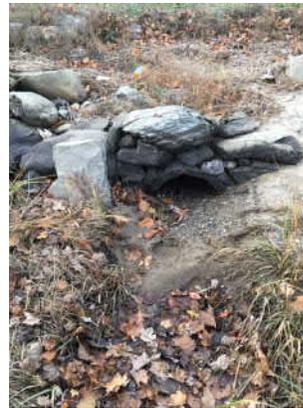
Staining:	No
Turbidity:	NA
Discharging:	No
Discharge Amount:	None
Discharge Color:	NA
Oil Sheen:	No
Odor:	No
Structure Under Water:	No

Outfall Issue:	Minor blockage
Inspection Notes:

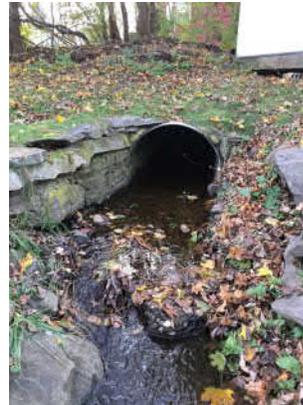
Staining:	No
Turbidity:	No
Discharging:	Yes
Discharge Amount:	Moderate
Discharge Color:	Red
Oil Sheen:	No
Odor:	No
Structure Under Water:	Yes

Outfall Issue:	None
Inspection Notes:	Outfall may be culvert outlet

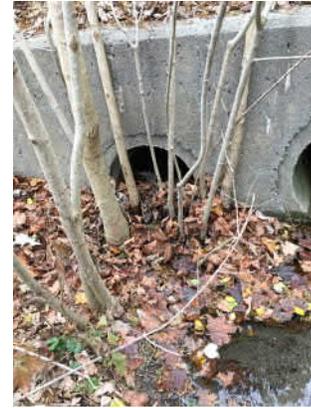
Staining:	No
Turbidity:	NA
Discharging:	No
Discharge Amount:	None
Discharge Color:	NA
Oil Sheen:	No
Odor:	No
Structure Under Water:	No

Outfall Issue: **Obstructed by vegetation**

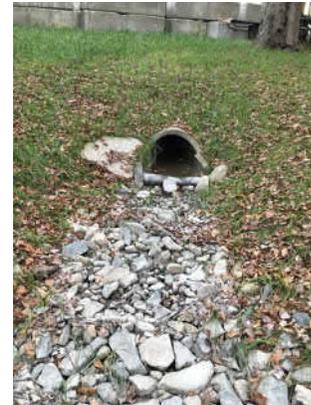
Staining:	No
Turbidity:	NA
Discharging:	No
Discharge Amount:	None
Discharge Color:	NA
Oil Sheen:	Yes
Odor:	No
Structure Under Water:	No

Outfall Issue: **Oil sheen**

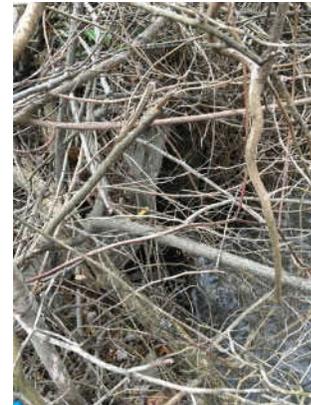
Staining:	No
Turbidity:	Yes
Discharging:	Yes
Discharge Amount:	Substantial
Discharge Color:	Brown
Oil Sheen:	No
Odor:	No
Structure Under Water:	No

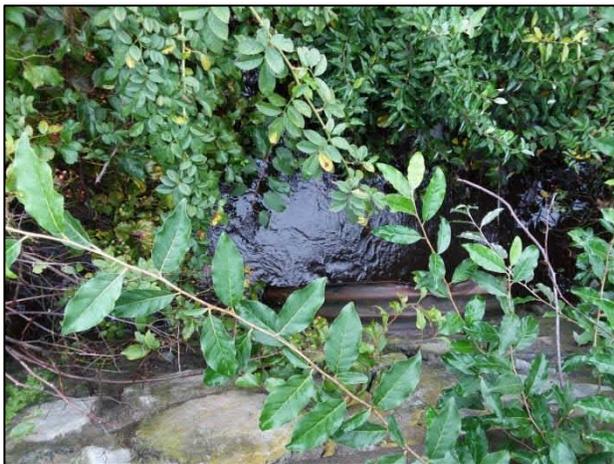
C-12: Lees River Ave – Upstream

C-12	Lees River Ave	Unnamed	CMP inlet, 2 outlets in stone headwall	Sizes unknown, minor roadway cracks	[size unknown]	Inspection (high priority)
C-13 (I)	Route 6	Unnamed	Approx. 42" RCP		No	Inspection (low priority)
C-14	Read St	Unnamed	Unknown	Inaccessible, overgrown	[size unknown]	Inspection (high priority); enforce National Grid vegetation plan?

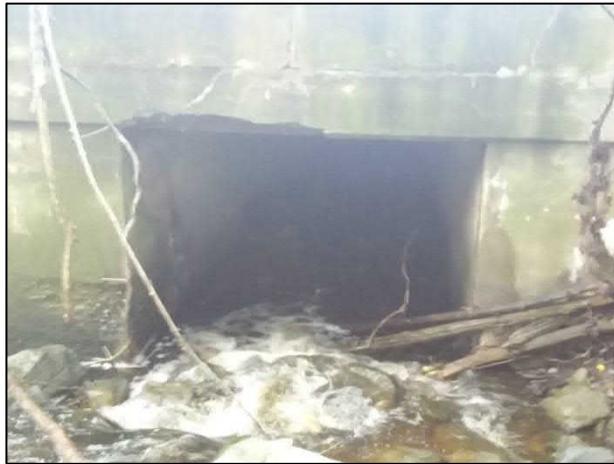
C-16: Route 138

Structure ID	Street Name	Stream Conveyed	Culvert Characteristics	Comments	Potential Small Bridge Program Candidate	Recommended Actions
C-16 (I) C-15 (O)	Route 138/Riverside Ave	Breeds	84" x 60" RC box 96" x 48" RC box		No	Inspection (low priority)
C-17 (O)	Prospect St	Breeds	96" CMP flared end		No	Inspection (high priority)
C-18 (I) C-19 (O)	Fordham Dr	Breeds	Unknown	Inaccessible	No	Inspection (high priority)
C-20	Riverside Ave	Buffington	Double 72" RCP	Deteriorated headwall; sinkholes in road (Highway Dept.); submerged at high tide (GRRIP6)	Yes	Inspection (high priority); capacity analysis
C-21 (O)	Buffinton St & Route 138	Buffington	Double 48" RCP		No	Inspection (high priority); capacity analysis
C-22 (I)	Buffinton St & Route 138	Buffington	144" x 48" box		No	Inspection (high priority); capacity analysis
C-23	Roberge St	Buffington	72" x 84" RC box	Dirt road with metal plate	No	Inspection (high priority); capacity analysis

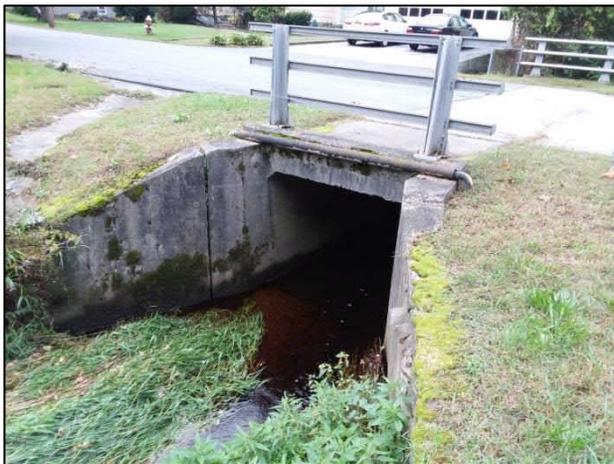
C-24: Washington Ave

C-24	Washington Ave	Buffington	72" x 64" RC box	Moderate roadway cracks	No	Inspection (high priority); capacity analysis
C-25	Wood St	Buffington	72" x 60" RC box		No	Inspection (high priority); capacity analysis
C-26	Haute Dr	Buffington	18'-0" x 4'-0" RC bridge		Yes	Inspection (high priority); capacity analysis

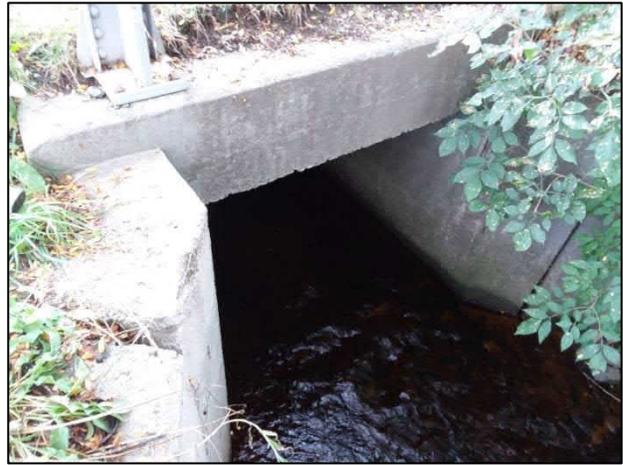
C-27: Lafayette St

Structure ID	Street Name	Stream Conveyed	Culvert Characteristics	Comments	Potential Small Bridge Program Candidate	Recommended Actions
C-27	Lafayette St	Buffington	72" x 60" RC box		No	Inspection (high priority); capacity analysis
C-29 (I) C-28 (O)	Brookside Rd/Regina Ave	Buffington	72" x 60" RC box	Minor roadway cracks	No	Inspection (high priority); capacity analysis
C-30	Midland Rd	Buffington	84" x 60" RC box		No	Inspection (high priority); capacity analysis
C-31	Chace St	Buffington	72" x 60" RC box		No	Inspection (high priority); capacity analysis
C-32 (I) C-33 (O)	Regan Rd/Feno Ct	Buffington	Double 54" RCP Double 48" CMP	High water at outlet	No	Inspection (high priority); capacity
C-34	Mohawk Rd	Buffington	Double 48" CMP	Pipe bottoms rusted out, minor road cracks	Yes	Inspection (high priority); capacity analysis
C-35	Almy Rd	Buffington	Double 48" CMP	Deteriorated, high water, minor roadway cracks and sags; Needs replacing (Highway Dept.)	Yes, applied	Replacement

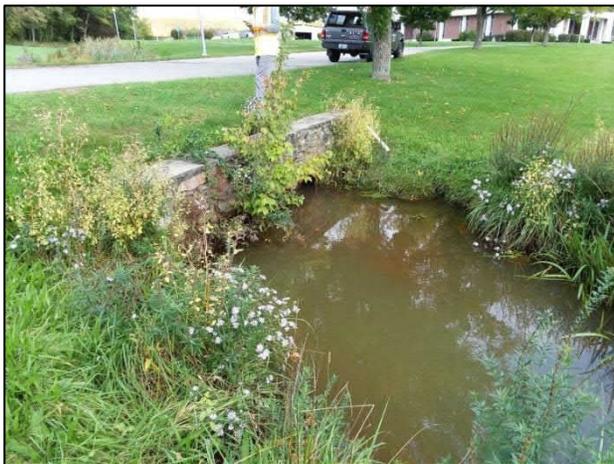
C-36: Water Dept. @ Whetstone Hill Road

C-36	Water Dept. driveway	Labor In Vain	Double flattened 36" x 24" CMP	High water	No	Inspection (high priority); capacity analysis
C-37	Whetstone Hill Rd	Labor In Vain	Double 30" RCP	Recommended for upsizing (HW 2005); minor roadway cracks	No	Replacement
C-38	Unnamed, not in service	Tributary to Labor In Vain	36" CMP		No	Inspection (low priority)

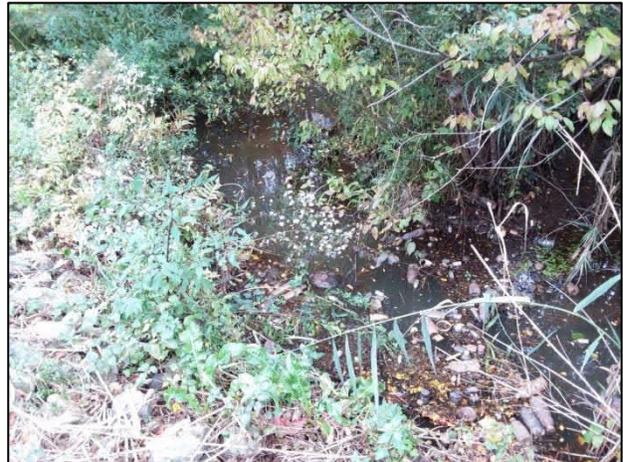
C-39: Route 138

Structure ID	Street Name	Stream Conveyed	Culvert Characteristics	Comments	Potential Small Bridge Program Candidate	Recommended Actions
C-39	County St (Rte 138)	Labor In Vain	Approx. 42"-48" RCP	Debris, submerged, not located; recommended for upsizing (HW 2005)	No	Replacement
C-40	South St	Labor In Vain	Double 60" CMP	Deteriorated concrete and pipes; recommended for upsizing (HW 2005); bid to upsize awarded in 2018	Yes	Replacement
C-41	Dublin St	Labor In Vain	102" CMP	Deteriorated concrete on headwalls; recommended for upsizing (HW 2005); needs replacing (Highway Dept.)	No	Replacement
C-42	Skating area parking lot	Labor In Vain	48" x 48" RC box	Upsized in 2010	No	Inspection (low priority)
C-43	Billy's Lane	Labor In Vain	Unstructured stone	Unpaved access road	No	Inspection (low priority)
C-44	Palmer St	Labor In Vain	36" x 58" CMPA	Undersized, minor road cracks	No	Inspection (high priority)
C-45	North St	Labor In Vain	Double 36" RCP	Undersized emergency dam spillway (Pare)	No	Inspection (high priority)
