FEASIBILITY STUDY FOR
THE EXTERIOR RESTORATION OF
SOMERSET OLD TOWN HALL

1480 COUNTY STREET, SOMERSET, MASSACHUSETTS

PREPARED FOR
THE SOMERSET HISTORICAL COMMISSION
MAY 9, 2016

CHRISTOPHER T. WISE - ARCHITECT, 103 SUMMIT AVENUE, PROVIDENCE, RI

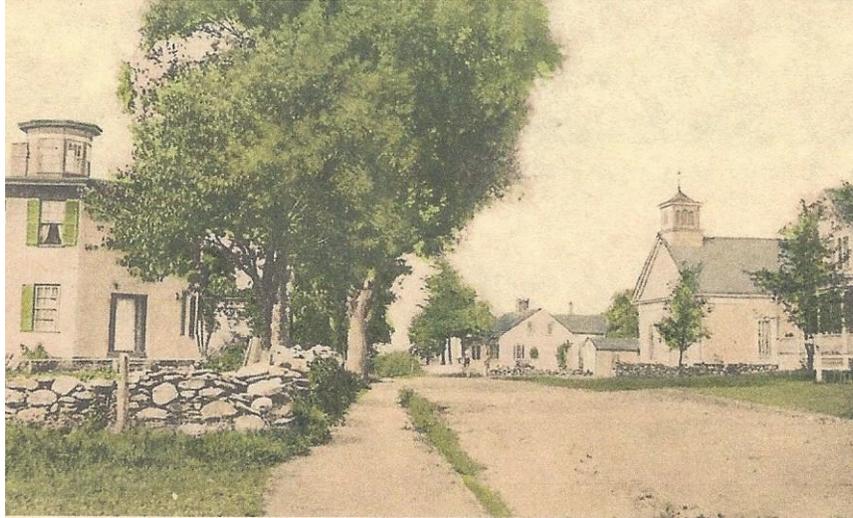
In addition to the aluminum siding, various other alterations have been made to the exterior of the building over the years. Perhaps most significantly, the cupola, which is visible in the few historic photographs that have been found, is missing. One window on the south side of the building has been modified into a door to provide an accessible entry, and a concrete wheelchair ramp with railings has been built adjacent to it. Also on the south side, a small window has been inserted which provides light to the women’s toilet room. On the principal west elevation, facing County Street, one window has been blanked off. The casings and cornice remain, but the sash has been removed and the opening filled

Historic photo showing Old Town Hall with cupola

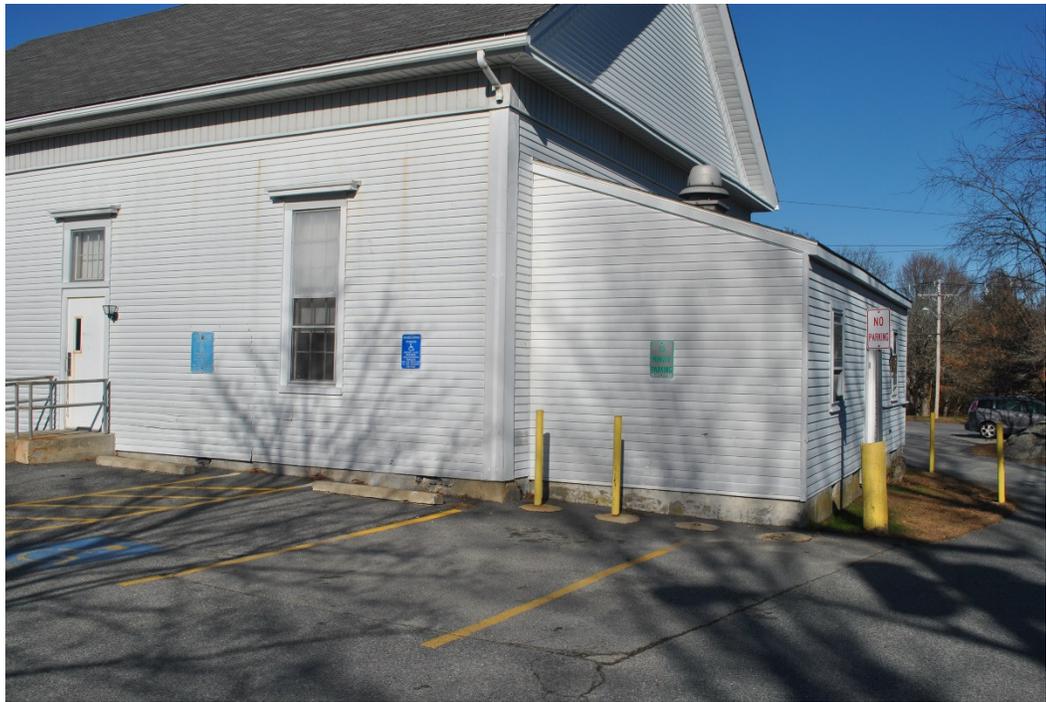
Looking from the Southeast
